2016 Corvette: Service Bulletin: Delayed Engagement After Sitting With Engine Off

#16-NA-014: Delayed Engagement After Sitting With Engine Off - (Jan 21, 2016)

Subject: Delayed Engagement After Sitting With Engine Off

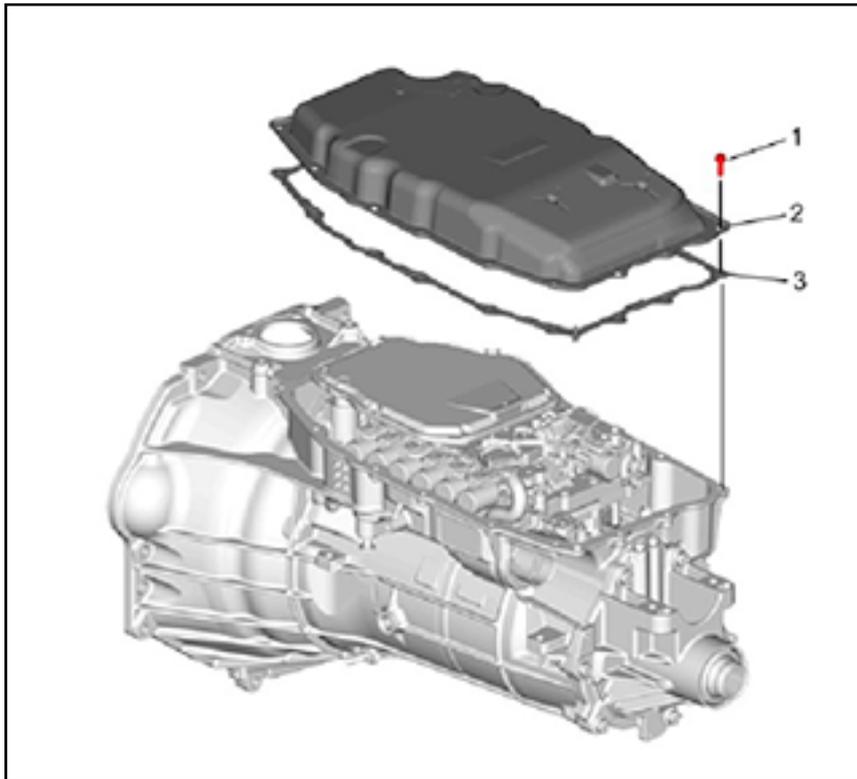
1. Remove the transmission from the vehicle and mount to the DT-48989 transmission holding fixture. Refer to *Transmission Replacement* in SI.
2. Remove the 15 bolts (1) securing the fluid pan and gasket to the transmission.

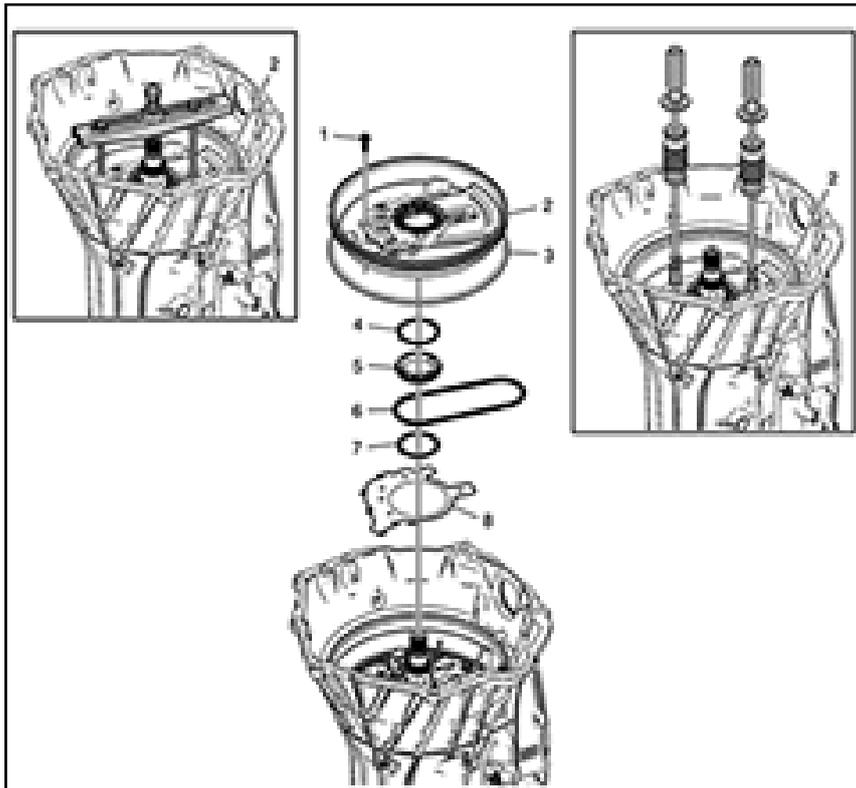
1. Using the DT-48285 Torx Plus socket, remove the two fluid baffle bolts (1) and fluid baffle (2). Discard the bolts.

1. Remove the driven sprocket (3) from the oil pump shaft leaving the drive link (chain) loose in the case.

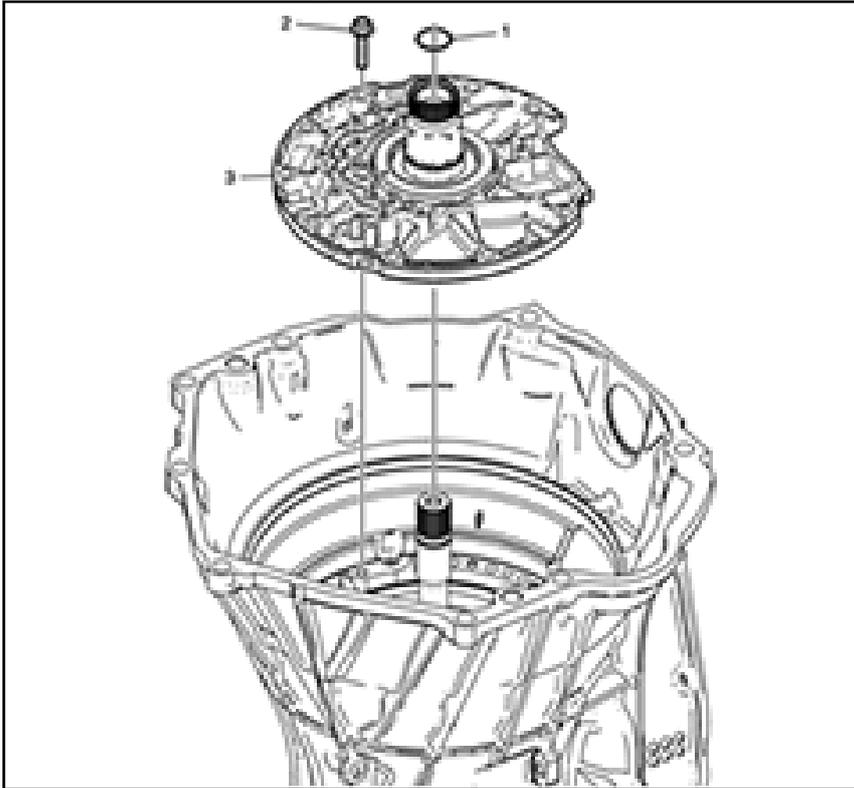
1. Remove the front cover (2) and seal (3). Inspect the seal and replace if worn or damaged.

2. Remove the drive sprocket (5).
3. Remove the drive link assembly (6).
4. Remove the front support cover gasket (8). Discard the gasket.
5. Inspect the front (4) and rear (7) drive sprocket thrust

1. Remove the 11 front cover bolts (1). Discard the bolts. The bolts have a dry sealant on them and may only be used once.
