2016 Corvette: Service Bulletin: Delayed Engagement After Sitting With Engine Off

#16-NA-014: Delayed Engagement After Sitting With Engine Off - (Jan 21, 2016)

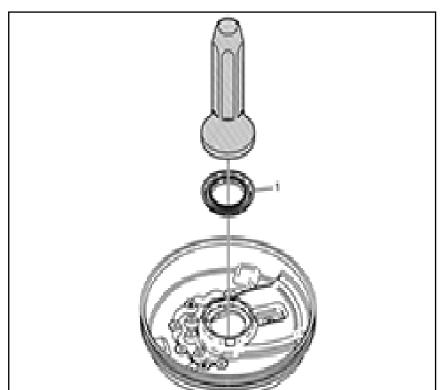
New cover 24277964

Note: The casting void has been eliminated from the underside of the cover (see illustration).
