2014 - 2016 Corvette: GM TechLink: Updated Corvette Driveline Support Assembly Replacement Procedure

Updated Corvette Driveline Support Assembly Replacement Procedure

- **Source:** GM TechLink - August 2016

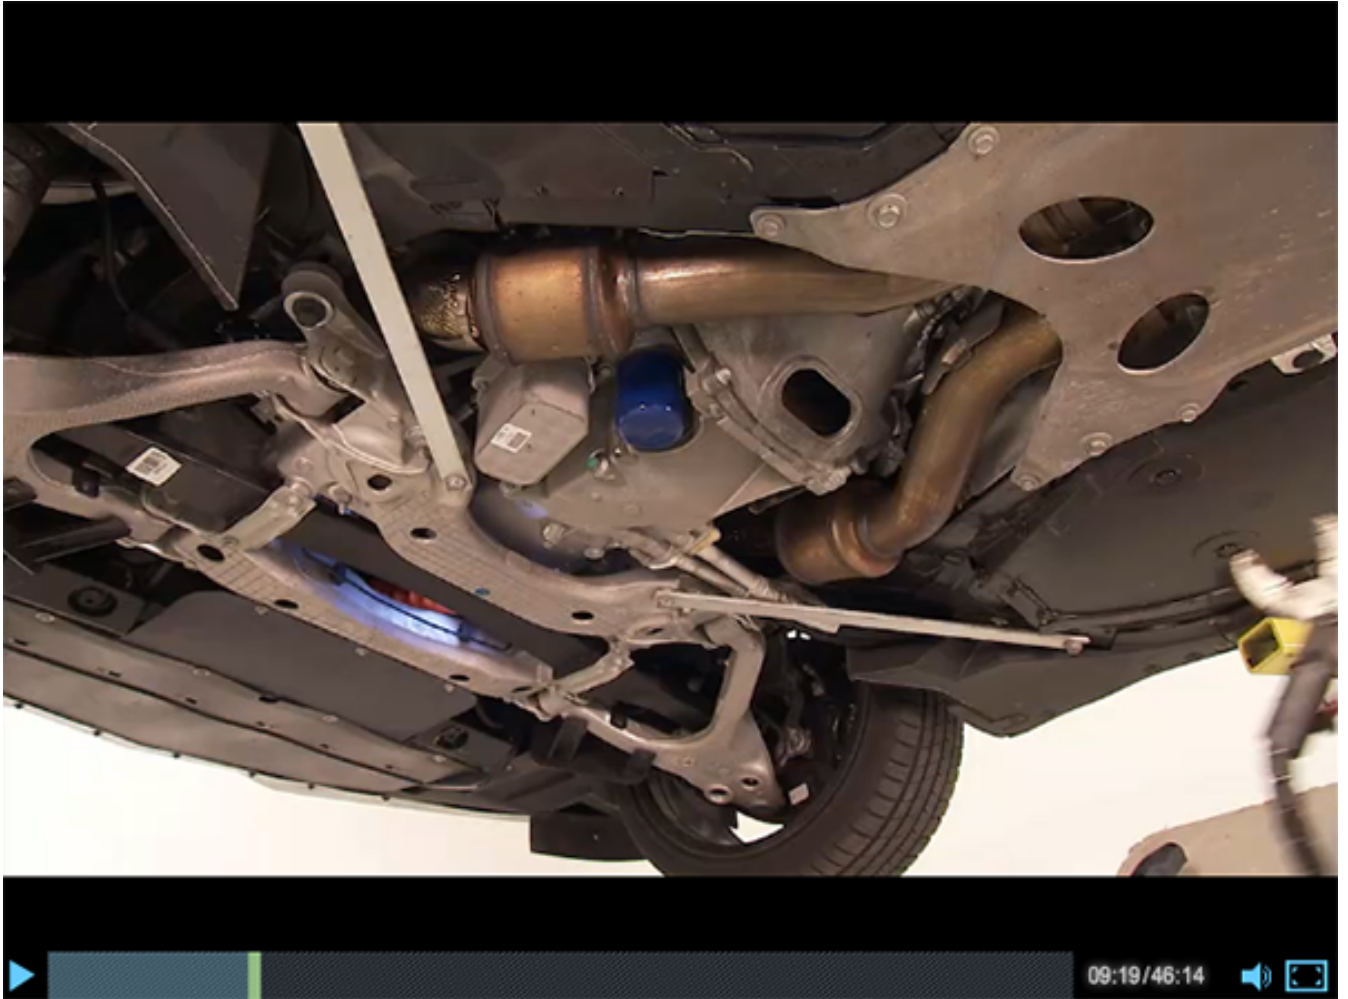
Fig. 5

A video on the updated procedure is included in the September 2016 Emerging Issues seminar (10216.09V) that is available on the GM Center of Learning. (Fig. 5)
