2014 - 2016 Corvette: GM TechLink: Updated Corvette Driveline Support Assembly Replacement Procedure

Updated Corvette Driveline Support Assembly Replacement Procedure

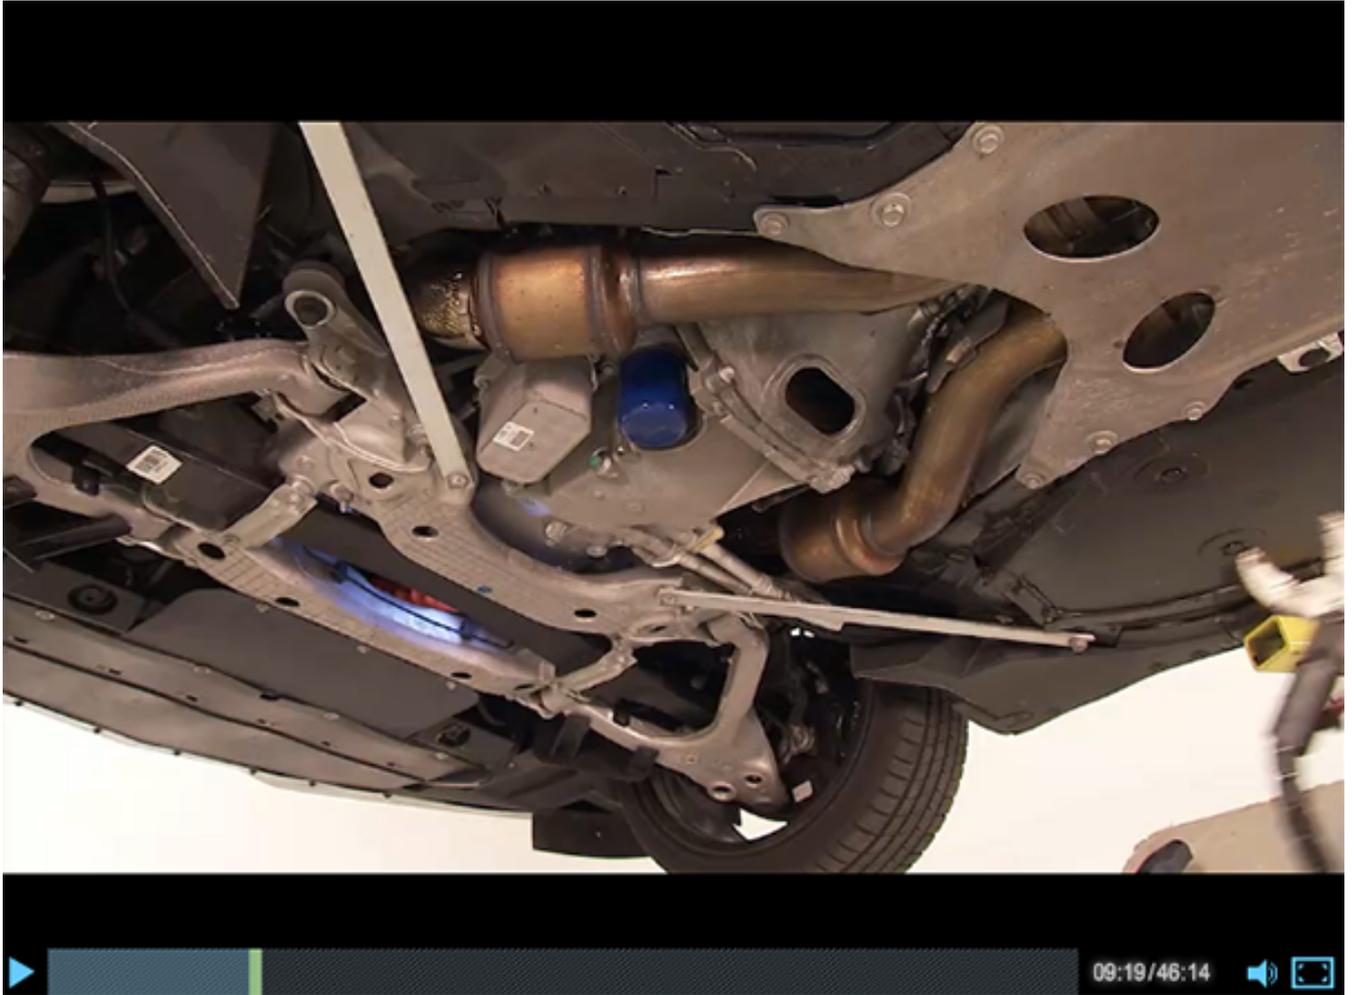
Fig. 5

A video on the updated procedure is included in the September 2016 Emerging Issues seminar (10216.09V) that is available on the GM Center of Learning. (Fig. 5)
