2016 - 2017 Corvette: Service Bulletin: #17-NA-025: Repeated Radio/display Resets, Volume Control Inoperative, Waiting for Update Media Message, Voice Command For Calling Bluetooth Phone Contacts Inoperative, Service Rear Vision System Message, Radi

**#17-NA-025: Repeated Radio/display Resets, Volume Control
Inoperative, Waiting for Update Media Message, Voice Command
For Calling Bluetooth Phone Contacts Inoperative, Service Rear
Vision System Message, Radio Turns On Unwanted At Startup,
and/or Navigation Radio Destination State Defaults To WV - (Mar
3, 2017)**

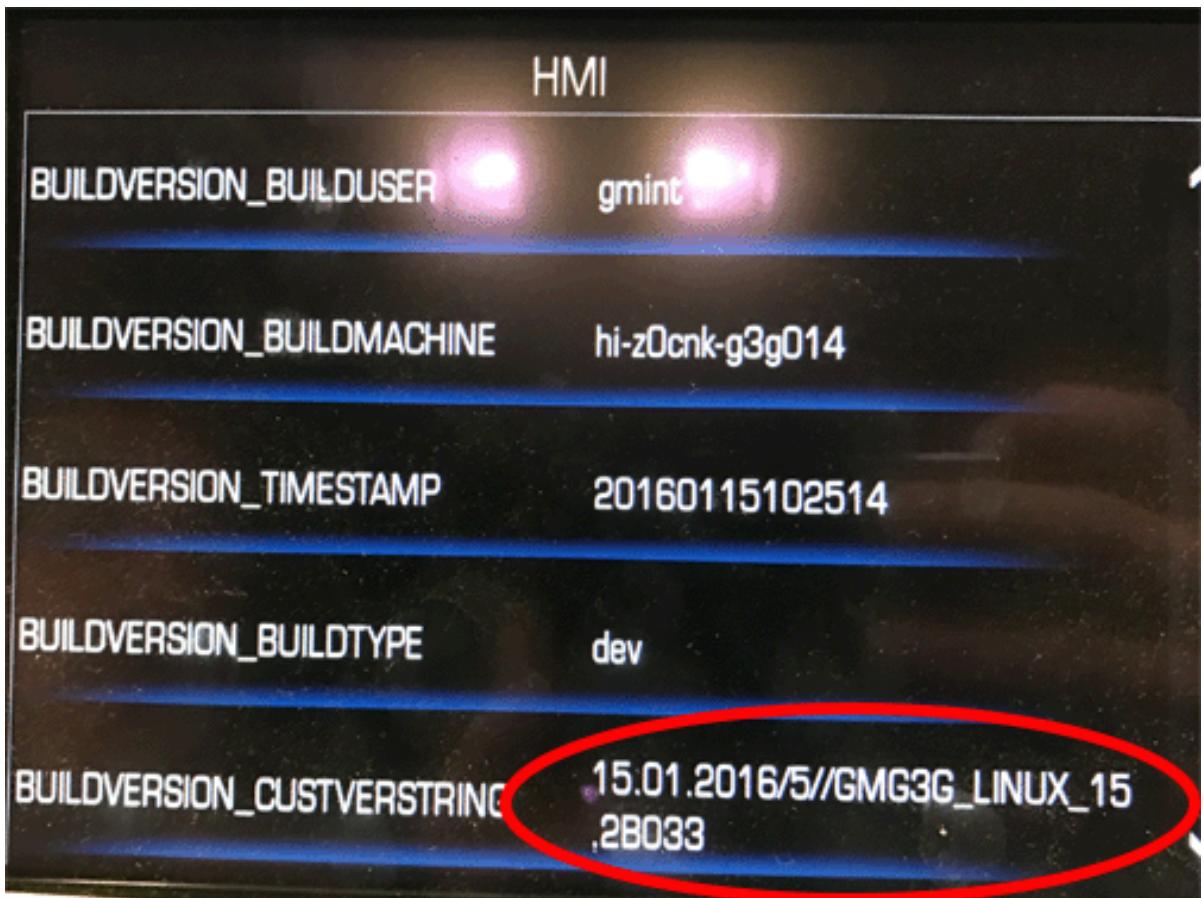
If you encounter a vehicle with the above concern, check the HMI build version.

Verify the HMI build version by completing the following:

To verify the HMI build version, on the radio, push the following button combination together (refer to chart below), then select HMI from the onboard development screen.
