# 2016 - 2017 Corvette: Service Bulletin: #17-NA-025: Repeated Radio/display Resets, Volume Control Inoperative, Waiting for Update Media Message, Voice Command For Calling Bluetooth Phone Contacts Inoperative, Service Rear Vision System Message, Radi

**#17-NA-025: Repeated Radio/display Resets, Volume Control Inoperative, Waiting for Update Media Message, Voice Command For Calling Bluetooth Phone Contacts Inoperative, Service Rear Vision System Message, Radio Turns On Unwanted At Startup, and/or Navigation Radio Destination State Defaults To WV - (Mar 3, 2017)**

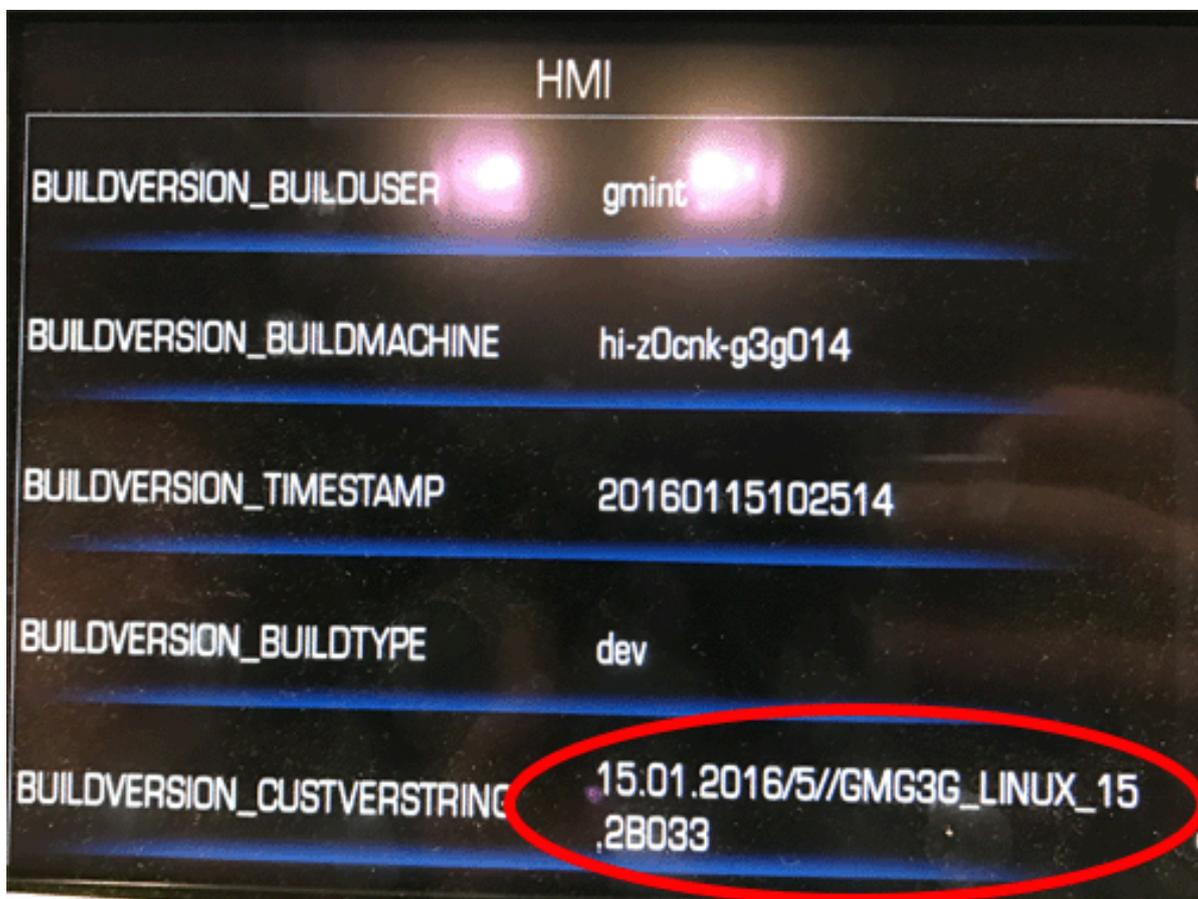
<i>Cause</i>	This may be due to a software anomaly.
--------------	--

If you encounter a vehicle with the above concern, check the HMI build version.

Verify the HMI build version by completing the following:
