**2016 - 2017 Corvette: Service Bulletin:  
 #17-NA-025: Repeated Radio/display Resets,  
 Volume Control Inoperative, Waiting for Update  
 Media Message, Voice Command For Calling  
 Bluetooth Phone Contacts Inoperative, Service  
 Rear Vision System Message, Radi**

**#17-NA-025: Repeated Radio/display Resets, Volume Control Inoperative, Waiting for Update Media Message, Voice Command For Calling Bluetooth Phone Contacts Inoperative, Service Rear Vision System Message, Radio Turns On Unwanted At Startup, and/or Navigation Radio Destination State Defaults To WV - (Mar 3, 2017)**

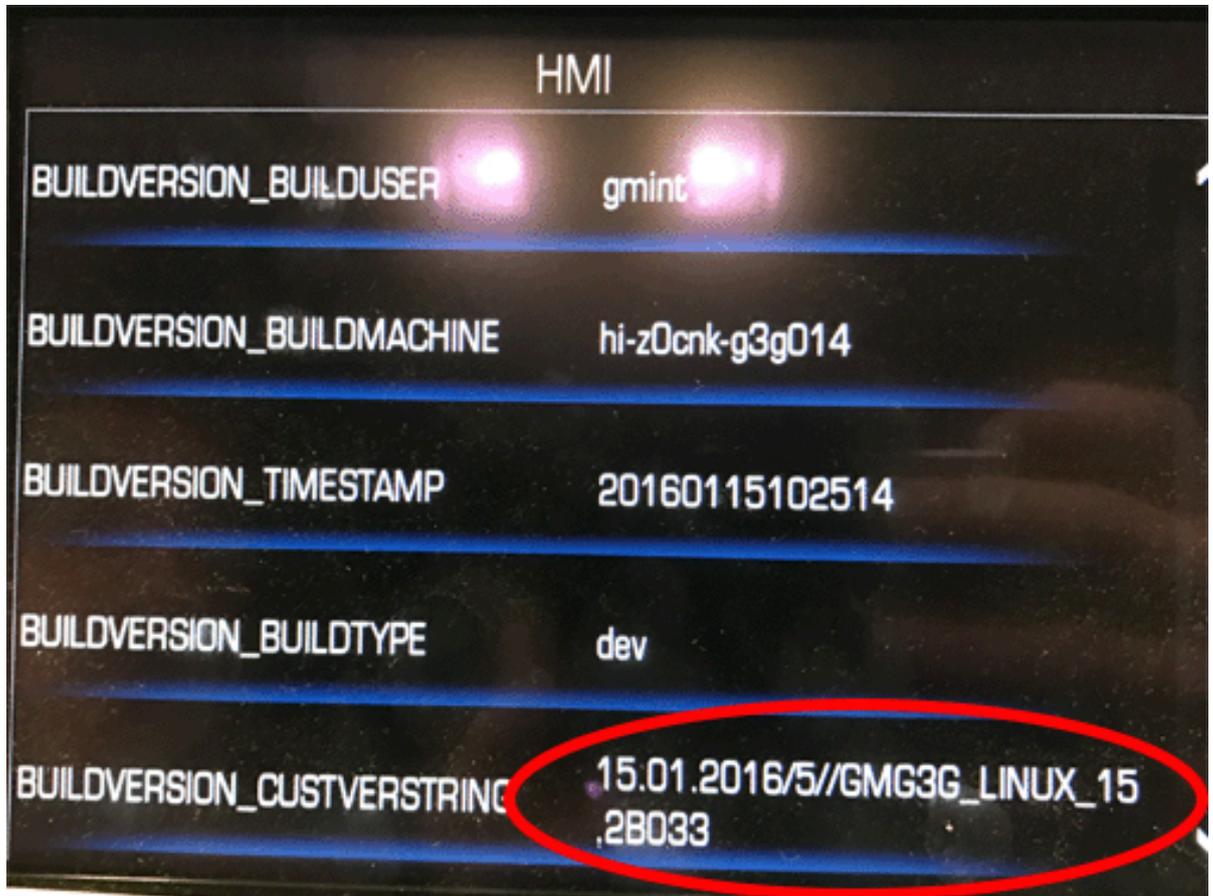
<i>Cause</i>	This may be due to a software anomaly.
--------------	--

If you encounter a vehicle with the above concern, check the HMI build version.

Verify the HMI build version by completing the following:
