1991 Corvette: Service Bulletin: Squeak and Rattle Diagnosis Guide

Subject: SQUEAK AND RATTLE DIAG. GUIDE DIAGNOSTIC AID/CORRECTION

Model and Year: 1991 CORVETTE

Bulletin Number: 91-264-10 - (03/25/1991)

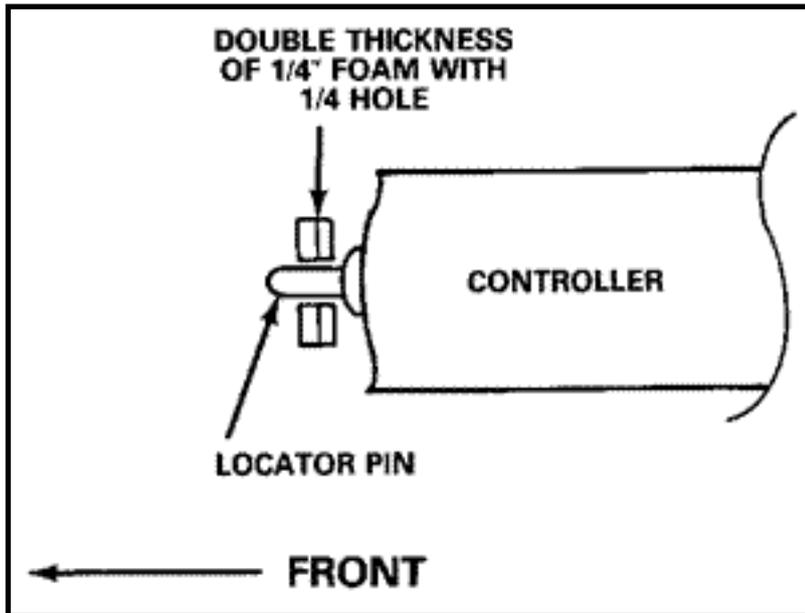
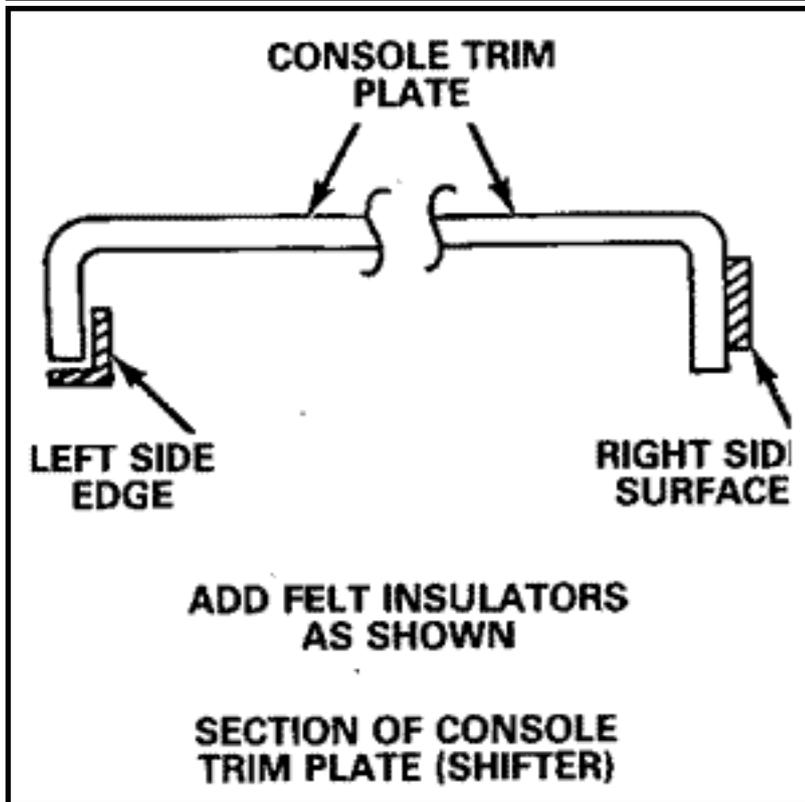
FIGURE 5

2. Buzzing of fuse box rivet 2. Apply small 1/4" foam heads to instrument panel insulator between rivet head cover. and cover as shown and cover as shown in Figure 5, view A.

3. Buzzing of fuse box door 3. Apply felt insulators (1/4" X in the opening. 1") as shown in Figure 5, view B. Position felt into the radius of the opening.
