1989 - 1991 Corvette: Service Bulletin: Proper Installation and Seating of the SIR Coil Assembly

Subject: PROPER INSTALLATION AND SEATING OF THE SIR COIL ASSEMBLY

Model and Year: 1989-91 CAPRICE, CAMARO, CORVETTE, CORSICA AND BERETTA

Bulletin Number: 91-204-3B - (01/23/1991)

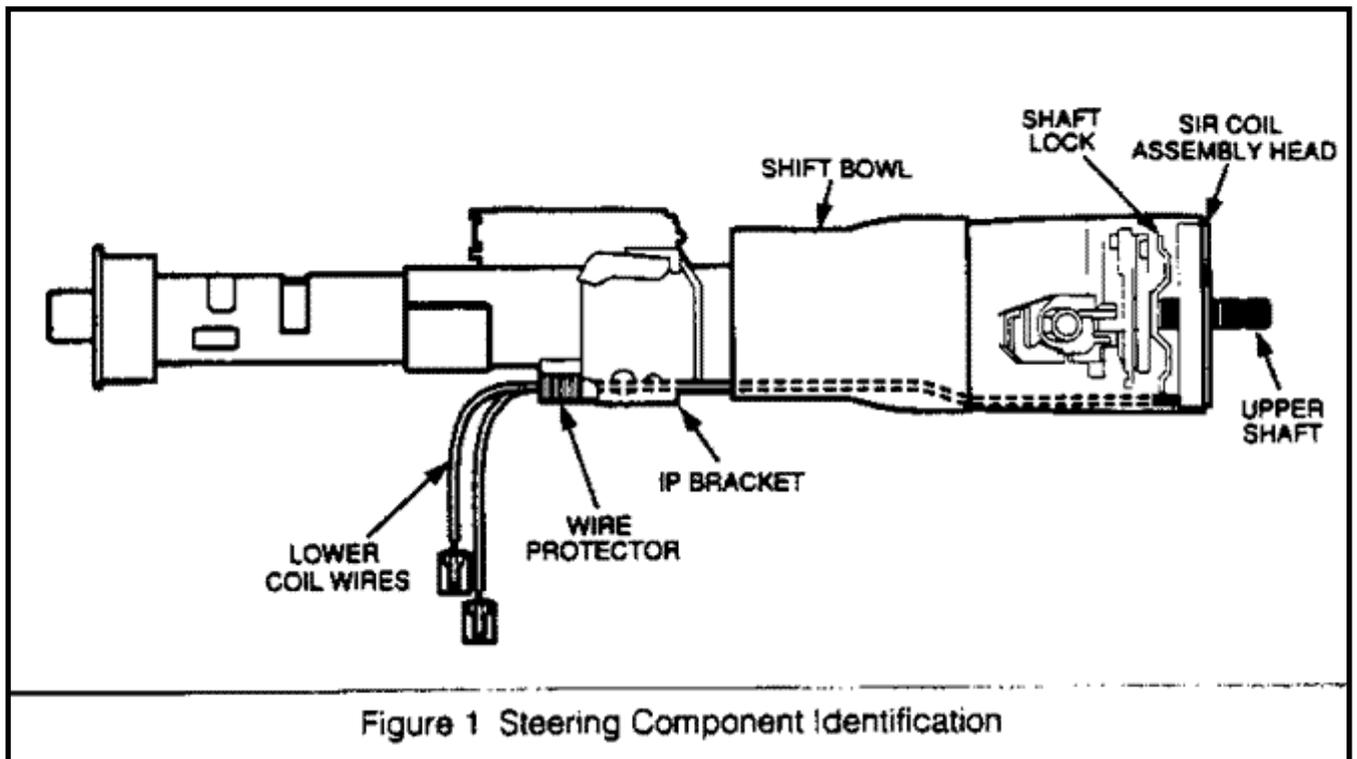
The lower SIR coil assembly wires can be kinked near the shaft lock mechanism after service of the steering column. The improperly located wires interfere with the shaft lock and can be cut when the steering wheel is turned. The SIR coil must be reassembled correctly. During reassembly, do not force the coil down, and do not allow the lower coil wires to be trapped between the shaft lock and the coil assembly.

After the steering column has been serviced, the SIR coil assembly may be improperly seated with slack in the lower SIR coil wires in the shaft lock area.

The purpose of the following procedure is to eliminate slack in the lower SIR coil wires and avoid kinking of these wires in the shaft lock area. Proper installation and seating of the SIR coil assembly prevents the lower coil wires from being cut.

The following procedures may be performed with the steering column in the vehicle or as a bench procedure. If the steering column is not installed, position the column on the bench as it would appear in the vehicle. Refer to the vehicle service manual (Sections 3F, 3F4, and 3F5) for detailed repair procedures (See Figure 1).
