# 1984 - 1985 Corvette: Service Bulletin: Improperly Installed Reverse Idler Shaft Roll Pin

**Subject:** IMPROPERLY INSTALLED REVERSE IDLER SHAFT ROLL PIN

**Model and Year:** 1984-1985 CORVETTE

**Bulletin Number:** 85-31 - (01/09/1985)

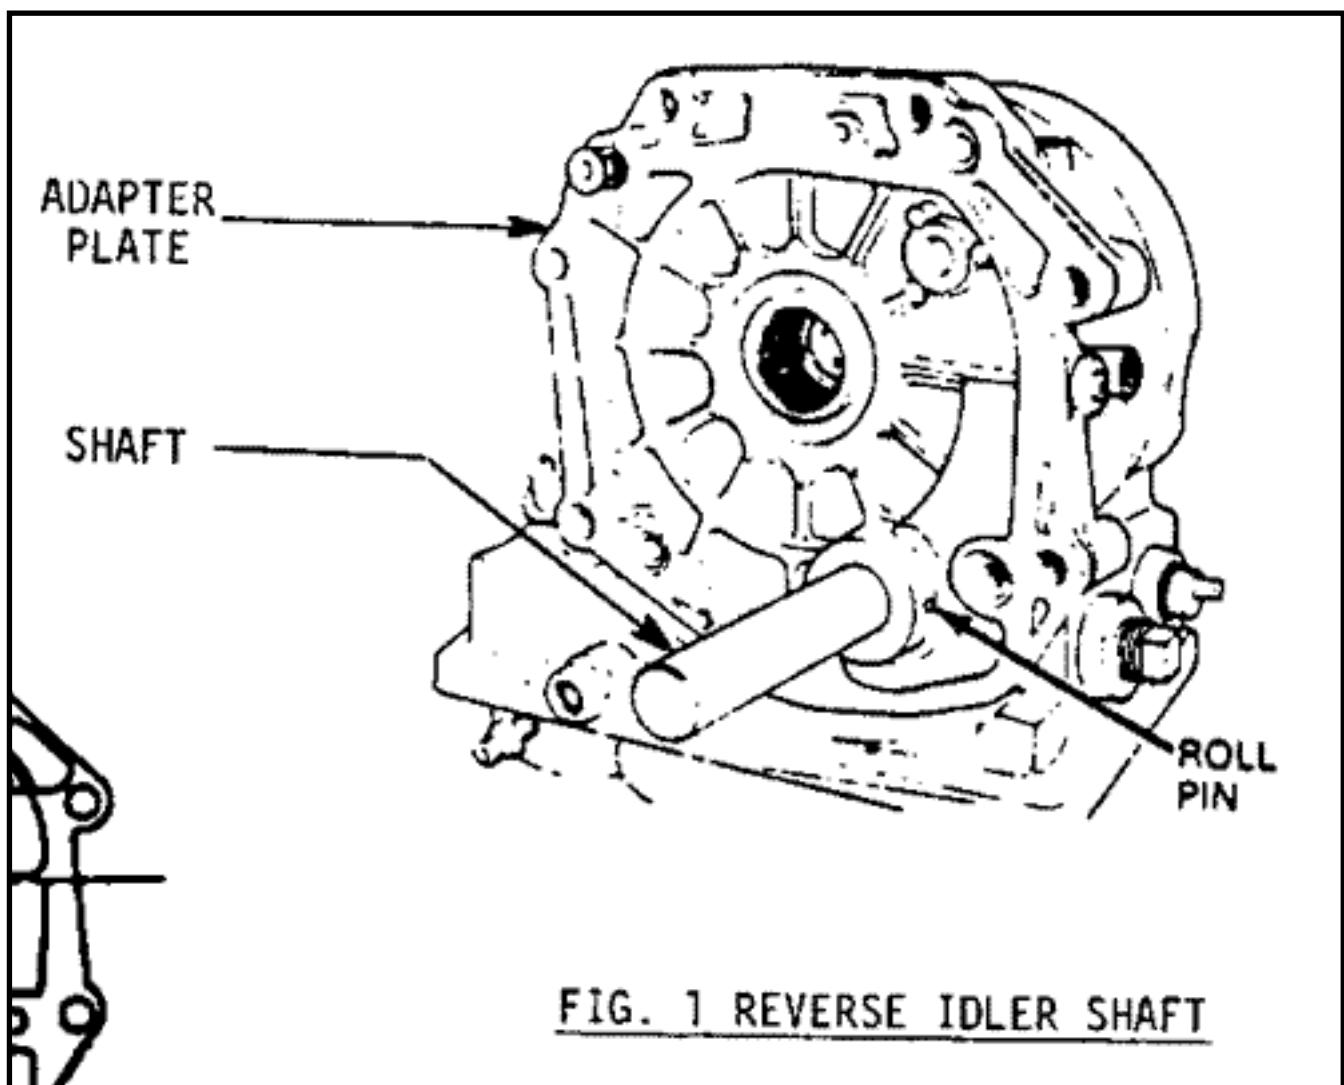
FIG. 1 REVER

Damage to the manual transmission may occur if the roll pin securing the reverse gear idler shaft to adapter plate (Figure 1) is not fully seated to prevent the shaft from spinning and/or backing out. To insure assembly operation results in the shaft securely locked in place, the roll pin has been lengthened from 0.50" to 0.75". When servicing transmissions with the shorter roll pin (0.50"), discard the roll pin and replace with longer roll pin (0.75") maximum.

The recommended procedure for removal and installation of the roll pin is as follows:
