1984 - 1985 Corvette: Service Bulletin: Improperly Installed Reverse Idler Shaft Roll Pin

Subject: IMPROPERLY INSTALLED REVERSE IDLER SHAFT ROLL
PIN

Model and Year: 1984-1985 CORVETTE

Bulletin Number: 85-31 - (01/09/1985)

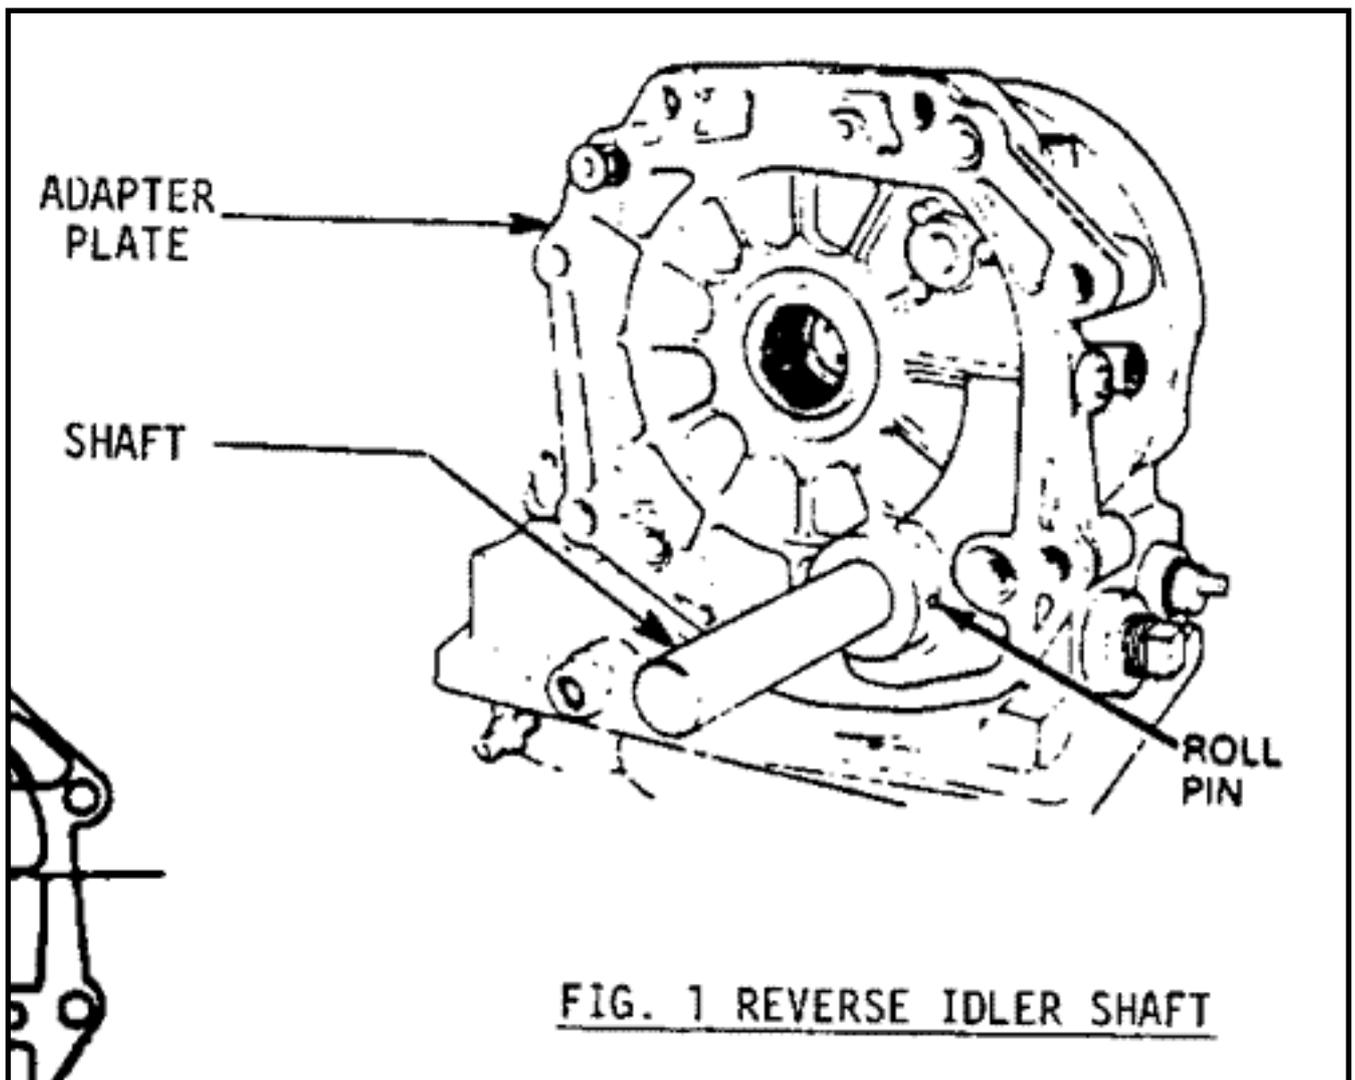
Damage to the manual transmission may occur if the roll pin securing the reverse gear idler shaft to adapter plate (Figure 1) is not fully seated to prevent the shaft from spinning and/or backing out. To insure assembly operation results in the shaft securely locked in place, the roll pin has been lengthened from 0.50" to 0.75". When servicing transmissions with the shorter roll pin (0.50"), discard the roll pin and replace with longer roll pin (0.75") maximum.

The recommended procedure for removal and installation of the roll pin is as follows:

A. PIN REMOVAL

1. Insert small punch tool into plate boss hole and carefully drive roll pin into reverse idler shaft (Figure 3).

CAUTION:

Driving roll pin too hard may cause to jam and result in shaft binding to adapter plate.

2. Pull reverse idler shaft from adapter plate and remove roll pin from shaft.

B. PIN INSTALLATION

1. Insert reverse idler shaft into adapter plate and align hole in shaft with hole in plate boss.

2. Insert 0.75" roll pin into plate boss hole and, with small punch tool, carefully drive roll pin flush with plate boss (Figure 2).

3. Verify that shaft cannot be pulled from adapter plate.
