2015 - 2016 Corvette: Service Bulletin: #16-NA-107: DTC U0184 Set, Radio Inoperative, Blue Screen, AM Clipping Noise, HD On/Off Status Not Retained in Stations, Time Lag on Transitions, No Audio with Internal Amp, Park Assist Symbol Position Wrong i

#16-NA-107: DTC U0184 Set, Radio Inoperative, Blue Screen, AM Clipping Noise, HD On/Off Status Not Retained in Stations, Time Lag on Transitions, No Audio with Internal Amp, Park Assist Symbol Position Wrong in Rear View Camera - (Sep 8, 2016)

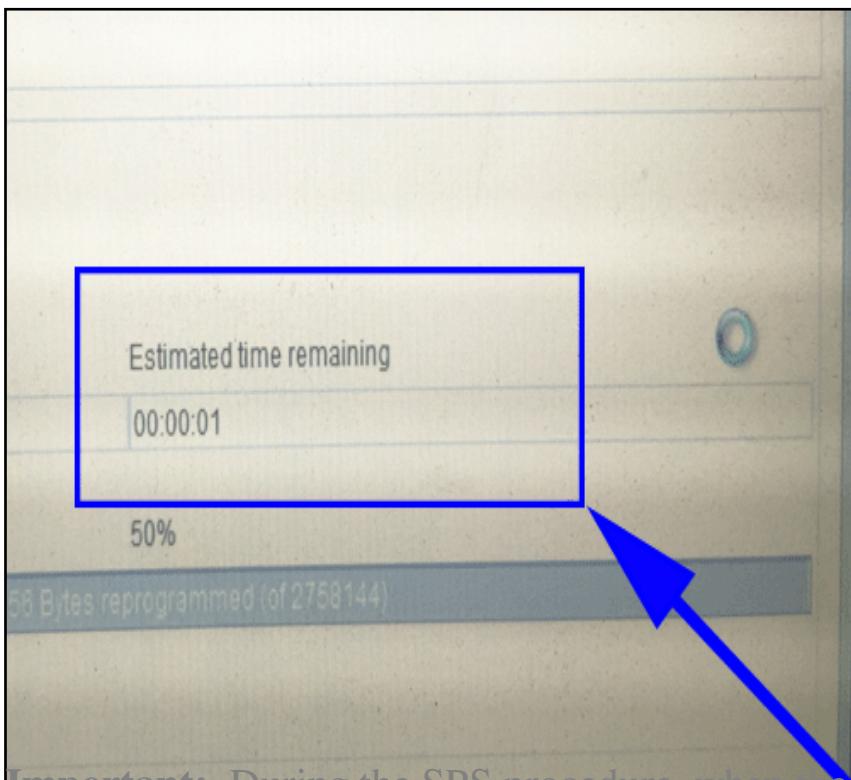
If you encounter a vehicle with the above concern, reprogram the radio with the latest calibrations. Refer to the proper SPS radio reprogramming procedure in SI.

Important: During the SPS procedure, when the estimated time remaining reaches 00:00:01, it may take a few minutes to complete the reprogramming. Be sure to wait until the reprogramming is completed.
