1969 Corvette: Service News: Directional Signal Switch Removal and Installation

Subject: Directional Signal Switch Removal and Installation
Model and Year: 1969 Tilt-Telescoping Column
Source: Chevrolet Service News
Page Number: 8
Date: March 1969 - Volume 41 - Number 3

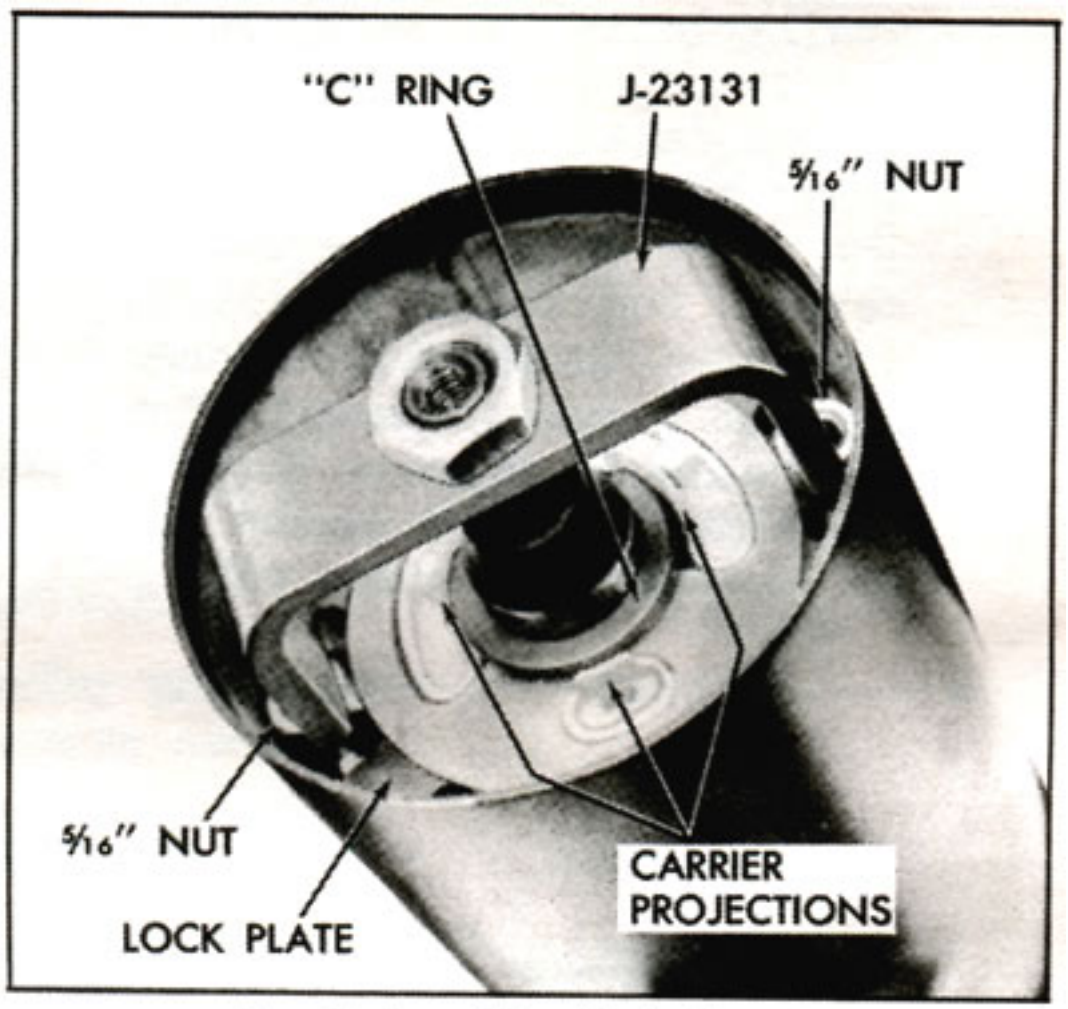
Fig. 8—Install Nut Under 'Legs'

Procedures for removal and installation of the directional signal switch on the 1969 Corvette Tilt-Telescoping steering column specify the use of Tool J-22191 to remove and install the "C" ring which retains the horn contact assembly in position on the steering shaft. Although this procedure will work satisfactorily, extreme care must be used to prevent the tool from slipping off the contact assembly and braking the plastic carrier projections.

1. Place tool J-23131 over the end of the steering shaft.
2. Place a 5/16 inch nut under both 'legs' of the tool on each side of the lock plate as shown in Figure 8. Reinstall lock screw to prevent shaft from moving out of column.
3. Using the shaft nut, compress the lock plate just enough to remove the "C" ring.
4. Remove the shaft nut, tool J-23131, and the two 5/16 inch nuts and proceed with removal of the directional signal switch.
