2020 Corvette: Recall Notice: #N202309350: Non-Compliance - Interior Trunk Release Button Inoperative Ten Minutes After Power Off

Subject: N202309350 — Interior Trunk
Release Button Inoperative Ten
Minutes After Power Off

Models: 2020 Chevrolet Corvette

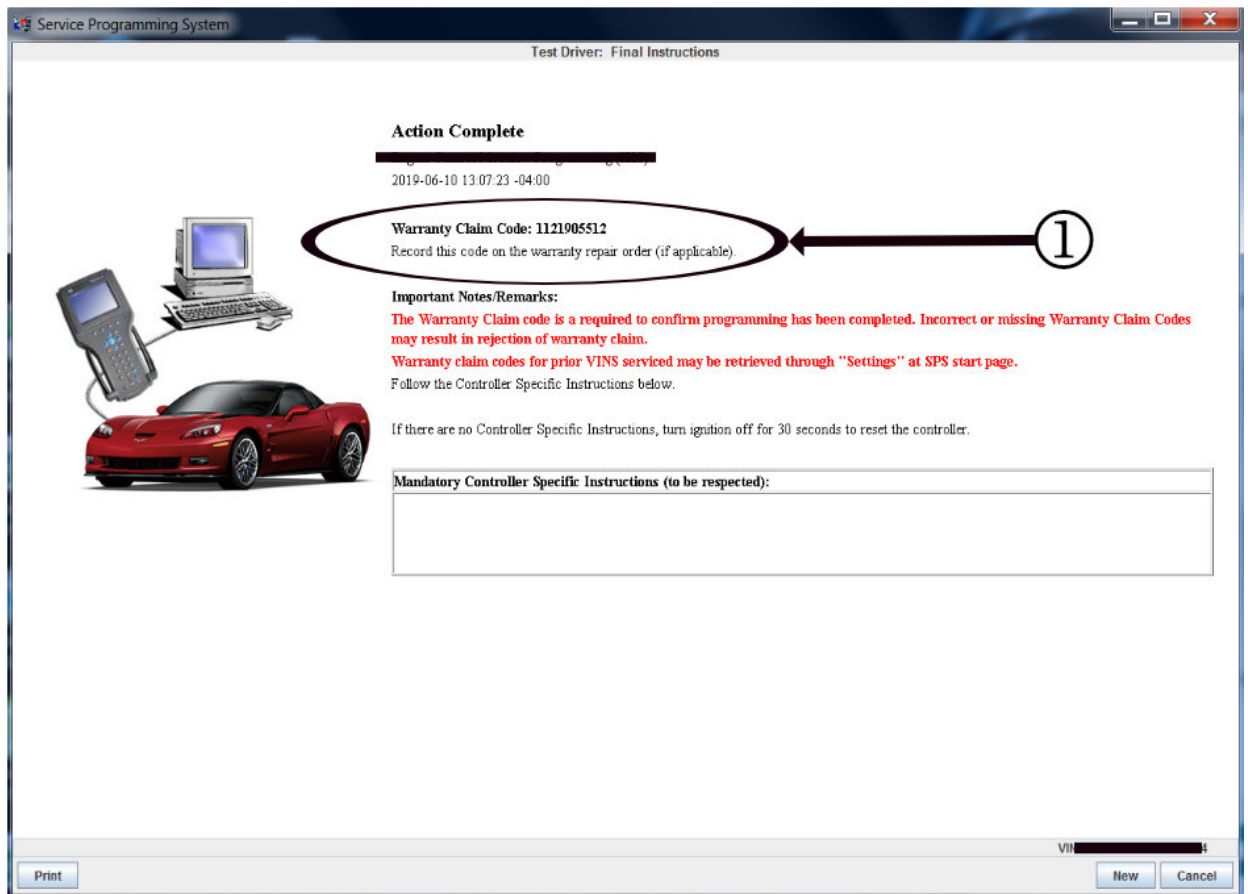
Important: TIS2WEB screen shown. Techline Connect screen is similar and will be included in the near future.

Important: To avoid warranty transaction rejections, you *MUST* record the warranty
