1986 - 1988 Corvette: Service Bulletin: Roof Panel Adjustment Procedures

Subject: Roof Panel Adjustment

1986 - 1988 Corvette Coupes

INSTALLATION INSTRUCTION SHEET

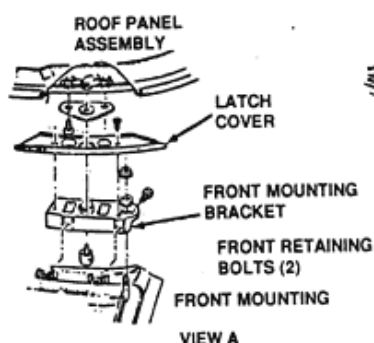
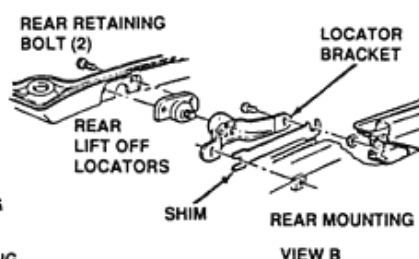
1. Place vehicle on level surface, lower both windows and move sunvisor out of the way.
2. Remove existing roof panel by unscrewing the (2) front and (2) rear retaining bolts.
3. Prior to installing the new roof panel assembly, make sure both front holding plate screws are untorqued allowing the parts to move freely but still remain in a repositioned location (View A).
4. Place the new roof panel assembly on the vehicle by engaging the locator brackets (View B). Then carefully attach the rear retaining bolts. After making sure the bolt threads are in line with the locator bracket, snug the bolts to 5 N.m. torque. Check to see if the approximate 6mm space and flush condition exists

5. Align the front retaining bolts in the front mounting brackets with the threaded hole in the "loose" front holding plates (View A). Torque the rear retaining bolts to 20 N.m., then the front retaining bolts to 15 N.m.

- Remove all trim panels/covers covering the front mounting bracket adjusting bolts (View C).
- Loosen these bolts to lower/raise the mounting bracket to improve weatherstrip contact, reinstall and remove roof panel to obtain correct fit.
- Add/remove shims behind the rear locator bracket, reinstall and remove roof panel until a satisfactory parallel fit is obtained.
