1984 Corvette: Service Bulletin: Engine Stops Running When Starting with Air Conditioning "On"

Subject: Engine Stops Running When Starting with Air Conditioning "On"
Model and Year: 1984 Corvette with Automatic Transmissions
Source: Chevrolet Dealer Service Bulletin
Bulletin No: 84-240
Section: 8B (XII)
Date: Feb. 1985

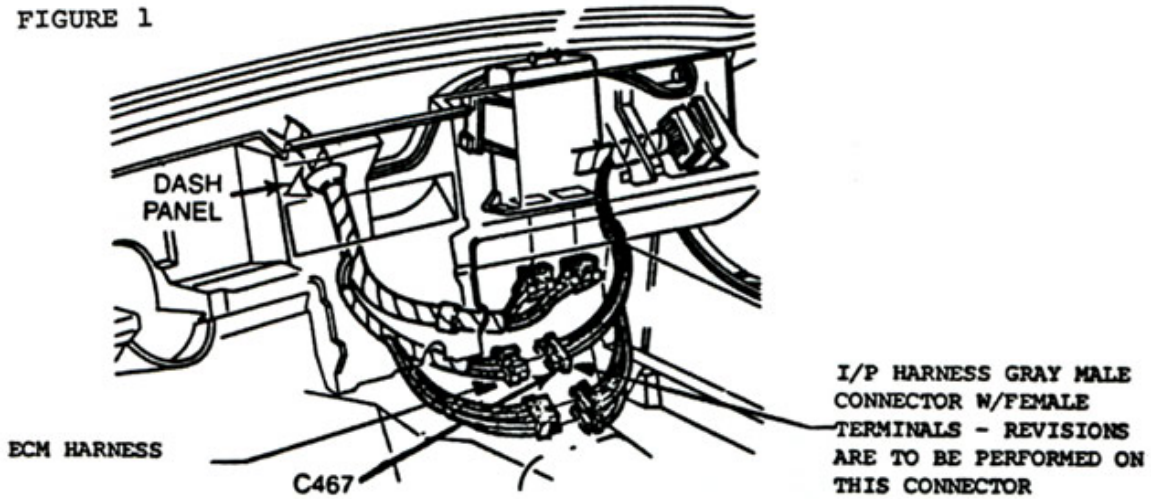
FIGURE 1

1. Remove I/P upper trim pad assembly. Remove L.H. and R.H. hush panels.
2. Extract female terminal (green wire) from gray I/P to ECM harness connector C-467, circuit 66 (see Figure 1.)
3. Cut off and discard extracted female terminal. Fold severed green wire back and tape it to the I/P harness, making sure the severed wire end is well insulated with electrical tape.
4. Utilize the 22 feet of 16 Ga. GXL black wire by stripping one end and crimping, P/N 12015856, female terminal on the stripped end. Insert the new terminal into connector C-467, Pin F.

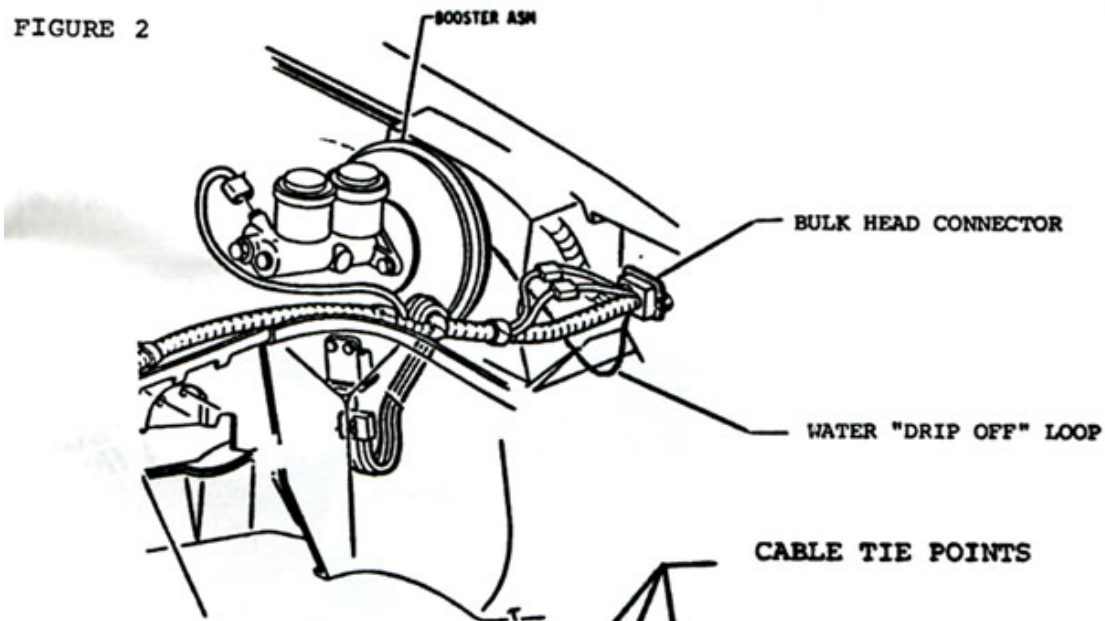
FIGURE 2

6. Using masking tape, secure the signal wire to the A/C ducts to avoid wire abrasion and rattles.
7. Remove I/P harness bulk head caps on the passenger compartment side, as well as the engine compartment side. DO NOT disconnect the bulk head connectors.
8. Feed the signal wire through the open (unused) bulk head, Pin #E4, located adjacent to a 12 Ga. red wire. it may be necessary to strip the feed end of the signal wire approximately two (2) inches from the end and "solder tint" the wire to aid in guiding the wire through the bulk

9. Once the signal wire has been fed through the bulk head connector, grease is to be packed around the signal wire at both sides of the connector. This step assures an adequate bulk head connector to signal wire seal.
10. Reinstall the bulk head harness caps.
11. Loop the signal wire down below the bulk head connector and back up behind the brake booster (see Figure 2.)
12. Route the signal wire along the R.H. hood release cable securing the wire to the cable with three (3) cable ties.
13. At the R.H. rear corner of the engine, direct the wire to the front of the engine and install it in the existing engine harness conduit (see Figure 3.)

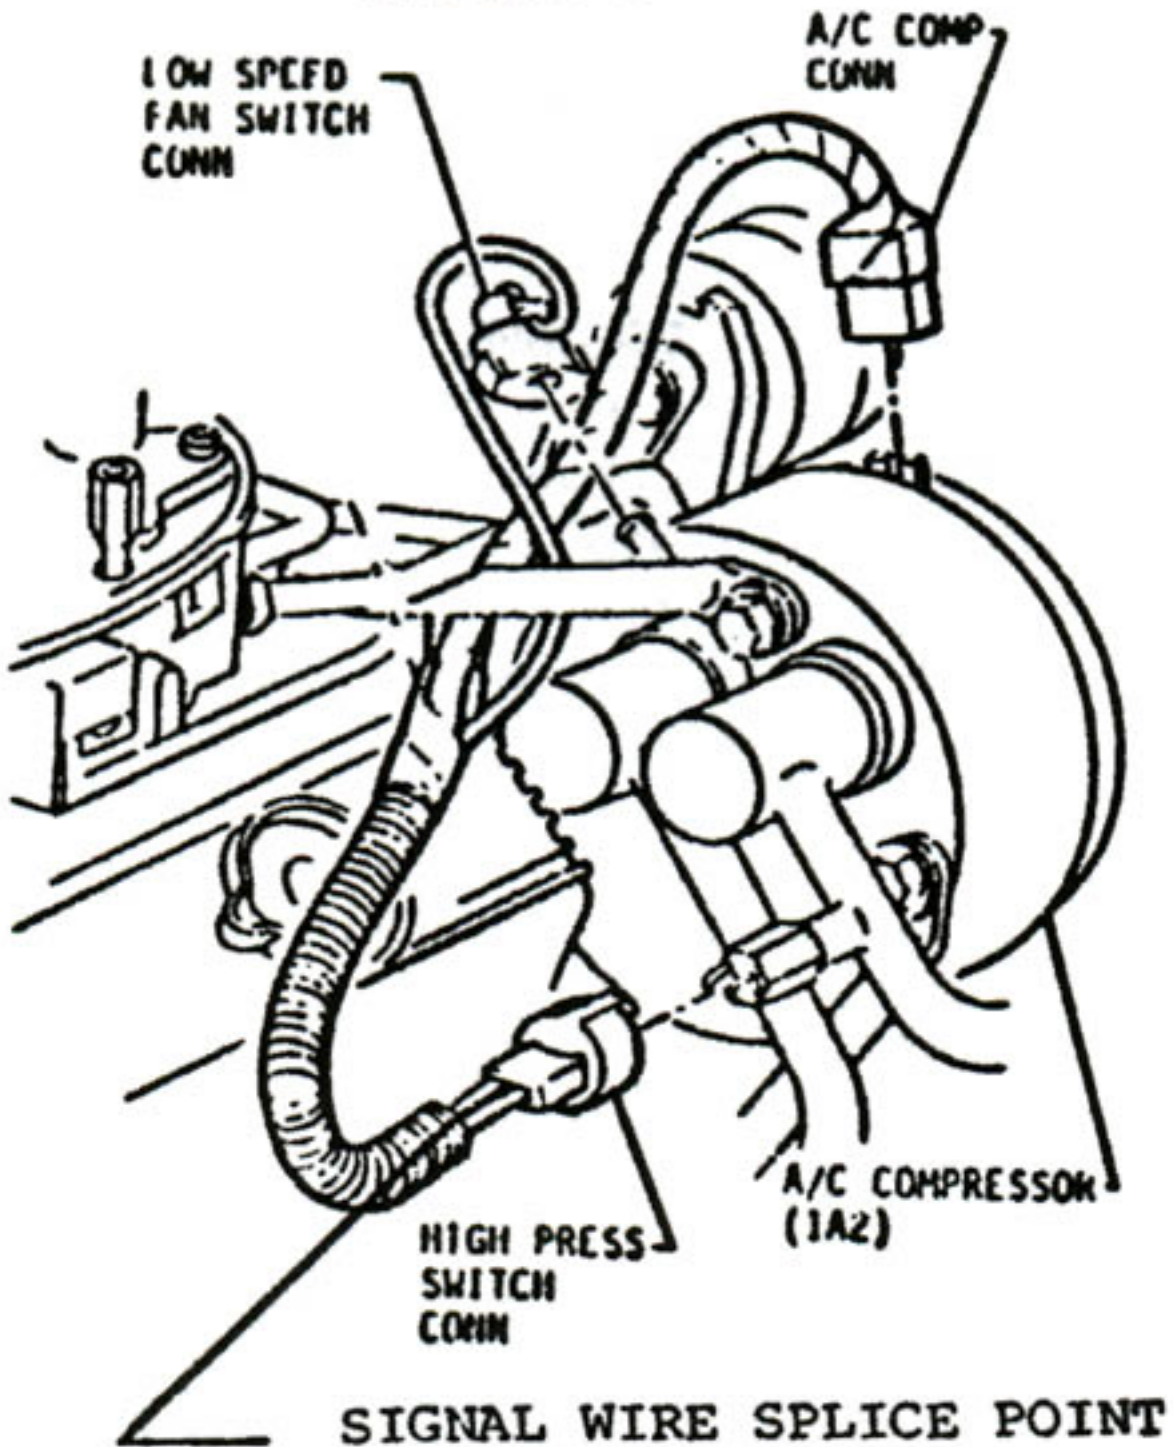
FIGURE 4

14. Remove the harness end tape and strip the insulation back .5 inches on the green wire at the high pressure A/C switch connector (see Figure 4.)
15. Remove excess signal wire length, if necessary, and strip end back .75 inches. Wrap the signal wire around the A/C clutch green wire and solder to insure a good connection.
16. Retape harness at high pressure switch connector.
17. Reinstall I/P upper trim panel and hush panels.
