2015 - 2016 Corvette Z06 / Z07: Service News: Important Carbon Fiber Rocker Molding Installation Instructions for Z06/Z07

SUBJECT Important Carbon Fiber Rocker Molding Installation
Instructions for Z06/Z07

MODELS 2015-2016 Corvette Z06/Z07 with 8 Speed Automatic
Transmission

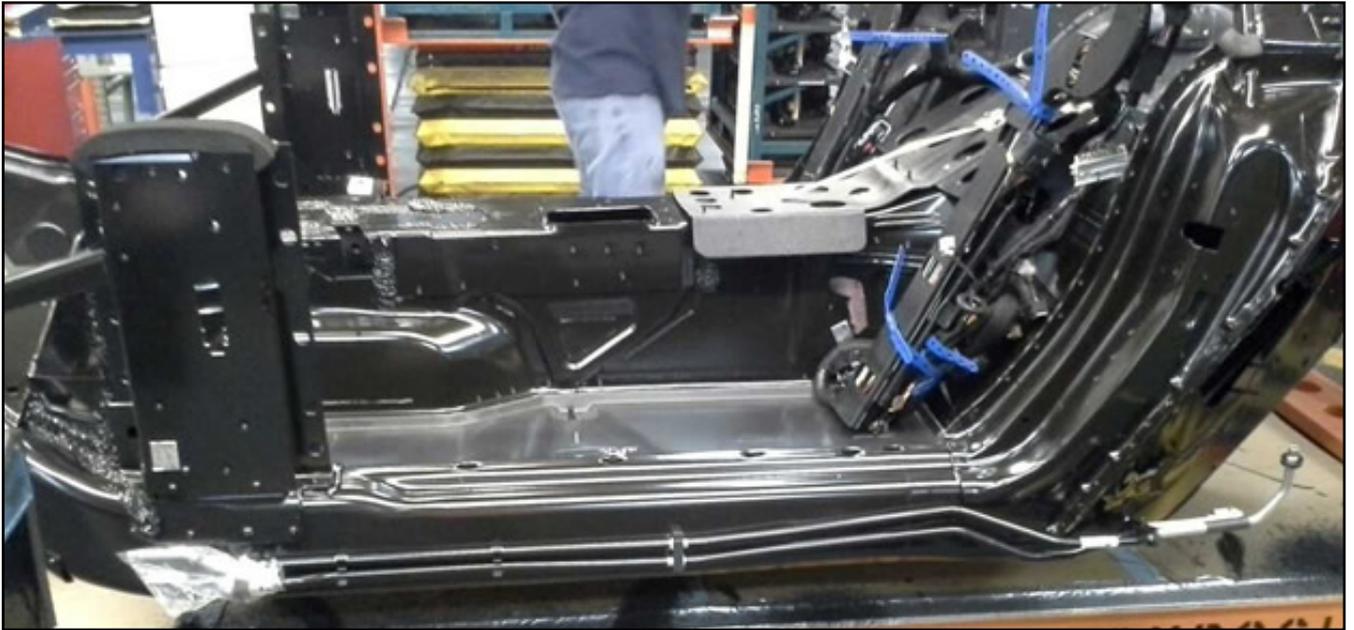
IMPORTANT: It has come to our attention that if you do not use a drill bit collet on the drill bit when drilling the holes for the rivets that attach the loose shipped carbon fiber rocker panels, It may be possible to drill a hole through the transmission cooler lines for the front auxiliary cooler.

The photo below shows the location of the automatic transmission cooler lines with the body's rocker molding removed.

Please make sure to drill all holes perpendicular to the outside surface. Also make sure to use a drill bit collet to control bit depth to only 12mm max into the rocker.
