2014 - 2016 Corvette: Service Bulletin: #16-NA-170: Brake Pulsation and/or Vibration During Brake Apply

#16-NA-170: Brake Pulsation and/or Vibration During Brake Apply - (July 20, 2016)

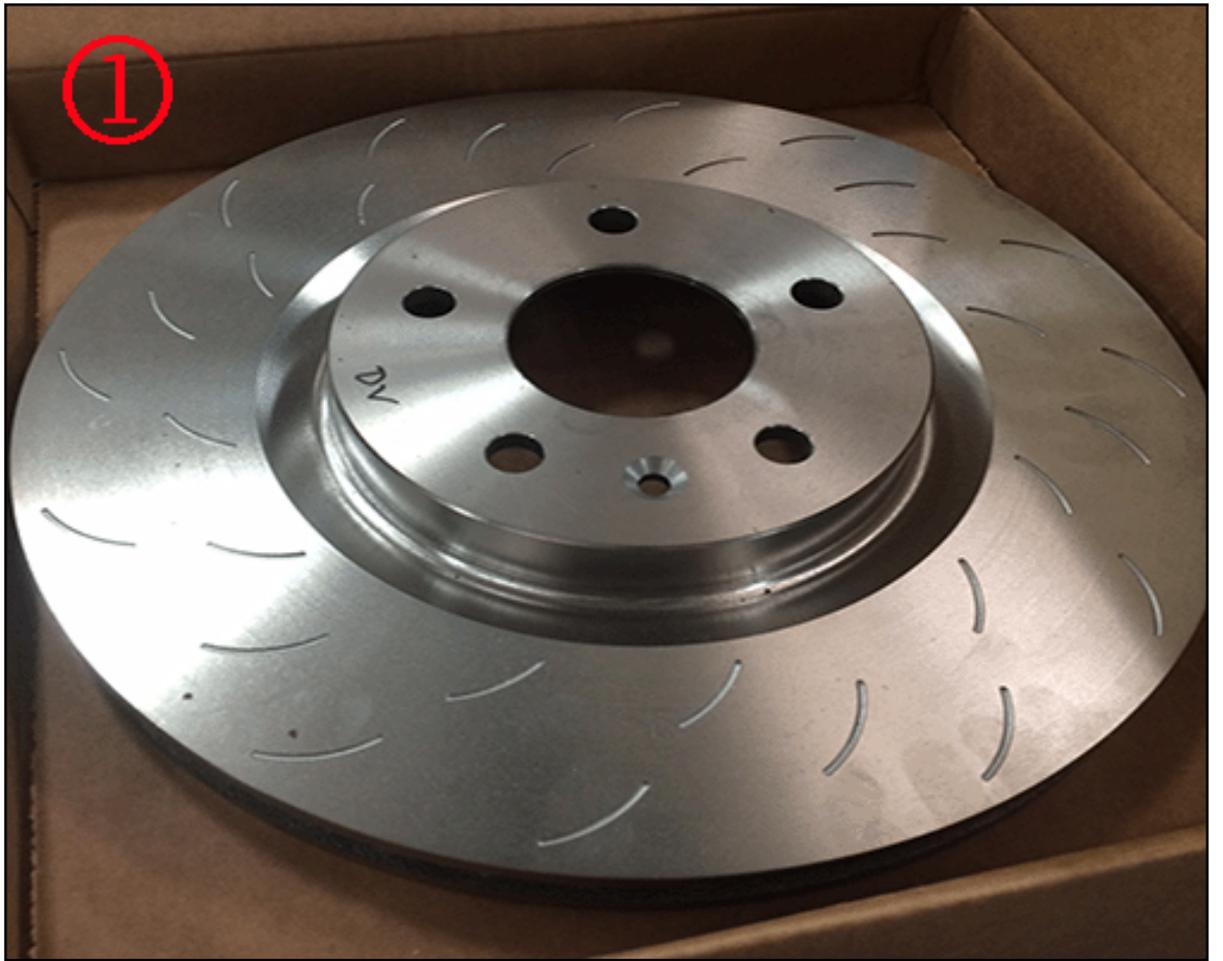
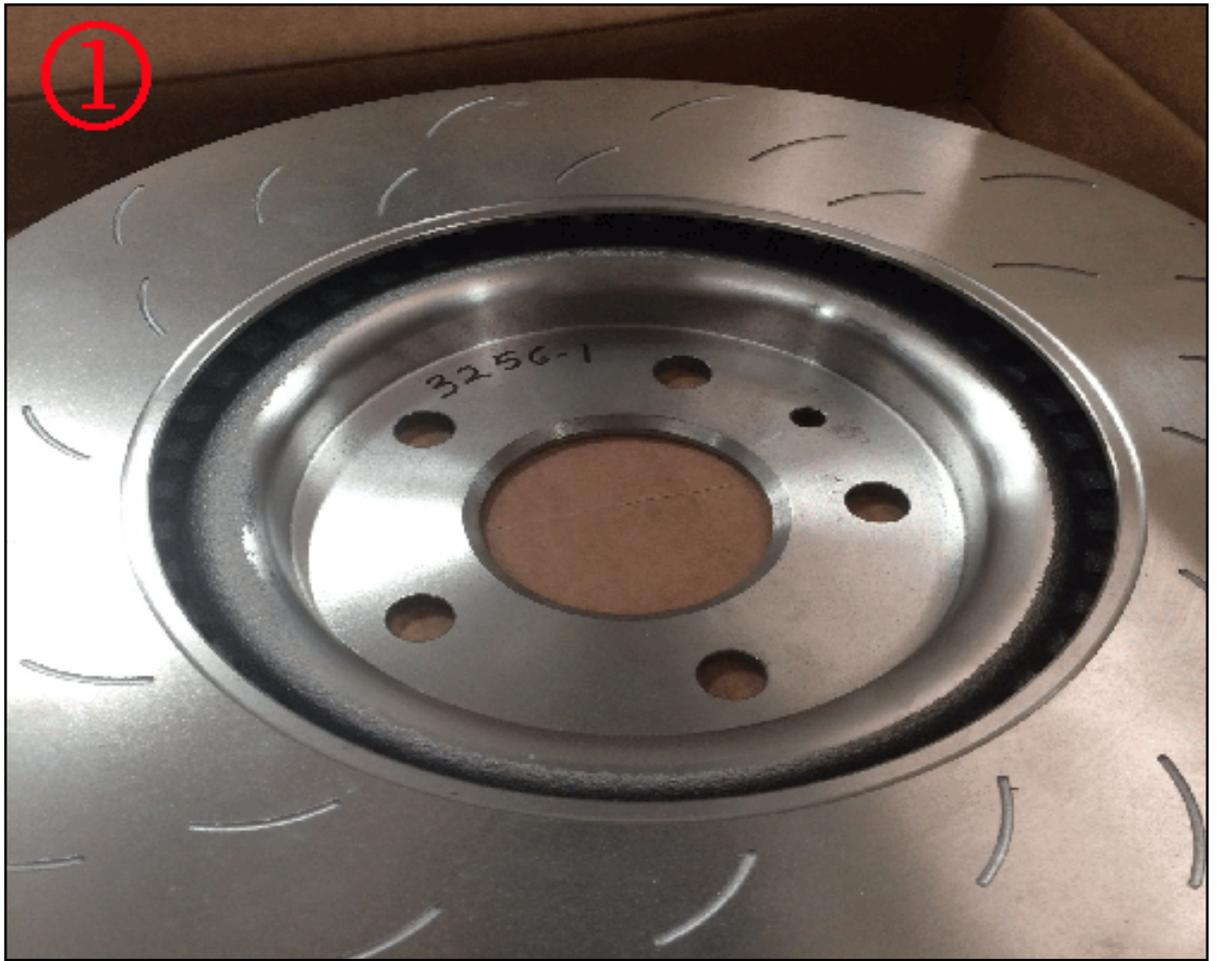
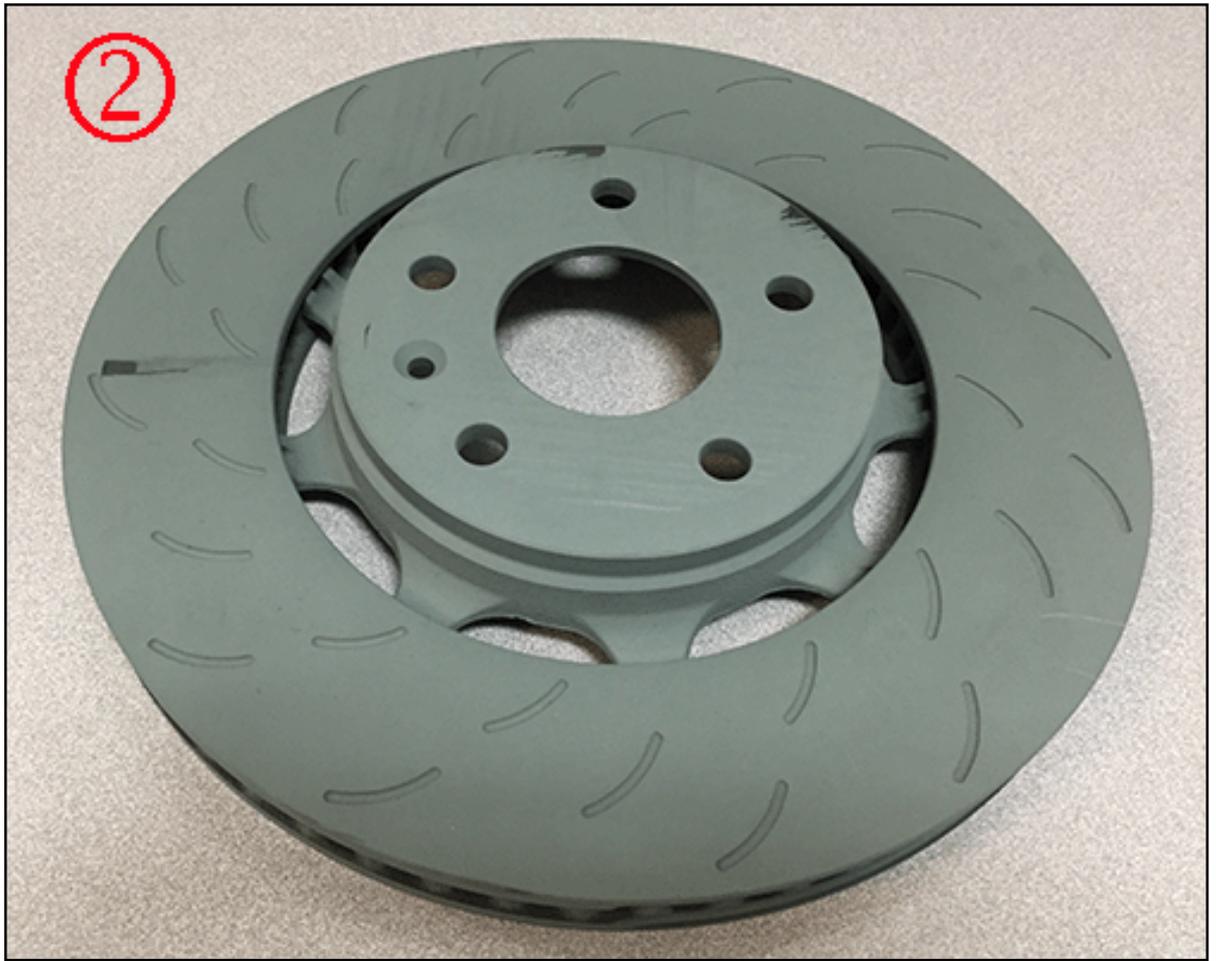
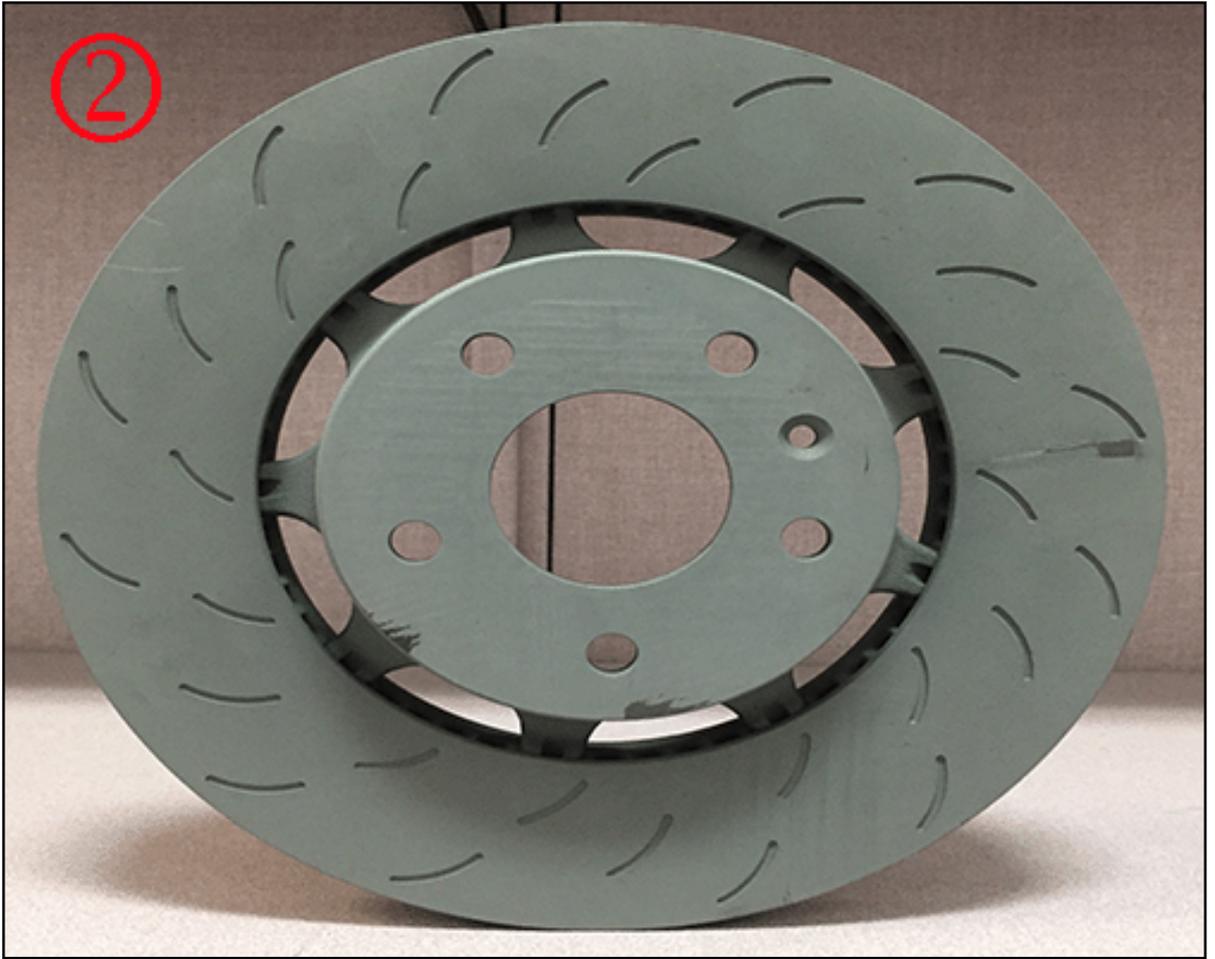
①

Customer may also comment they hear a rattle noise from the wheel area. The noise may go away when the brakes are lightly applied. This condition may be due to excessive lateral runout (LRO) or interation between the inner top hat section to the rotor ring.

- For front rotors and vehicles built prior to May 31, 2016, replace old two piece design (2) with new one piece design (1).
- For rear rotors and vehicles built prior to July 23, 2015, replace old two piece design (2) with new one piece design (1).

Important: The rotors *MUST* be replaced as a pair due to a design change.
