2014 - 2016 Corvette: Service Bulletin: #16-NA-170: Brake Pulsation and/or Vibration During Brake Apply

#16-NA-170: Brake Pulsation and/or Vibration During Brake Apply - (July 20, 2016)

Brand:	Model:	Model Year:	VIN:	Engine:	Transmi
		from to	from to		ssion:
Chevrolet	Corvette	2014 to 2016

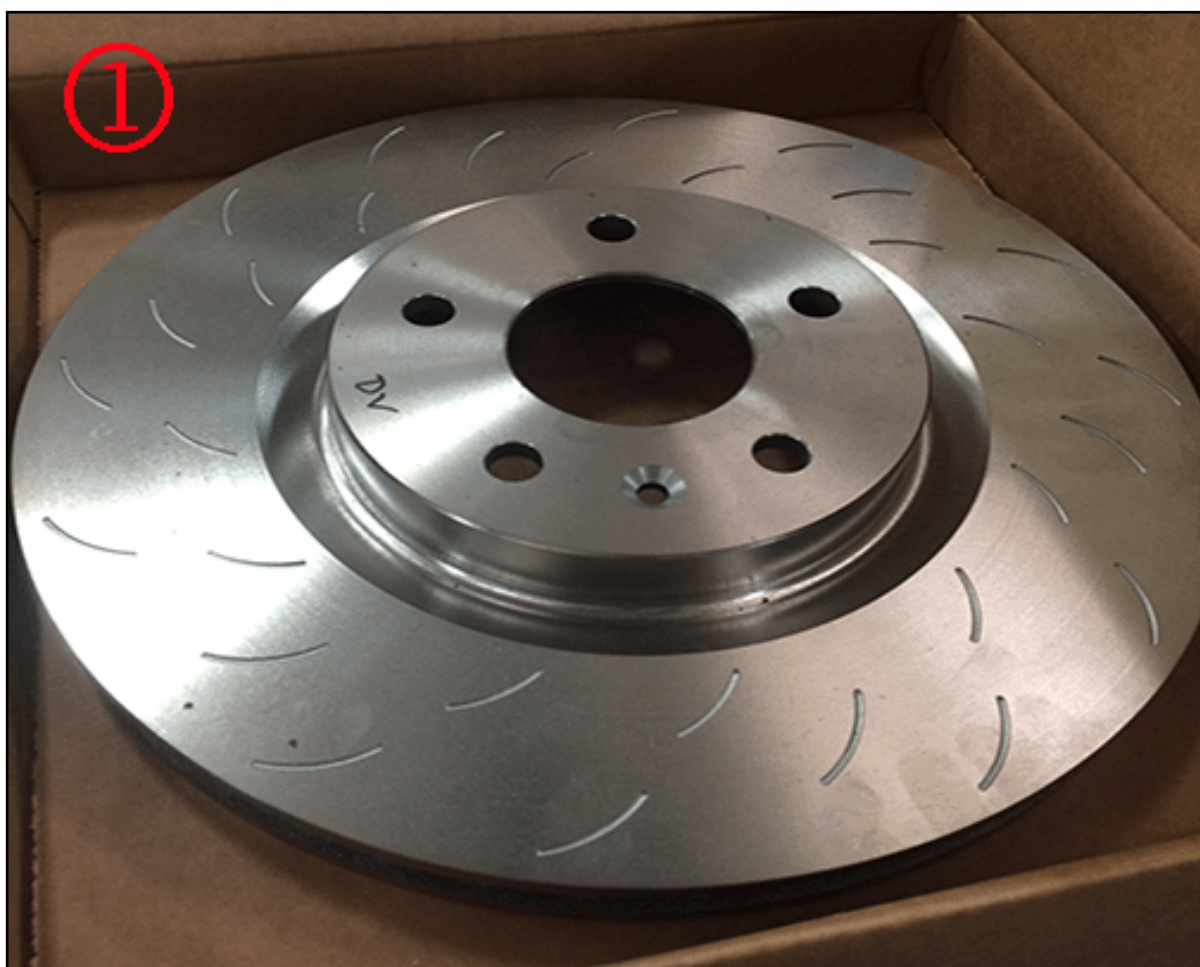
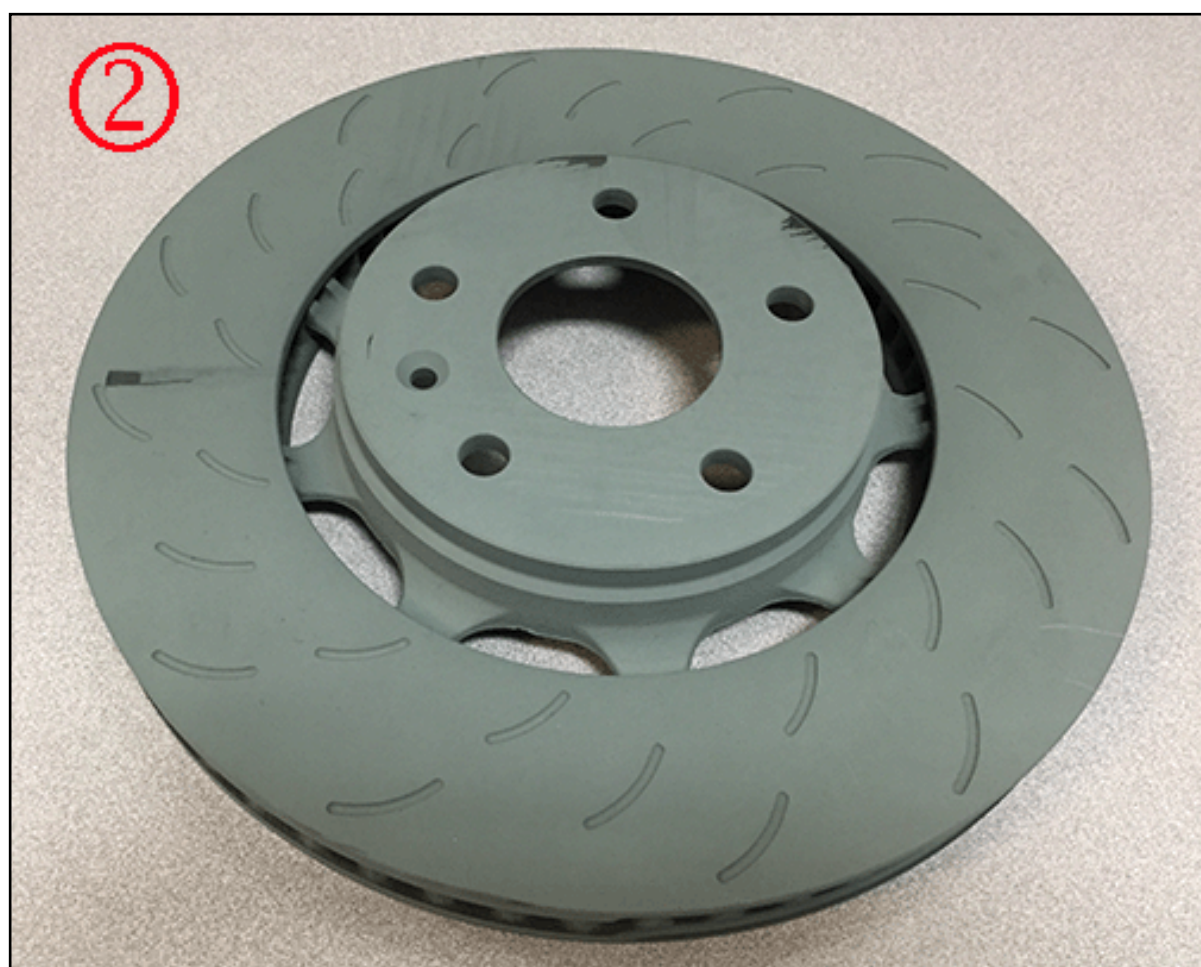
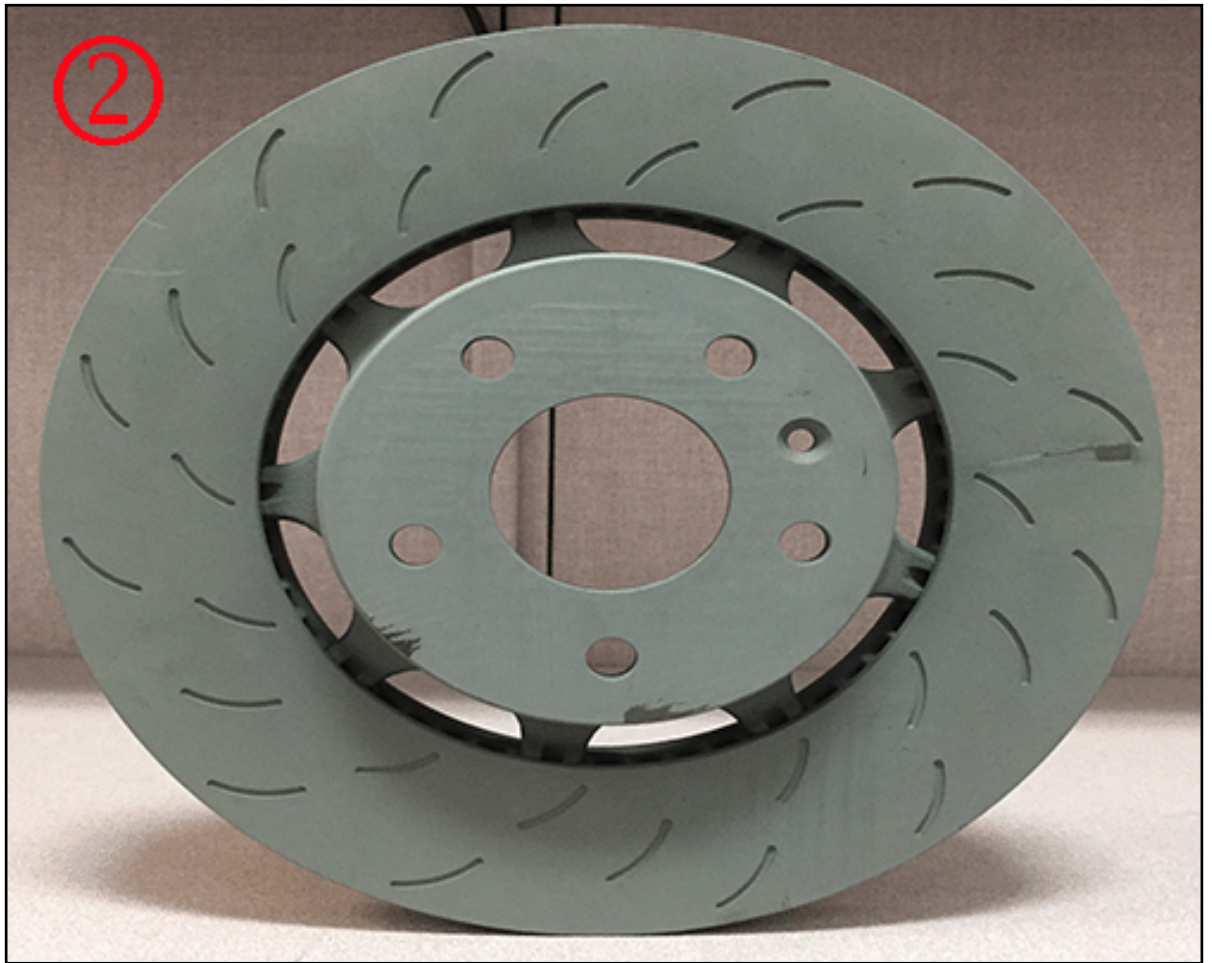
This condition may be due to excessive lateral runout (LRO) or interaction between the inner top hat section to the rotor ring.

- For front rotors and vehicles built prior to May 31, 2016, replace old two piece design (2) with new one piece design (1).
- For rear rotors and vehicles built prior to July 23, 2015, replace old two piece design (2) with new one piece design (1).

Important: The rotors *MUST* be replaced as a pair due to a design change.

Refer to *Brake Rotor Assembled Lateral Runout Correction* and *Front and Rear Brake Rotor Replacement-Both Sides* in SI.
