2014 - 2015 Corvette: Service Bulletin: Creak or Snap Noise Above Windshield from Removable Roof Lift Off Panel While Driving

GM Bulletin No.: #15-NA-016

MODELS: 2014 - 2015 Chevrolet Corvette

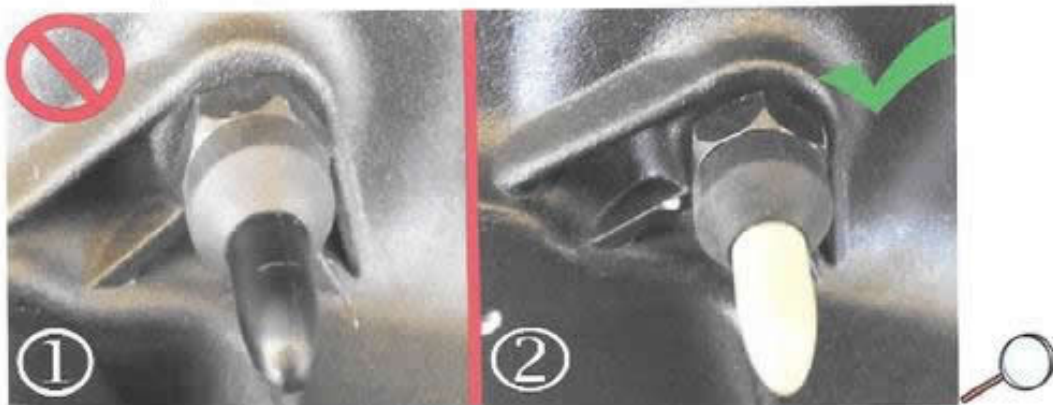
Condition	Some customers may comment on a creak or snap noise from the front of the removable roof lift off panel while driving. The noise is more predominant when ambient temperatures are high.
Cause	This may be caused by a stick-slip condition between the front latches against the strikers and the front locating pins to the locating cup in the strikers.

- (1) Example of a bad front locating pin.
- (2) Example of a good front locating pin.

If you encounter a vehicle with the above concern, replace both the front roof lift off panel strikers and both front locating pins. Refer to Roof Lift Off Panel/Window Front Striker Replacement and Removable Top Locating Pin Replacement in SI.

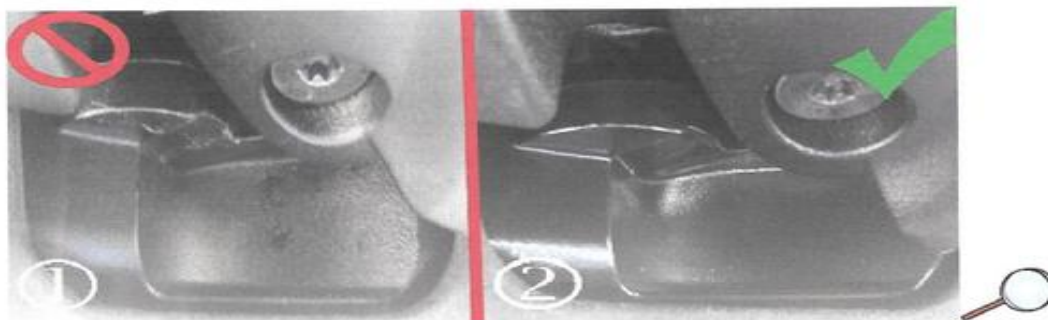
- (1) Example of a bad striker.
- (2) Example of a good striker.
