2014 - 2015 Corvette: Service Bulletin: Creak or Snap Noise Above Windshield from Removable Roof Lift Off Panel While Driving

GM Bulletin No.: #15-NA-016

Date: September 30, 2015

MODELS: 2014 - 2015 Chevrolet Corvette

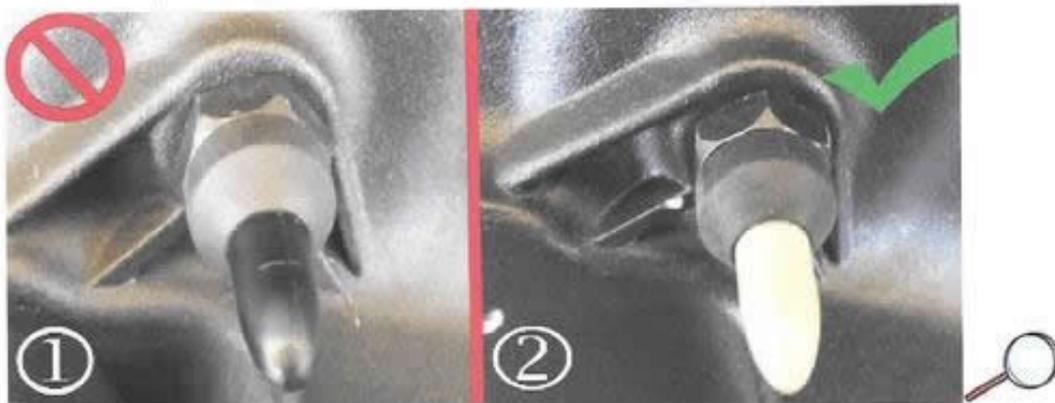
Condition	Some customers may comment on a creak or snap noise from the front of the removable roof lift off panel while driving. The noise is more predominant when ambient temperatures are high.
Cause	This may be caused by a stick-slip condition between the front latches against the strikers and the front locating pins to the locating cup in the strikers.

- (1) Example of a bad front locating pin.
- (2) Example of a good front locating pin.

If you encounter a vehicle with the above concern, replace both the front roof lift off panel strikers and both front locating pins. Refer to Roof Lift Off Panel/Window Front Striker Replacement and Removable Top Locating Pin Replacement in SI.

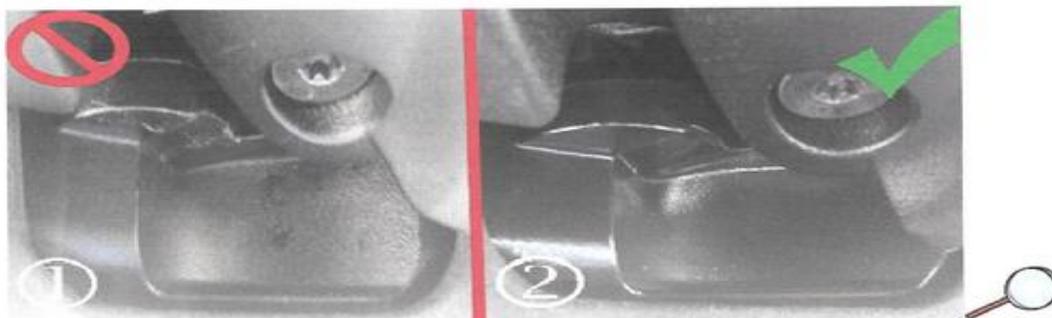
- (1) Example of a bad striker.
- (2) Example of a good striker.
