2015 - 2016 Corvette: Service Bulletin: Diagnostic Tip for Harsh Shifts After Mileage Accumulation Without Previous Transmission Repairs and/or Calibration Updates

#16-NA-213: Diagnostic Tip for Harsh Shifts After Mileage Accumulation Without Previous Transmission Repairs and/or Calibration Updates - (Jun 28, 2016)

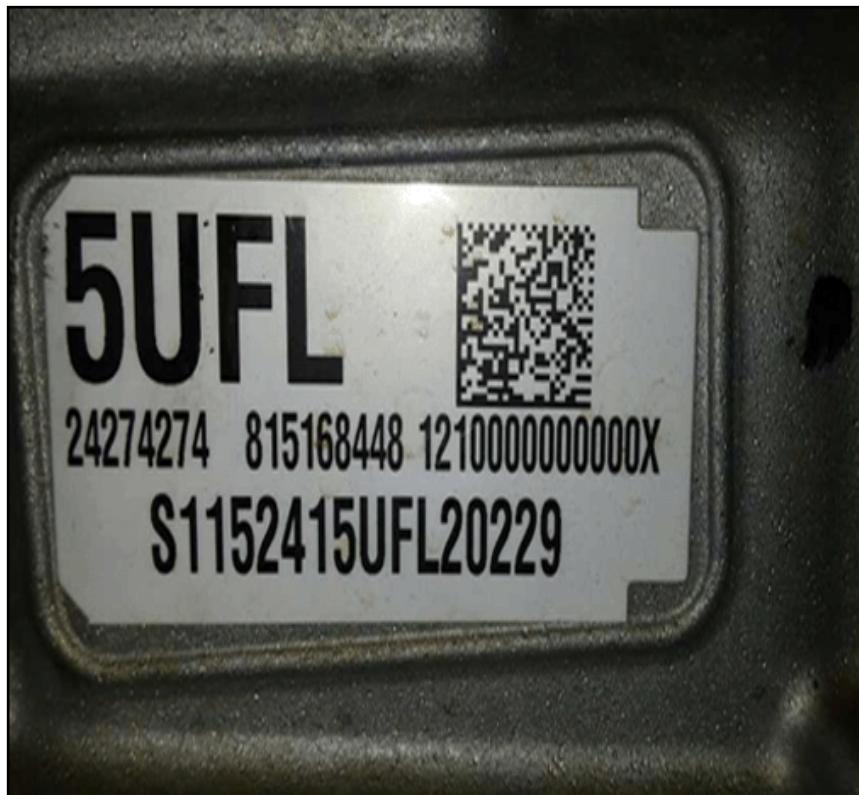
Check the julian date of the transmission by reviewing the TUN number on the side of the transmission. Transmissions built between July 1, 2015 (julian date 182) and Sept 14, 2015 (julian date 257) may have a suspect Clutch Control Solenoid.

TUN decoder See example below:

- Third and Forth digit – Calendar Year – “15”
- Fifth, Sixth and Seventh digits – day transmission was produced – “241”
- This transmission was produced on August 29, 2015

If the transmission julian date is between 182 and 257 the valve body should be replaced.
