# 2015 - 2016 Corvette: Service Bulletin: Diagnostic Tip for Harsh Shifts After Mileage Accumulation Without Previous Transmission Repairs and/or Calibration Updates

## #16-NA-213: Diagnostic Tip for Harsh Shifts After Mileage Accumulation Without Previous Transmission Repairs and/or Calibration Updates - (Jun 28, 2016)

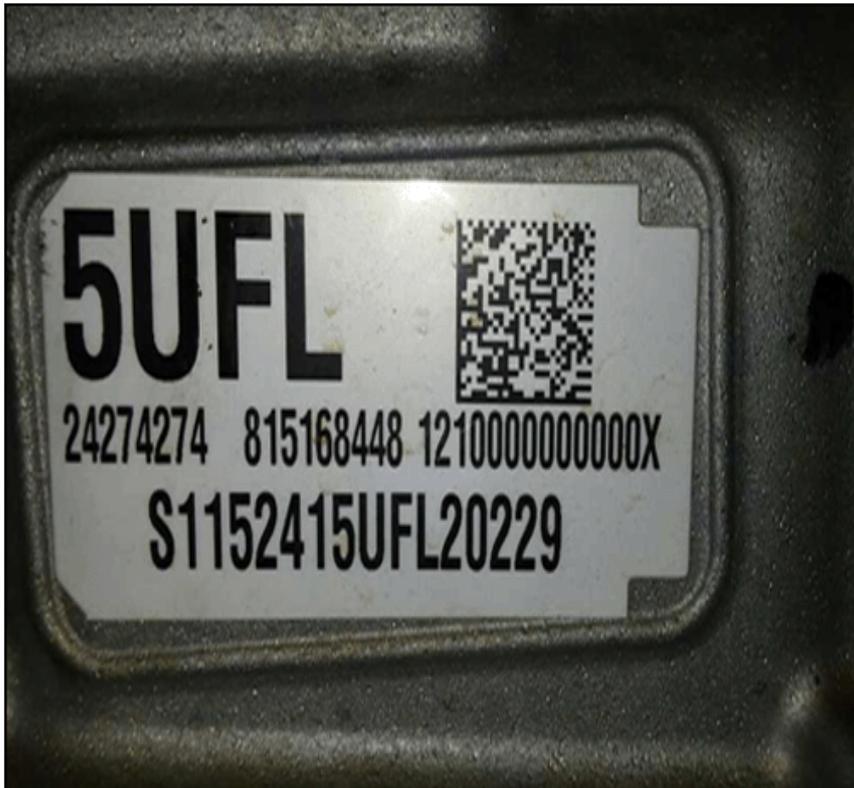
Check the julian date of the transmission by reviewing the TUN number on the side of the transmission. Transmissions built between July 1, 2015 (julian date 182) and Sept 14, 2015 (julian date 257) may have a suspect Clutch Control Solenoid.

TUN decoder See example below:

- Third and Forth digit – Calendar Year – “15”
- Fifth, Sixth and Seventh digits – day transmission was produced – “241”
- This transmission was produced on August 29, 2015

If the transmission julian date is between 182 and 257 the valve body should be replaced.
