**2015 - 2017 Corvette Z06: Service Bulletin:  
 #PIP5395B: Ticking Rattle Or Buzz Noise Heard  
 The Best In The Passenger Compartment - (Mar  
 20, 2017)**

**#PIP5395B: Ticking Rattle Or Buzz Noise Heard The Best  
 In The Passenger Compartment - (Mar 20, 2017)**

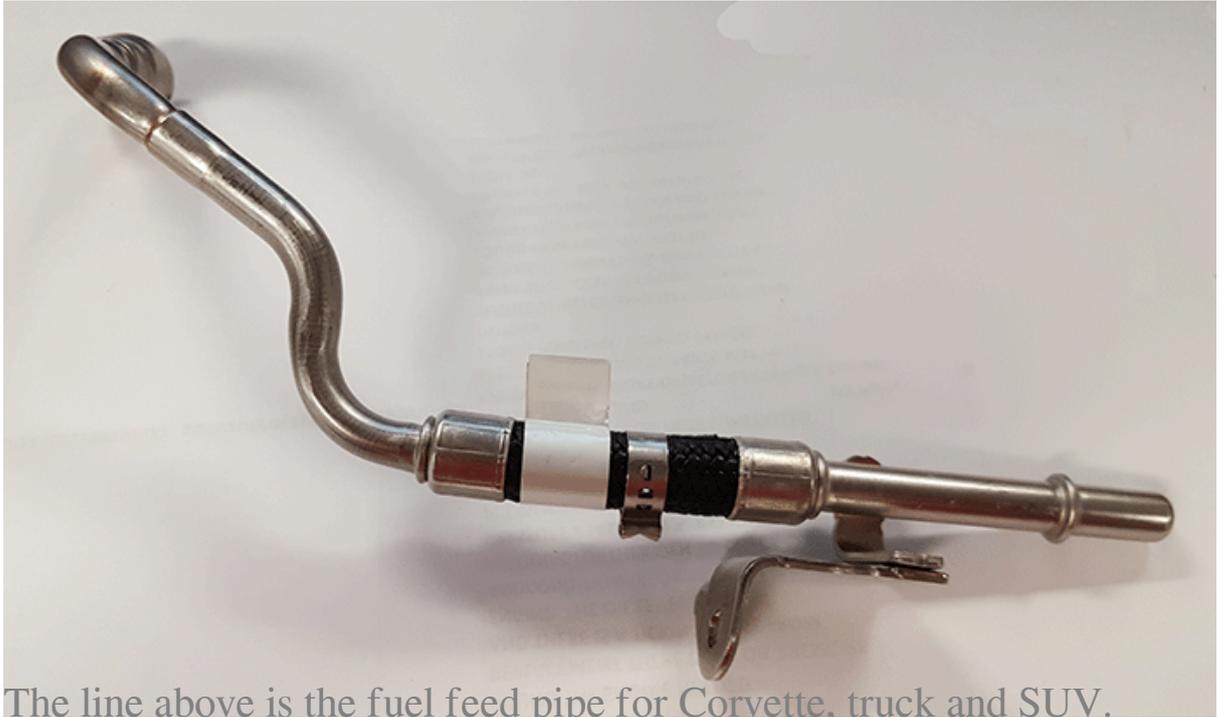
The line above is the fuel feed pipe for Corvette, truck and SUV.

This line connects the chassis fuel line to the high pressure fuel pump.

The fuel feed line between the high pressure fuel pump and chassis fuel line could be the cause allowing high pressure pulsation back to the low side of the fuel system. There is not a good way to test the check valve, the line will need to be replaced.

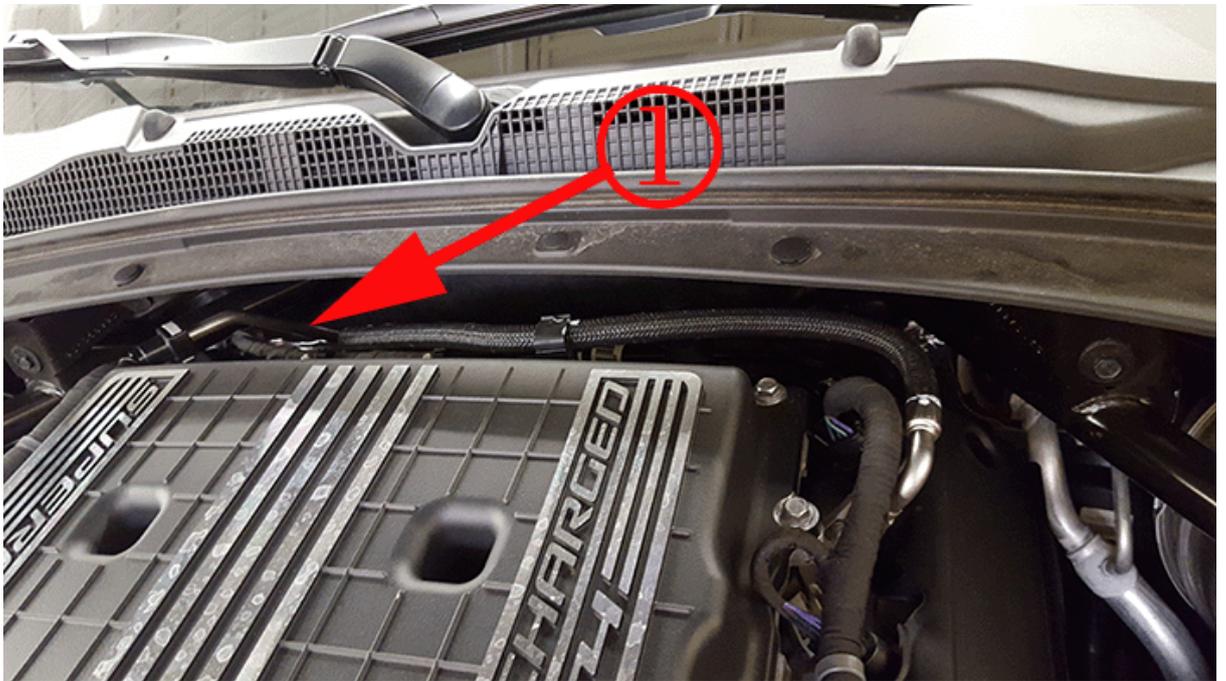
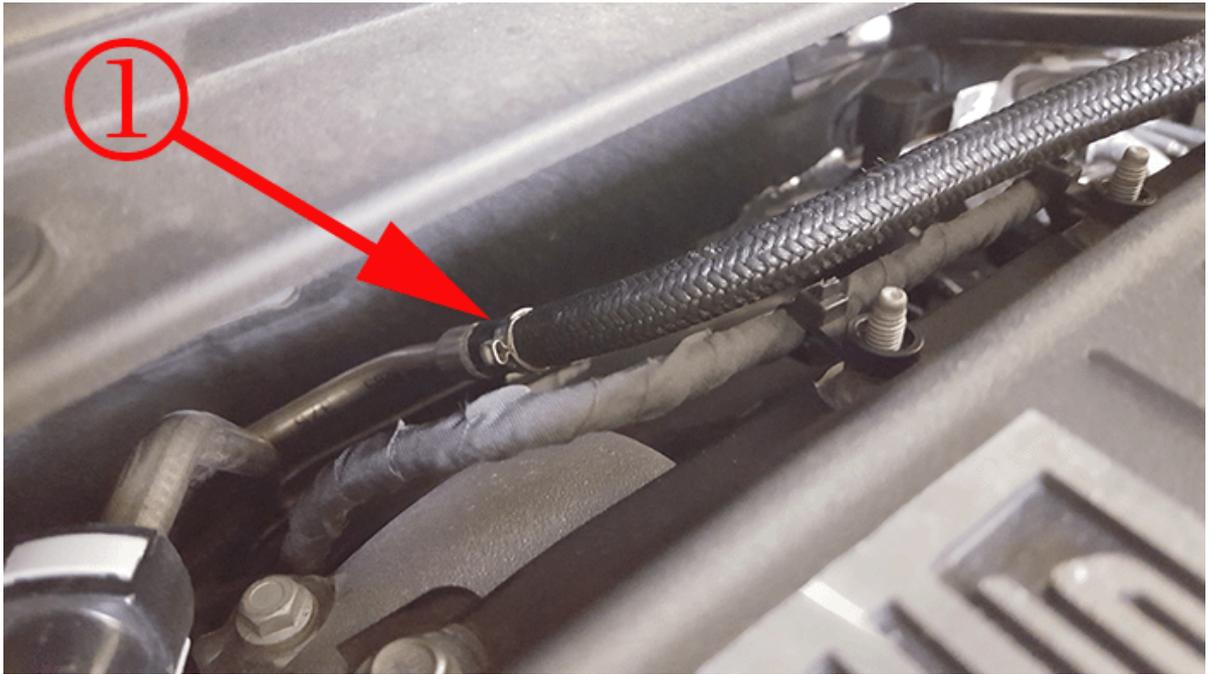
These pictures above shows the chassis fuel feed pipe for the LT4 supercharged ZL1 Camaro.

On LT1 Camaro and LT4 CTS-V this line would have a jumper line with quick disconnects at both ends.

One end will connect to the chassis line and the other to the high pressure pump feed line.
