2014 - 2017 Corvette: GM TechLink: Fuel Line Pulsation Sound

Fuel Line Pulsation Sound

GM TechLink

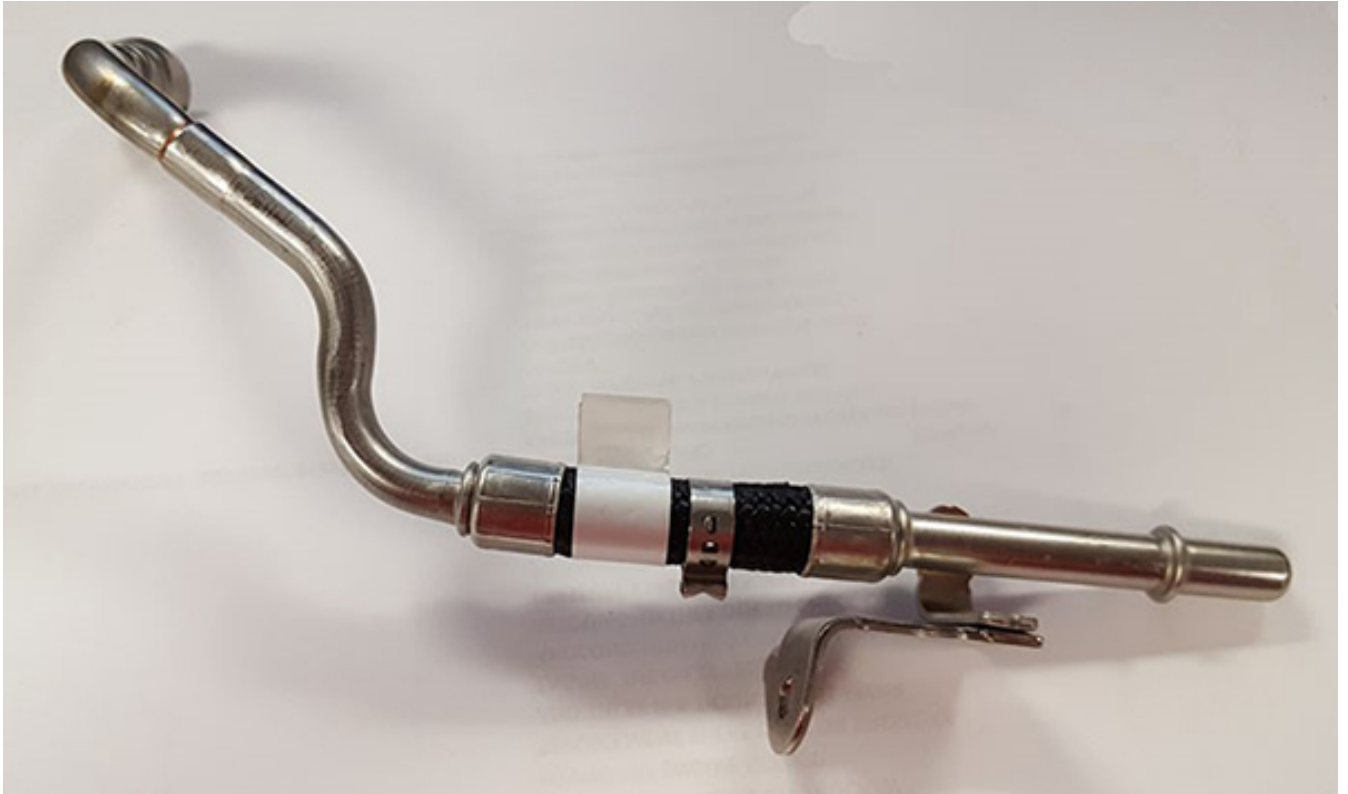
FIG. 9

There are two different types of fuel lines that contain a check valve. The lines vary by model. Only one line should be used on Corvette, truck and SUV models. (Fig. 9) The line connects the chassis fuel line to the high pressure fuel pump. (Fig. 10)

Listen to the fuel line connection at the left side of the engine. The fuel feed line between the high pressure fuel pump and chassis fuel line may be allowing high pressure pulsation back to the low side of the fuel system. If the sound is heard, the line will need to be replaced. On some trucks and SUVs, a vibration also may be observed in the fuel line at the fuel tank.
