2016 - 2017 Corvette: Service Bulletin: #PIP5330B: Coolant Loss And/Or Coolant Odor

#PIP5330B: Coolant Loss And/Or Coolant Odor - (Jun 15, 2017)

| Subject: | | | Coolant Loss And/Or Coolant Odor | | | | |

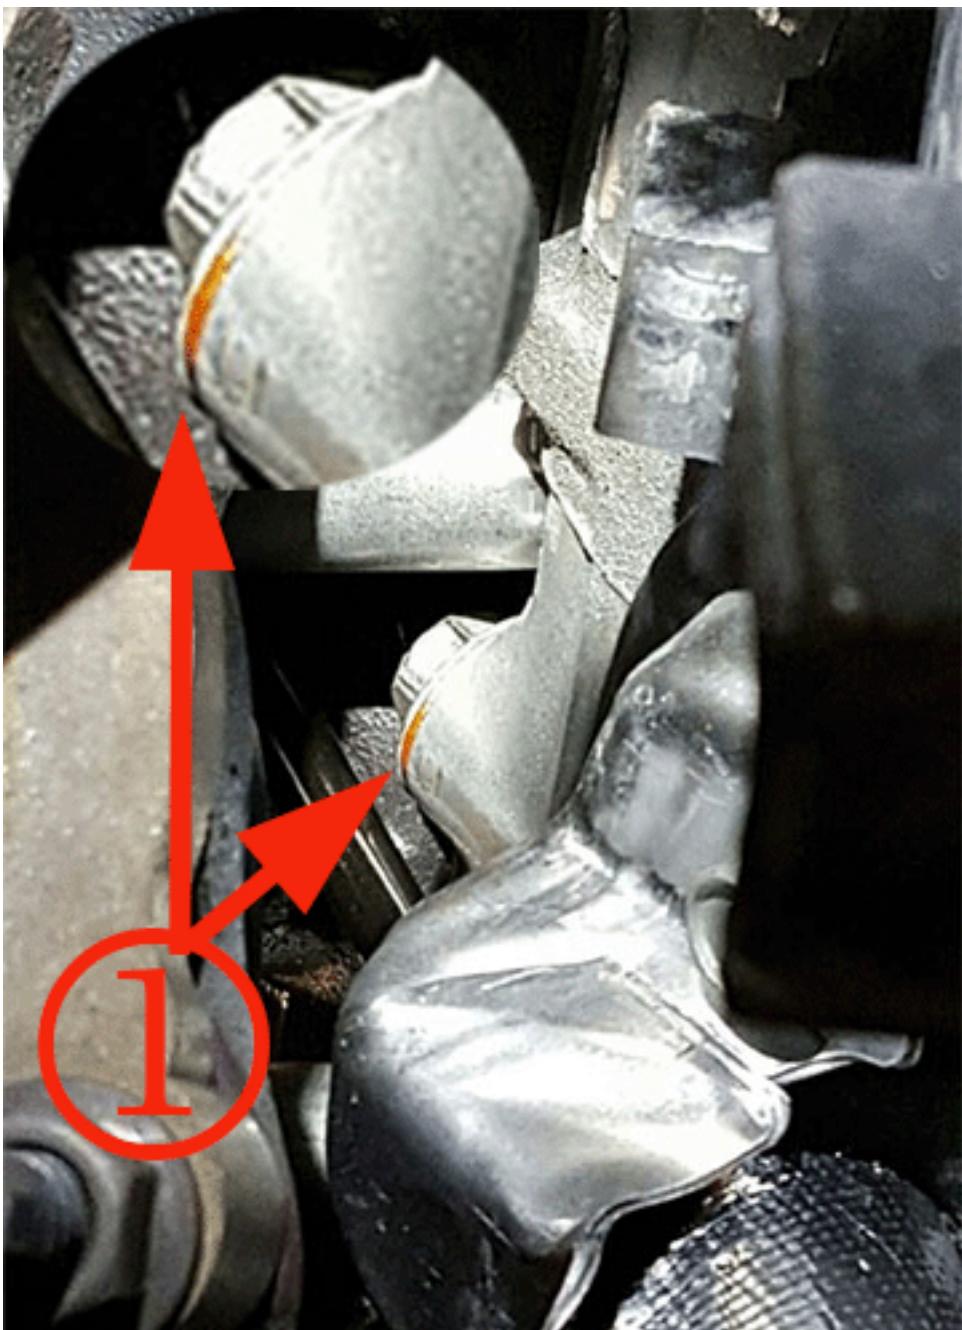
If the coolant is low pressure test the cooling system looking for leaks at the outer head bolts. See below:

If a leak is found the head with the concern will need to be replaced.
