## 2016 - 2017 Corvette: Service Bulletin: #PIP5330B: Coolant Loss And/Or Coolant Odor

### #PIP5330B: Coolant Loss And/Or Coolant Odor - (Jun 15, 2017)

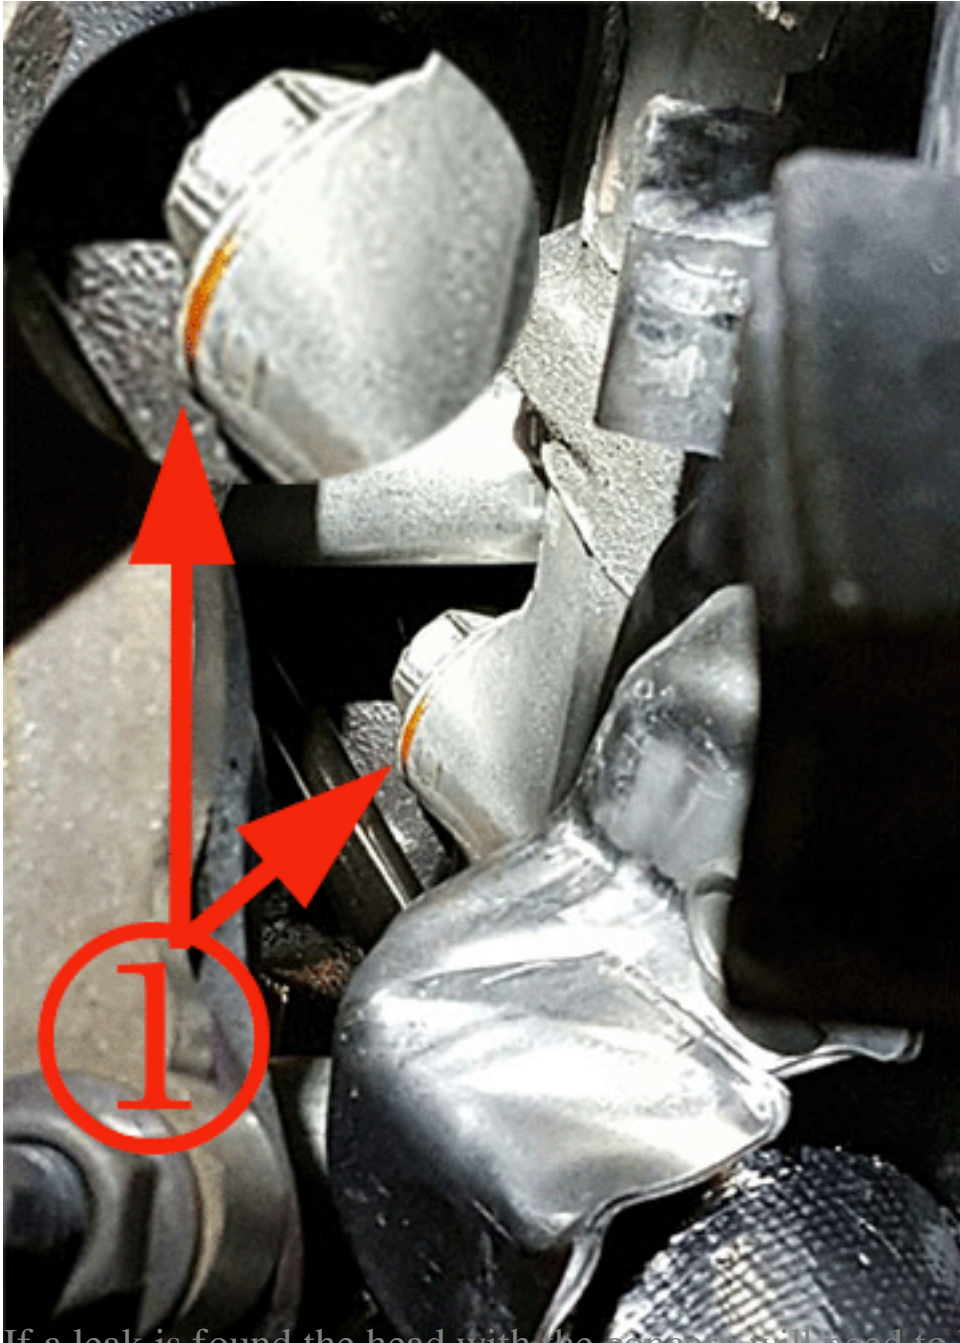
If the coolant is low pressure test the cooling system looking for leaks at the outer head bolts. See below:

If a leak is found the head with the concern will need to be replaced.
