# 2014 - 2020 Corvette: Service Bulletin: #17-NA-271: Clicking Noise from Front Wheels While Turning at Slow Speeds

## #17-NA-271: Clicking Noise from Front Wheels While Turning at Slow Speeds - (Oct 13, 2020)

**Subject:** Clicking Noise from  
Front Wheels While  
Turning at Slow Speeds

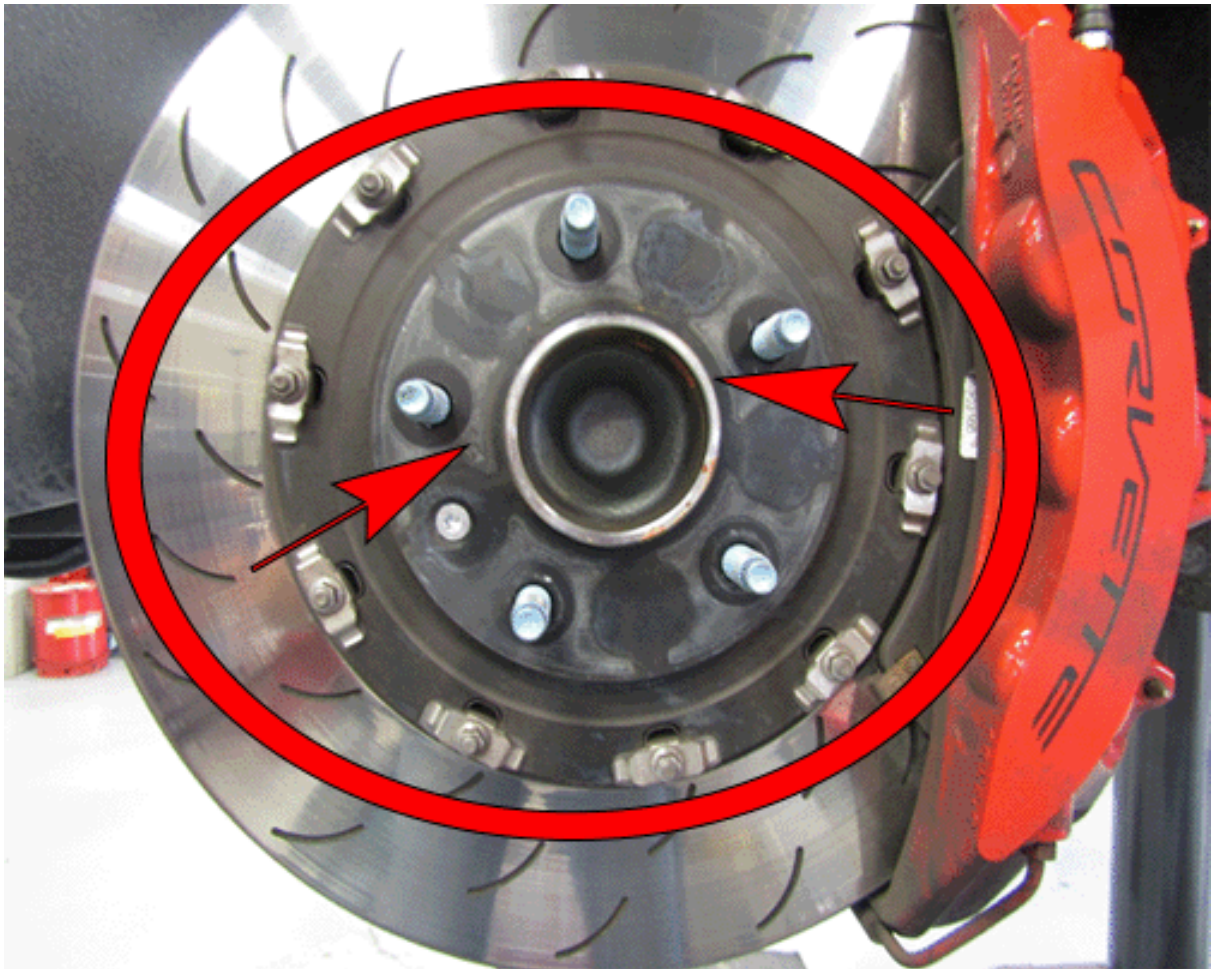
- Clean the wheel mounting surface of the brake rotors, or sometimes referred to as the brake rotor top hats, as follows:

- Using 3M red Scotch-Brite 7447 pad or equivalent with approved brake cleaner (ex. Part number 19370705 (U.S.), 88901247 (Canada)), wipe the wheel mounting surface of the rotor (brake rotor top hat) and the wheel pilot at the center of the rotor, removing any residual grey or black material that has accumulated on the rotors.

**Note:** All cleaning must be done by hand. *DO NOT* use pneumatic or power tools.

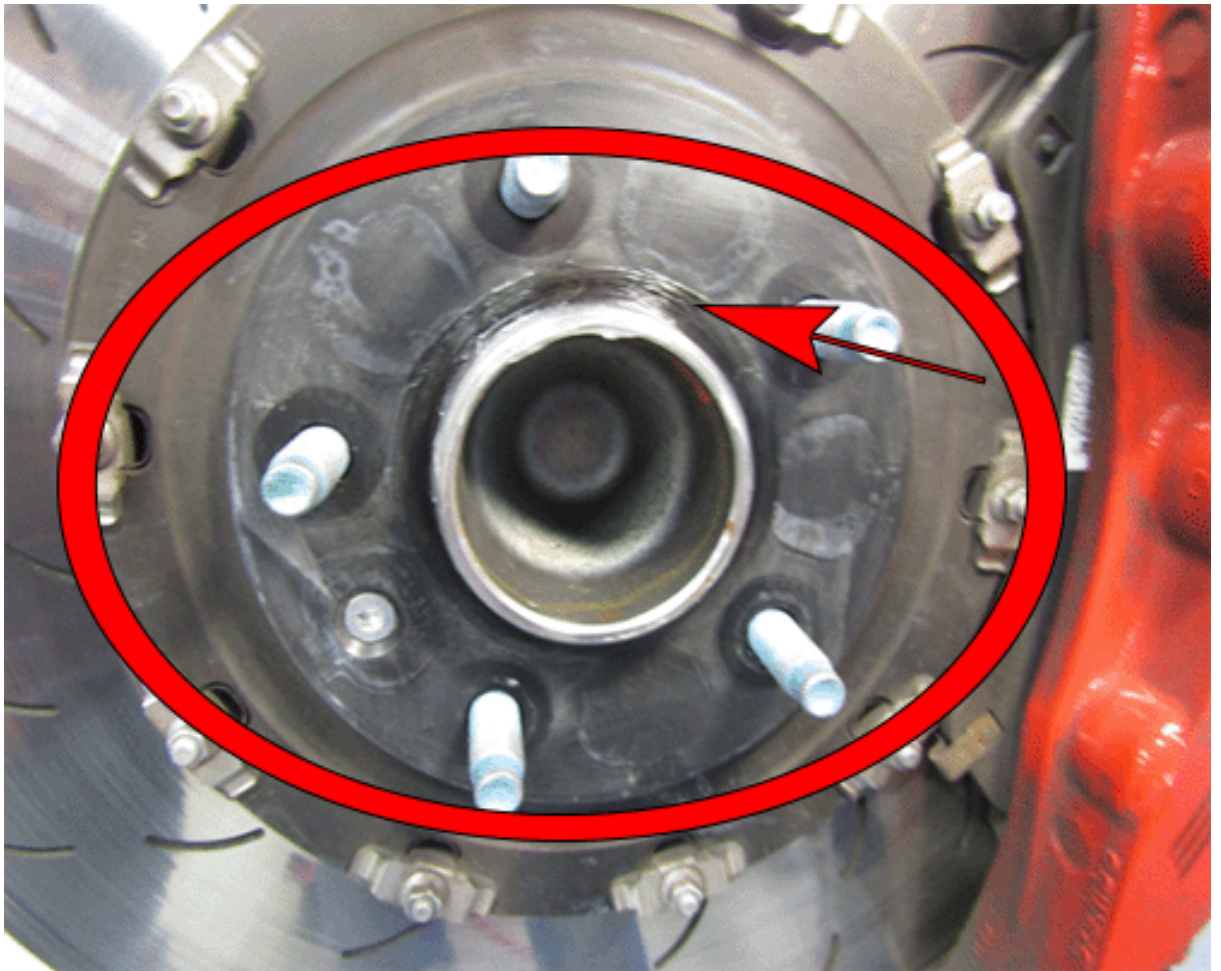
- Using Super Lube paste, P/N 12371287 (in Canada, 10953437) or equivalent, apply a light coat around the center pilot of the hub *ONLY*.
- Reinstall both of the wheels using the original wheel nuts. Refer to *Tire and Wheel Removal and Installation* in SI.
