2014 - 2020 Corvette: Service Bulletin: #17-NA-271: Clicking Noise from Front Wheels While Turning at Slow Speeds

#17-NA-271: Clicking Noise from Front Wheels While Turning at Slow Speeds - (Oct 13, 2020)

Subject: Clicking Noise from
Front Wheels While
Turning at Slow Speeds

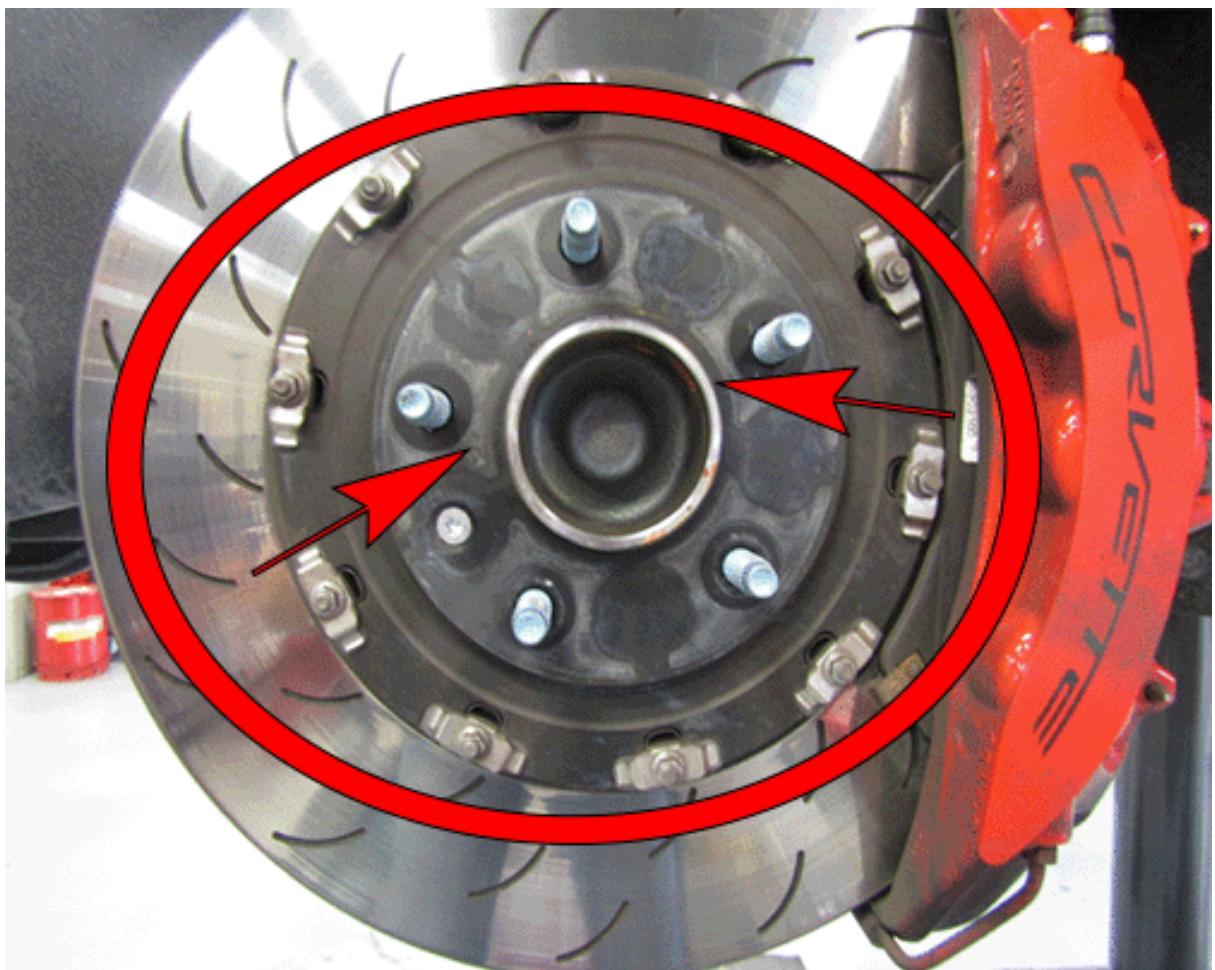
- Clean the wheel mounting surface of the brake rotors, or sometimes referred to as the brake rotor top hats, as follows:

- Using 3M red Scotch-Brite 7447 pad or equivalent with approved brake cleaner (ex. Part number 19370705 (U.S.), 88901247 (Canada)), wipe the wheel mounting surface of the rotor (brake rotor top hat) and the wheel pilot at the center of the rotor, removing any residual grey or black material that has accumulated on the rotors.

Note: All cleaning must be done by hand. *DO NOT* use pneumatic or power tools.

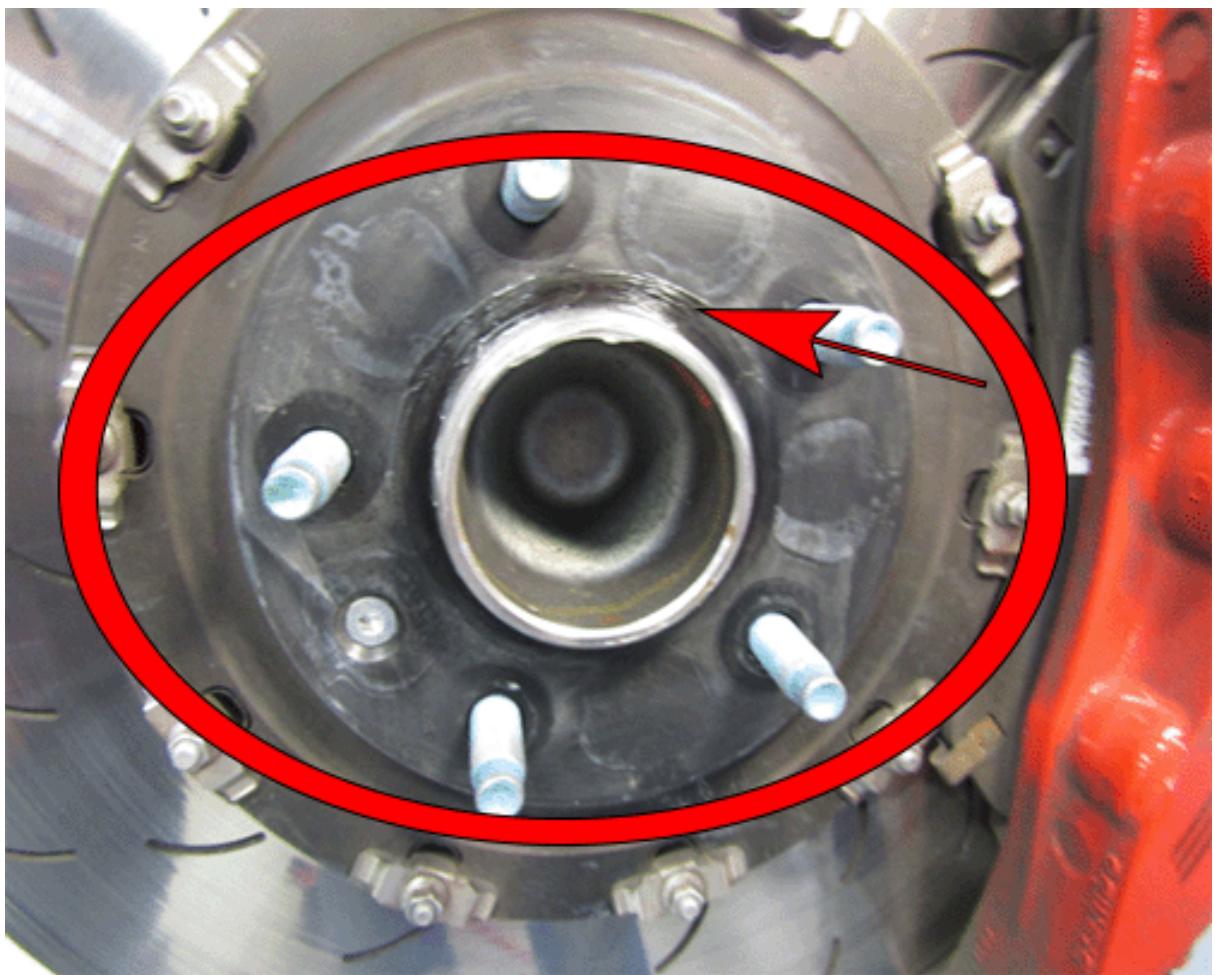
- Using Super Lube paste, P/N 12371287 (in Canada, 10953437) or equivalent, apply a light coat around the center pilot of the hub *ONLY*.
- Reinstall both of the wheels using the original wheel nuts. Refer to *Tire and Wheel Removal and Installation* in SI.

Important: Be sure the wheels and rotors are thoroughly dry prior to installation.
