2014 - 2020 Corvette: Service Bulletin: #17-NA-271: Clicking Noise from Front Wheels While Turning at Slow Speeds

#17-NA-271: Clicking Noise from Front Wheels While Turning at Slow Speeds - (Oct 13, 2020)

Subject: Clicking Noise from
Front Wheels While
Turning at Slow Speeds

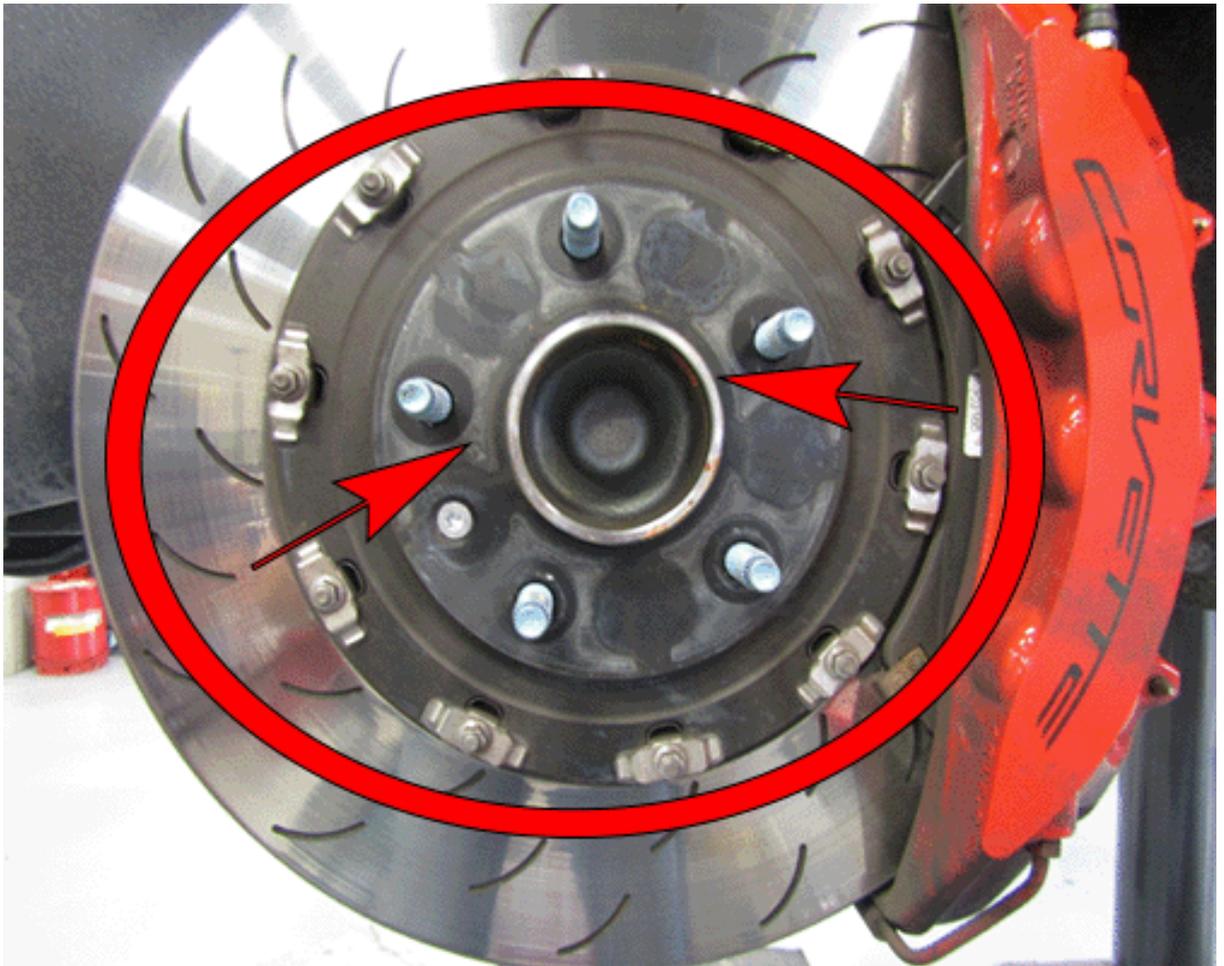
- Clean the wheel mounting surface of the brake rotors, or sometimes referred to as the brake rotor top hats, as follows:

- Using 3M red Scotch-Brite 7447 pad or equivalent with approved brake cleaner (ex. Part number 19370705 (U.S.), 88901247 (Canada)), wipe the wheel mounting surface of the rotor (brake rotor top hat) and the wheel pilot at the center of the rotor, removing any residual grey or black material that has accumulated on the rotors.
