2020 - 2021 Corvette: Service Bulletin: #PIC6429: Addressing Customer Concerns on Brake Noises - (Jan 20, 2021)

Subject: Addressing Customer Concerns on
Brake Noises

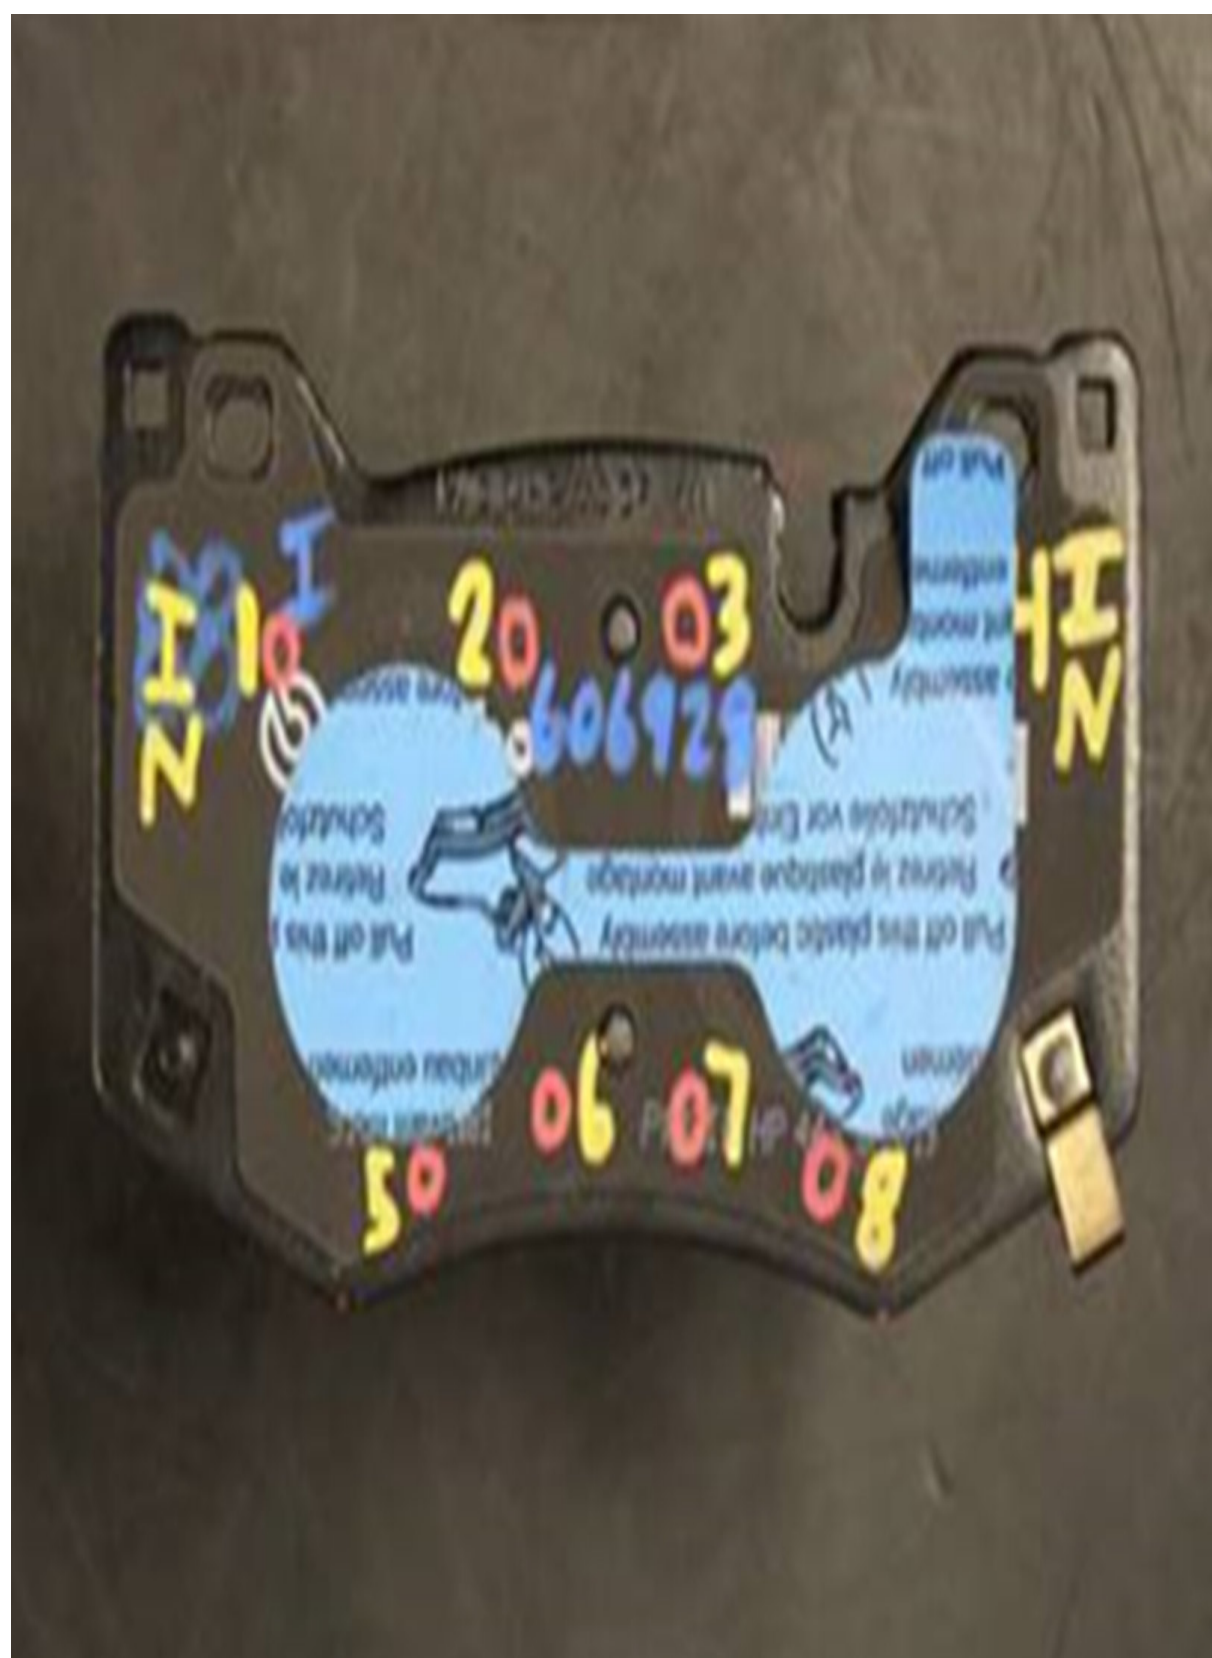
If the customer describes a brake noise coming from the vehicle, perform bulletin 17-NA-040 as described. When removing the front brake pads on a Z51-equipped vehicle, the servicing technician should notice that there is a piece of double-sided tape that secures the front brake pads firmly to the caliper pistons. See the photo below as an example. The blue area is this peel-and-stick double sided tape.

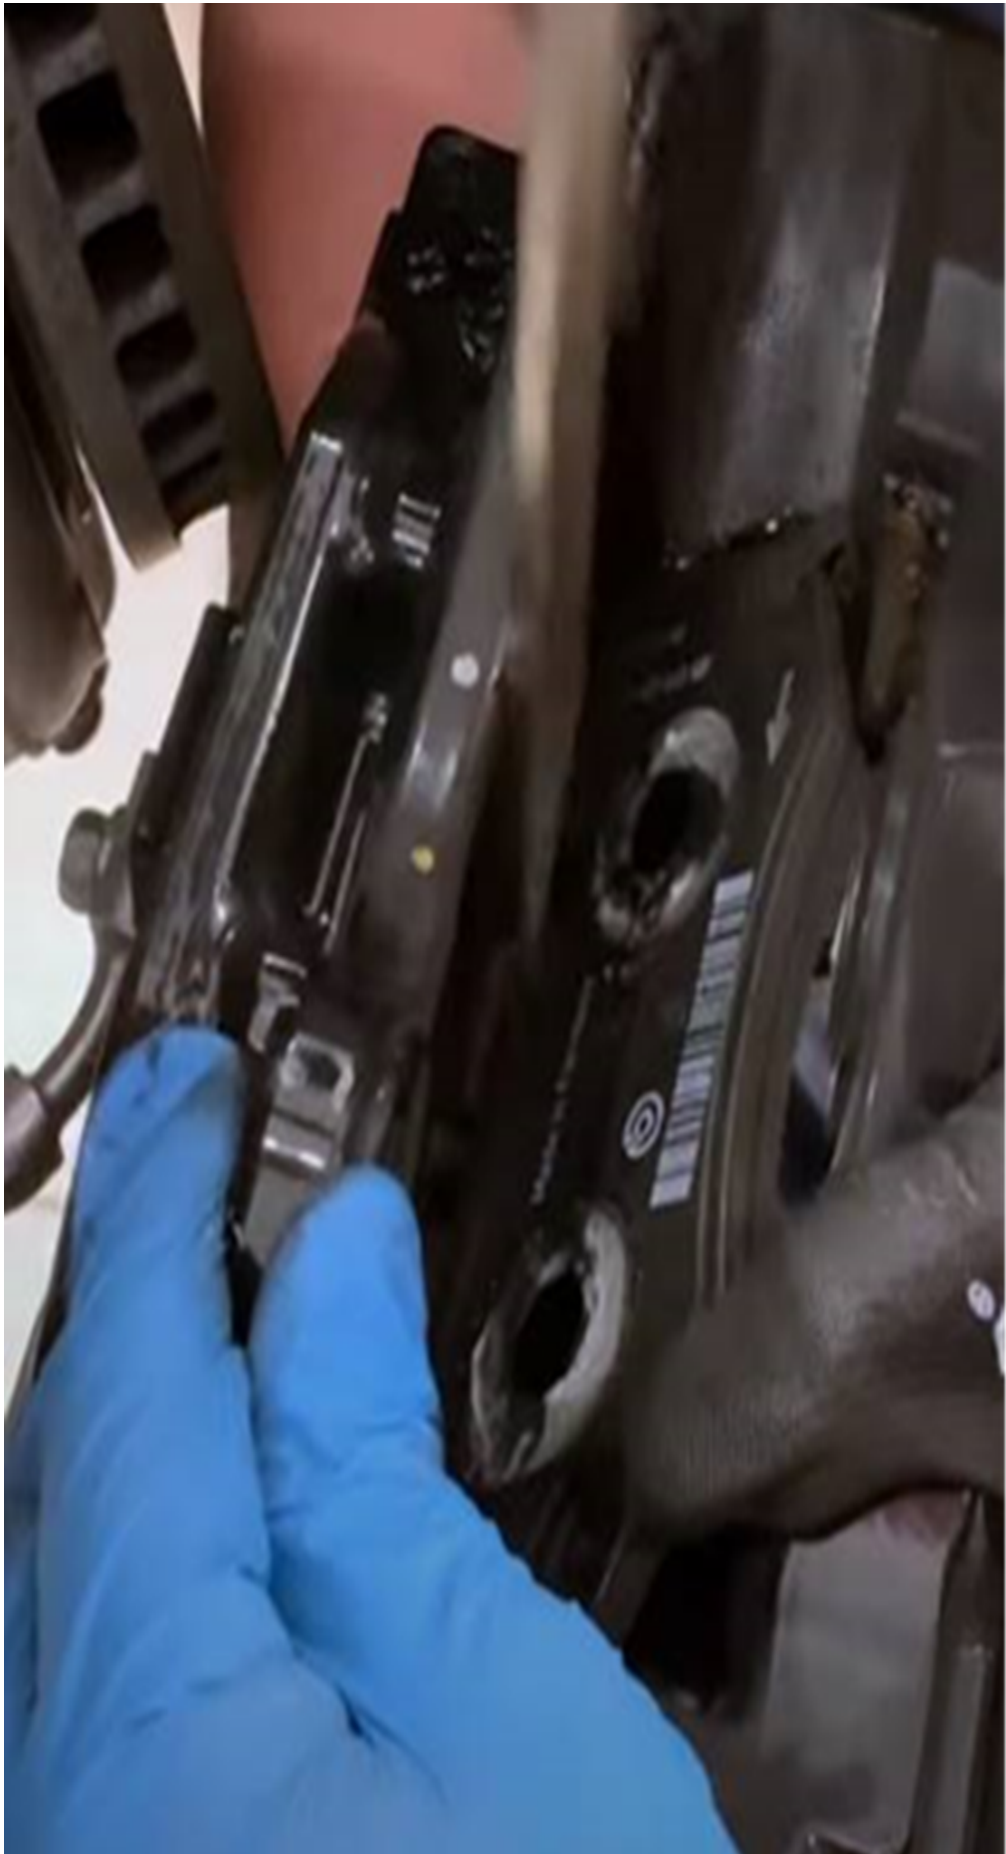
To apply the paste correctly, the pads must be removed from the calipers. See the photo below for an example of what the front brake pads look like once they have been separated from the caliper pistons.

This is normal when the front pads have been removed. When this has been done, remove as much of the remaining tape residue as possible. Then, apply the copper paste as directed in the bulletin. Once the copper paste has been applied correctly to the front brake pads, simply reinstall them into the calipers. There is no need to replace the front brake pads during this service because of the double-sided tape.
