2020 - 2021 Corvette: Service Bulletin: #PIC6429: Addressing Customer Concerns on Brake Noises - (Jan 20, 2021)

#PIC6429: Addressing Customer Concerns on Brake Noises - (Jan 20, 2021)

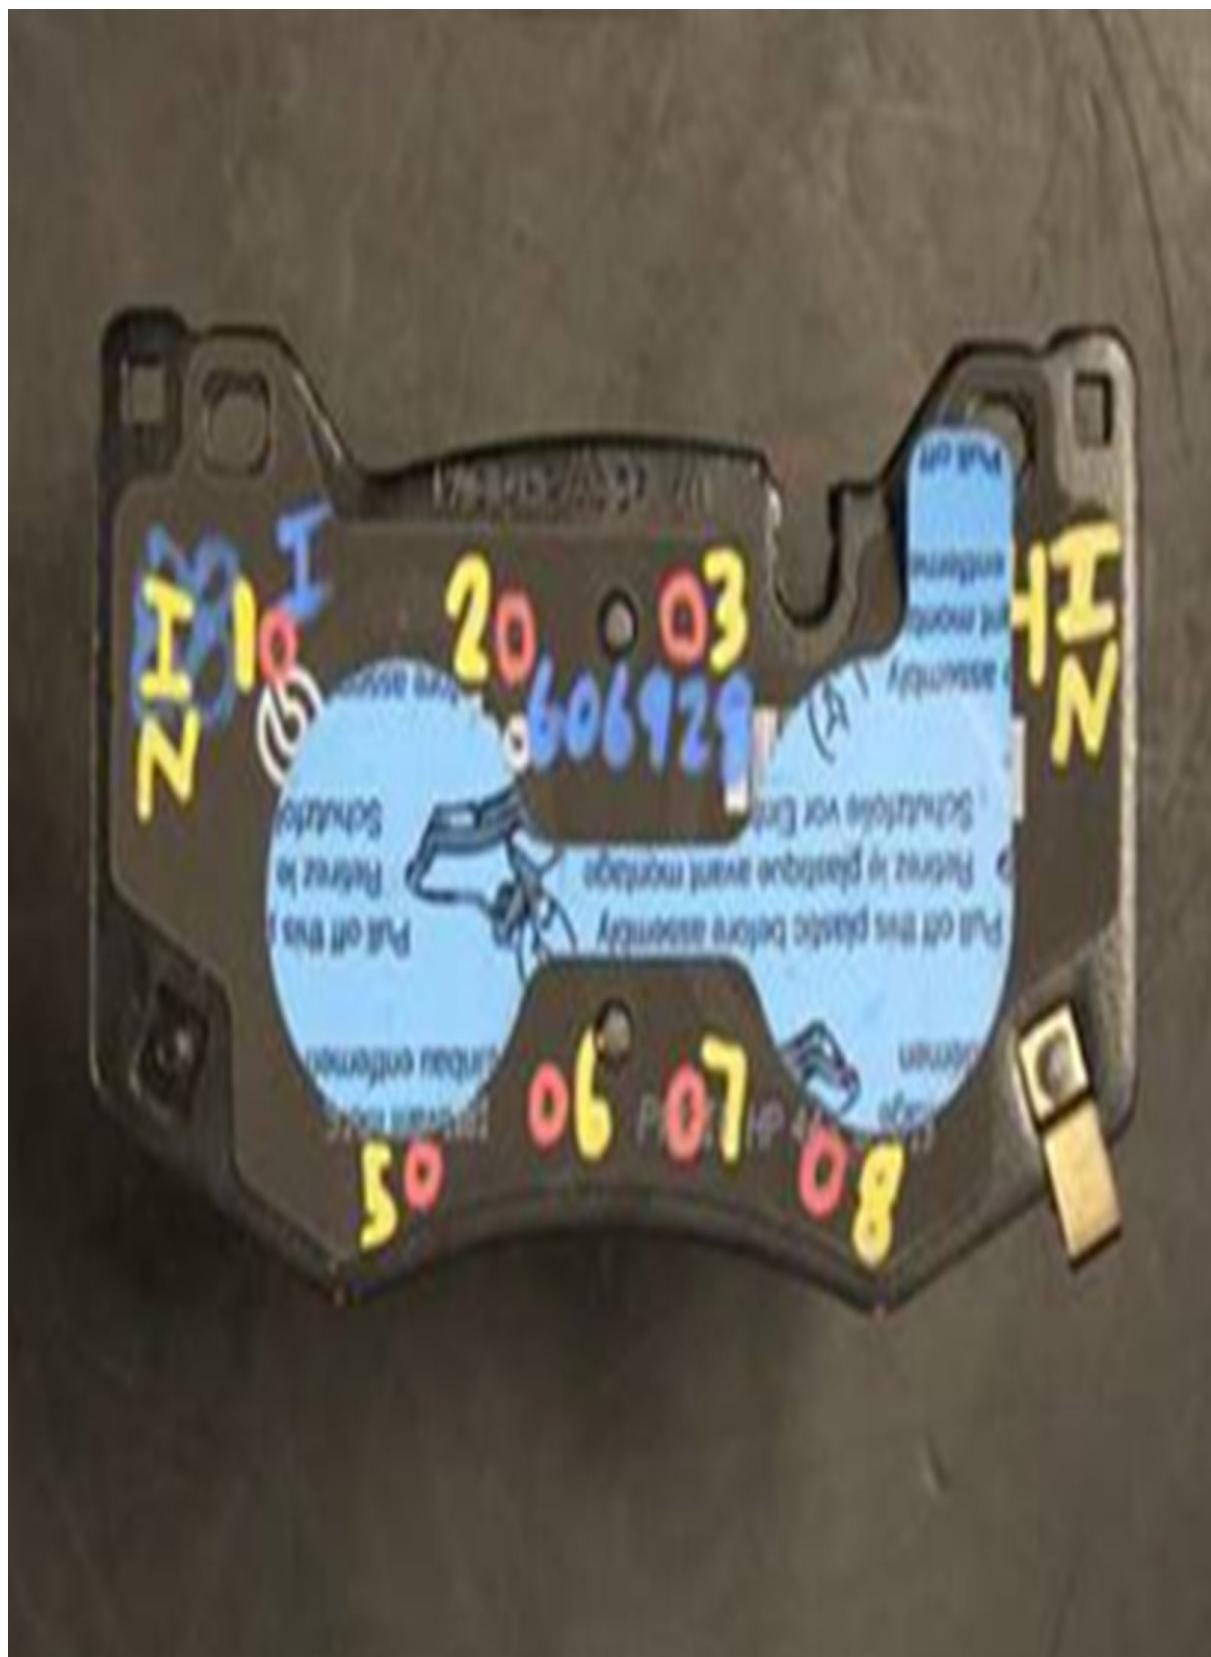
If the customer describes a brake noise coming from the vehicle, perform bulletin 17-NA-040 as described. When removing the front brake pads on a Z51-equipped vehicle, the servicing technician should notice that there is a piece of double-sided tape that secures the front brake pads firmly to the caliper pistons. See the photo below as an example. The blue area is this peel-and-stick double sided tape.

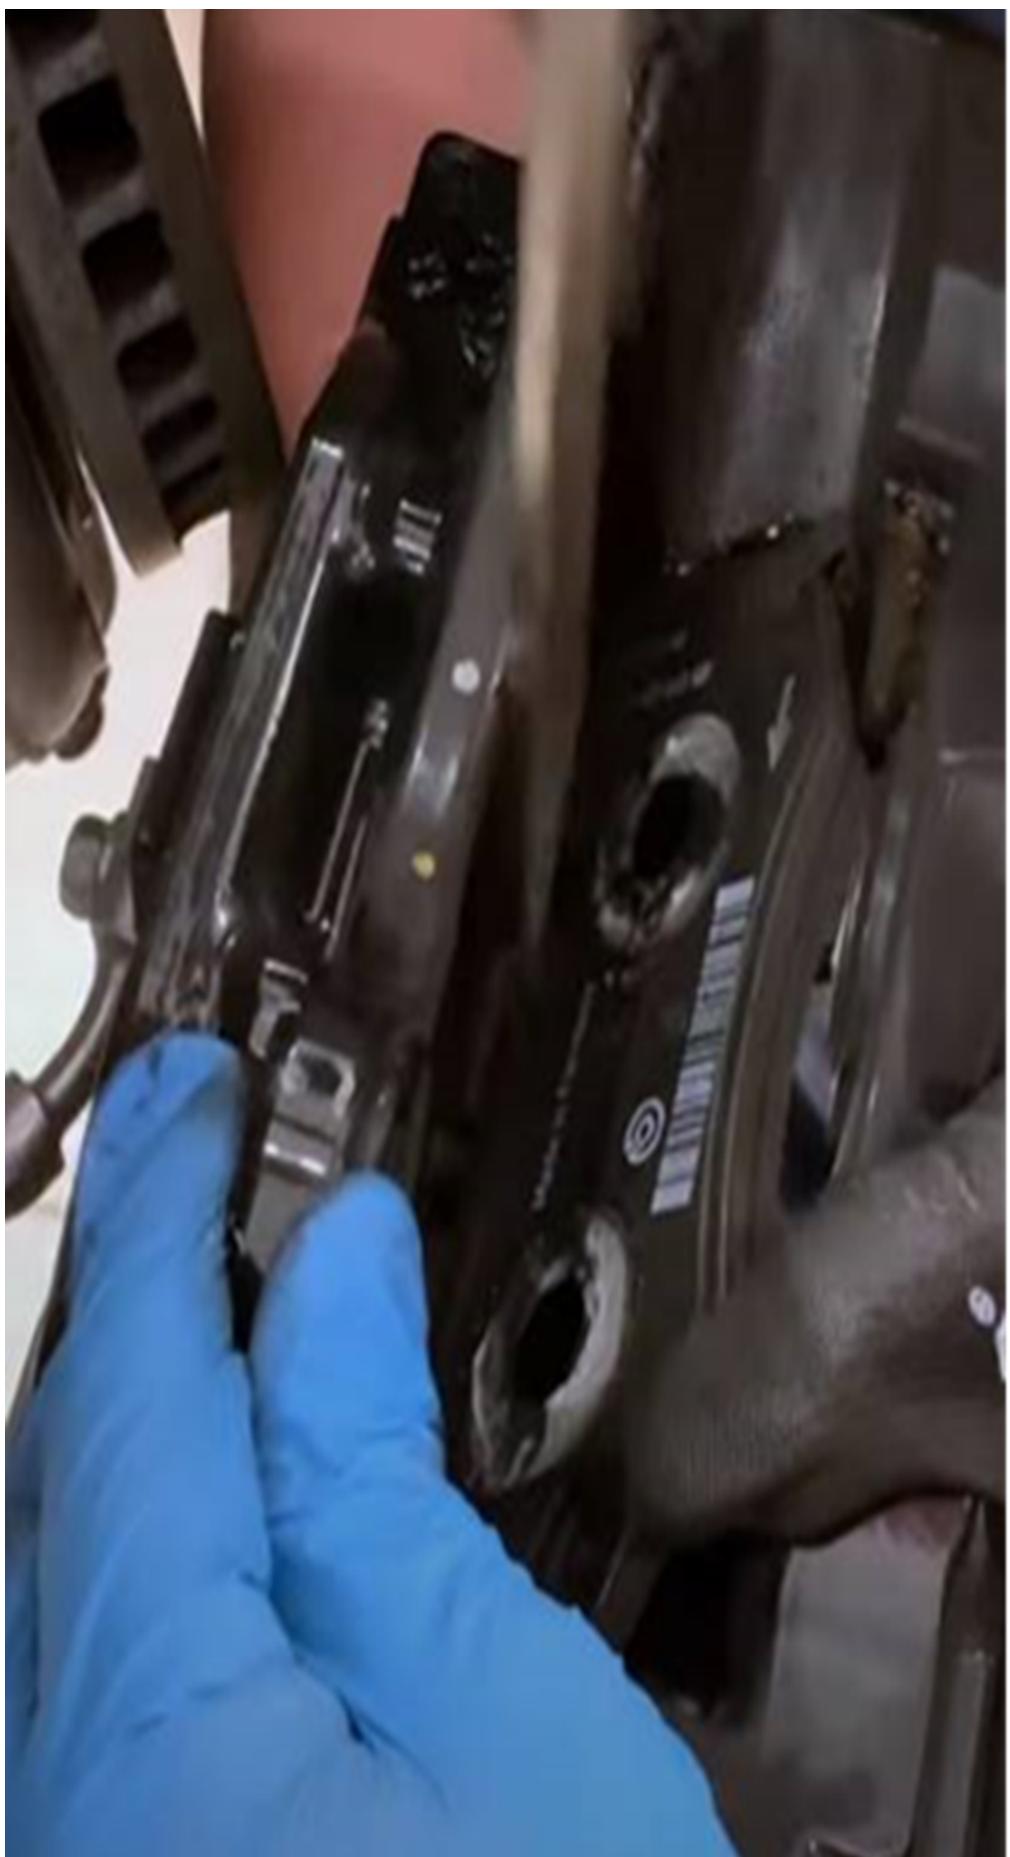
To apply the paste correctly, the pads must be removed from the calipers. See the photo below for an example of what the front brake pads look like once they have been separated from the caliper pistons.

This is normal when the front pads have been removed. When this has been done, remove as much of the remaining tape residue as possible. Then, apply the copper paste as directed in the bulletin. Once the copper paste has been applied correctly to the front brake pads, simply reinstall them into the calipers. There is no need to replace the front brake pads during this service because of the double-sided tape.
