# 2000 Corvette: Service Bulletin: Low Tire Pressure Message on DIC, Slow Air Loss

**Number:** 00-03-10-001

**Subject:** Low Tire Pressure Message Repeatedly Displayed on DIC, Slow Air Loss From Tire and Wheel Assembly (Replace Wheel Assembly)

**Model Year:** 2000 Chevrolet Corvette Built prior to VIN Breakpoint Y5001500

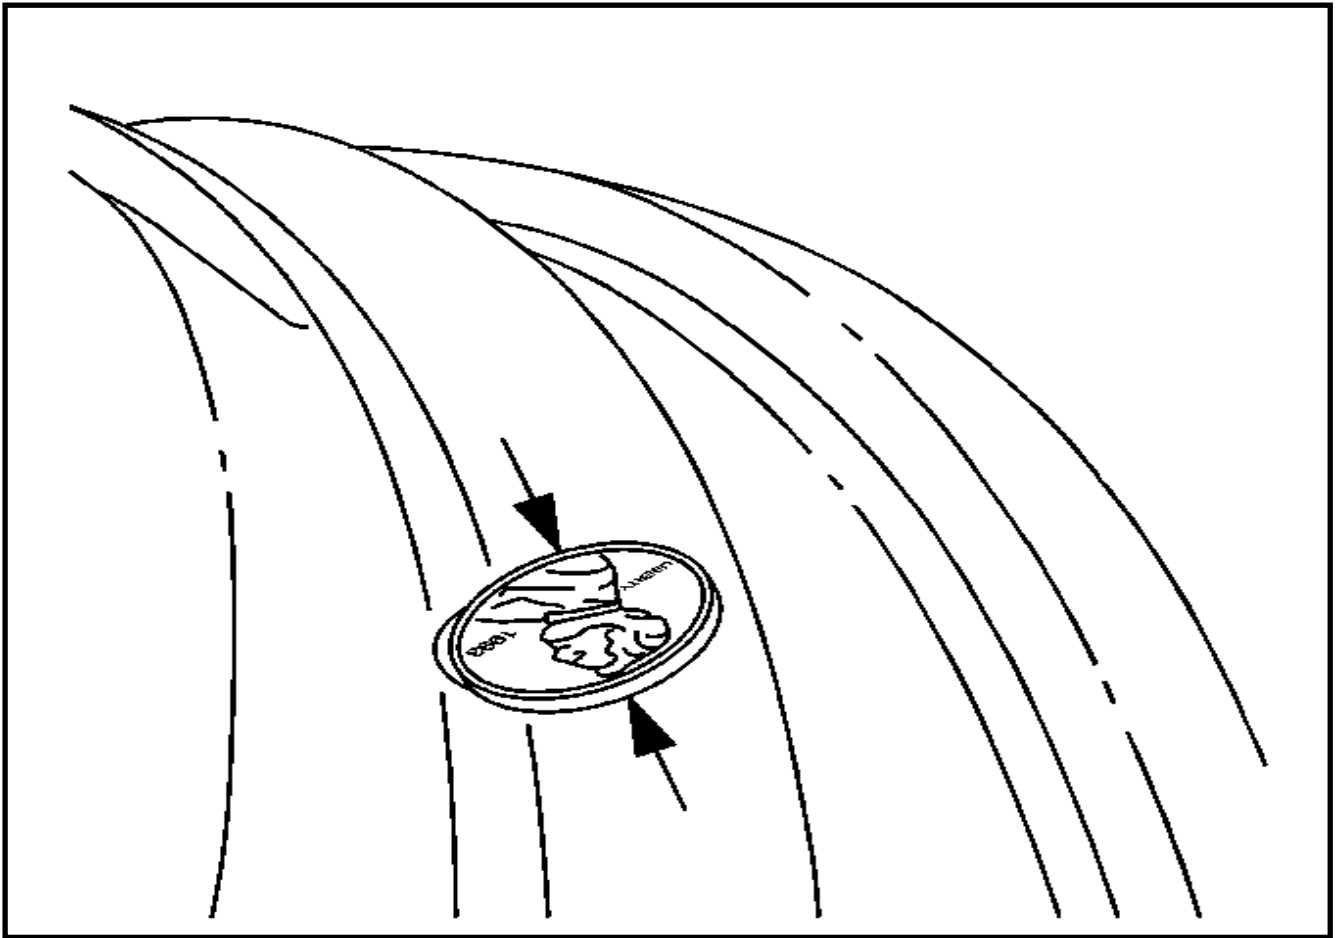
Wheels that exhibit a repeat leak down condition may have been machined in such a manner that the valve stem/tire pressure sensor counterbore is too deep, resulting in air leakage past the sensor's seal.

With the tire and valve stem/tire pressure monitor removed from the suspect wheel, place a penny in the counterbore where the valve stem/tire pressure monitor seats on the inside of the wheel. If the penny sits in the counterbore so that it is below the unmachined surface of the wheel at the points indicated by the arrows in the illustration (counterbore depth more than 1.1 mm (.043 in), replace the wheel assembly with the appropriate service part indicated in the chart below.

Part Number	Description
9593798	Wheel, Front
9593800	Wheel, Rear
