1990 - 1992 Corvette ZR-1: Service Bulletin: No Start Condition (Replace Starter)

Subject: NO START CONDITION (STARTER CORROSION-REPLACE STARTER)

Model and Year: 1990-1992 Corvette, Engine Code J (LT5)

Bulletin Number: 92-307-6 - (09/21/1992)

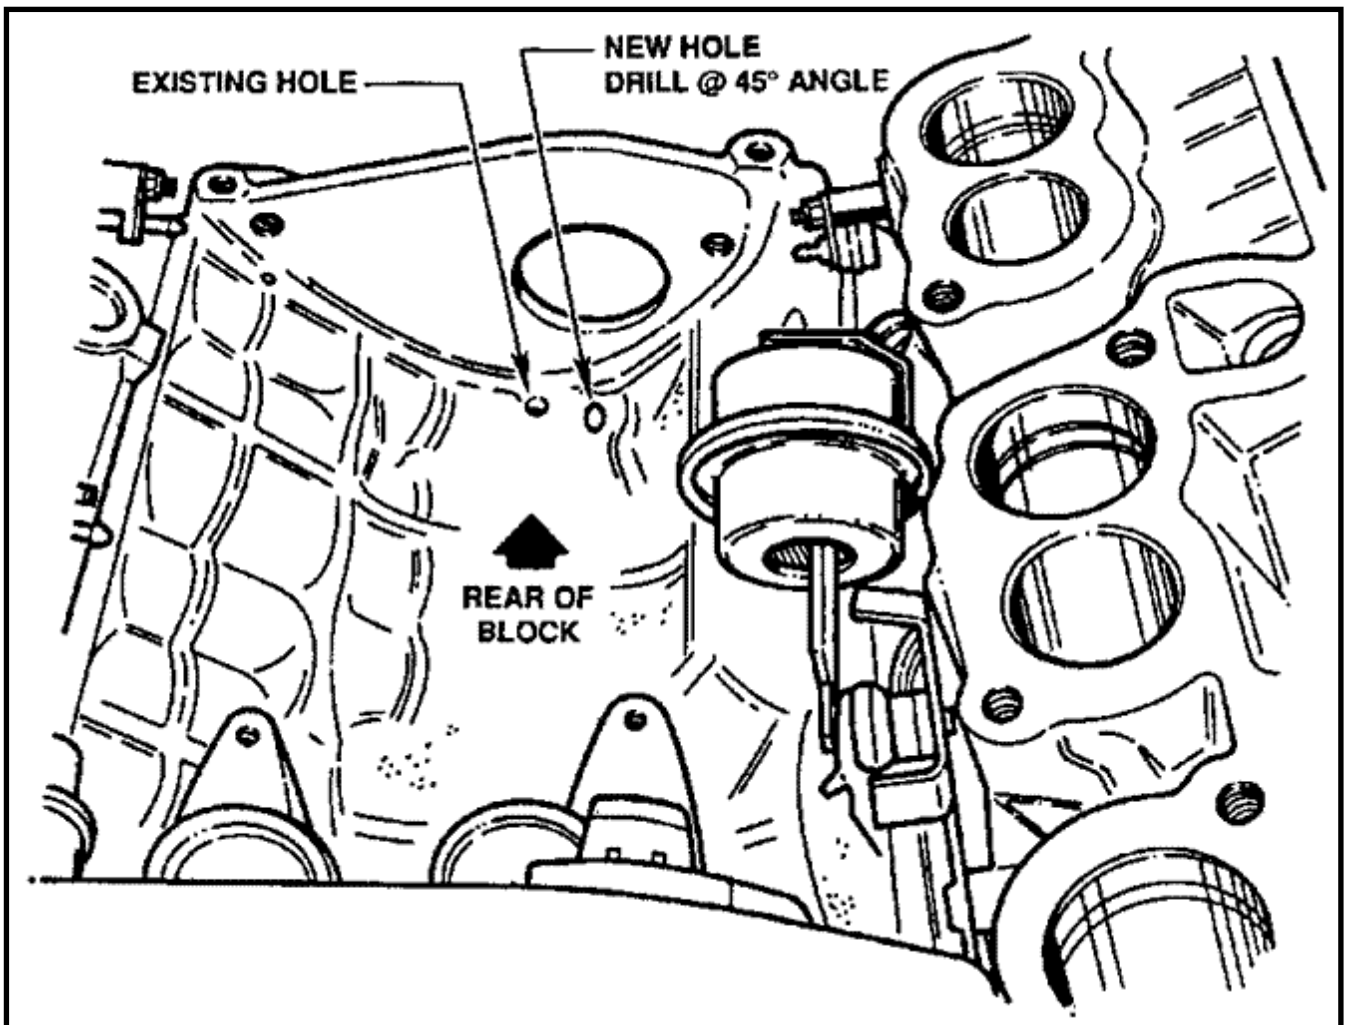
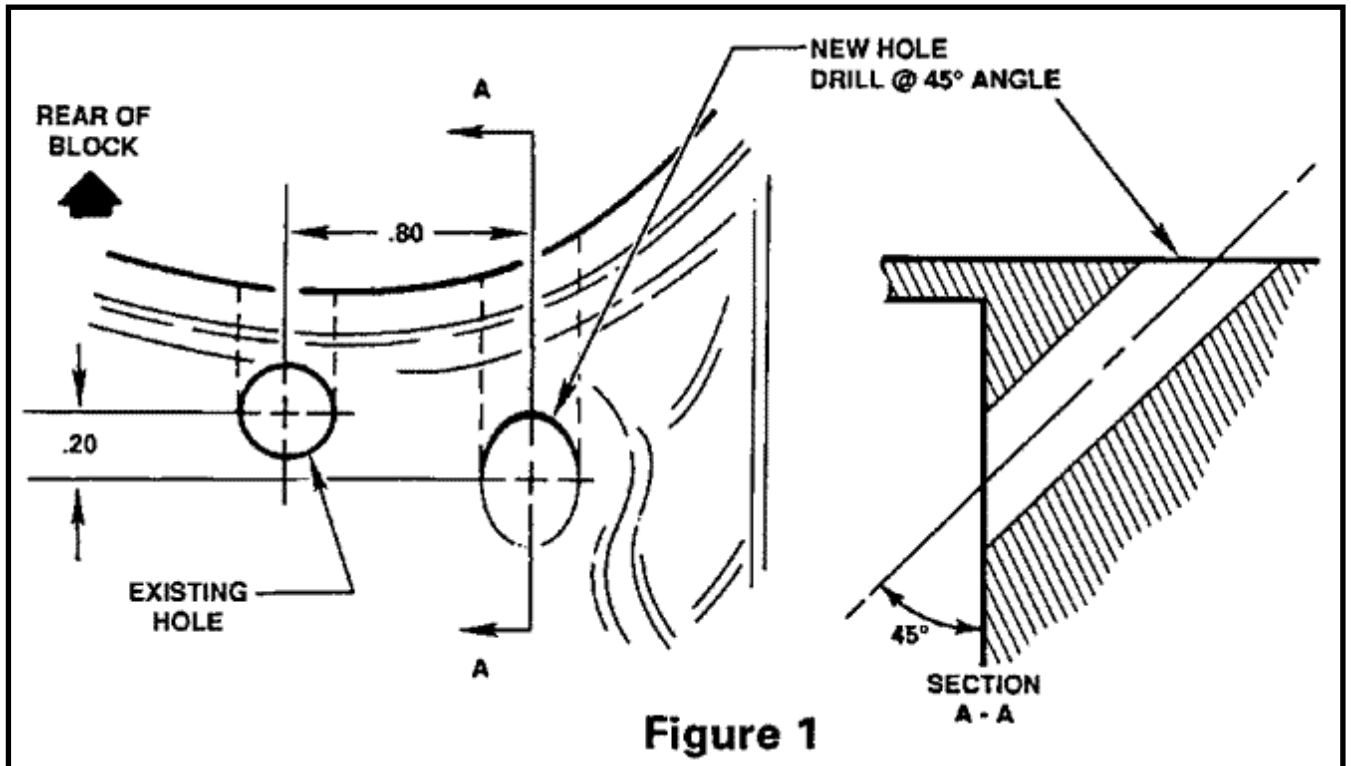
Figure 1

The starter on an LT5 engine is mounted in the engine "vee." A drain hole and drain tube are located at the rear of the engine valley. While washing the engine, debris may settle in the engine "vee" and block the drain system.

- 1 . Remove the old starter.
2. Clean any blockage in existing drain system.
3. Drill a 3/8" diameter hole through the engine "vee" to the back of the engine, allowing drainage (see Figure 1).
