1990 - 1992 Corvette ZR-1: Service Bulletin: No Start Condition (Replace Starter)

Subject: NO START CONDITION (STARTER CORROSION-REPLACE STARTER)

Model and Year: 1990-1992 Corvette, Engine Code J (LT5)

Bulletin Number: 92-307-6 - (09/21/1992)

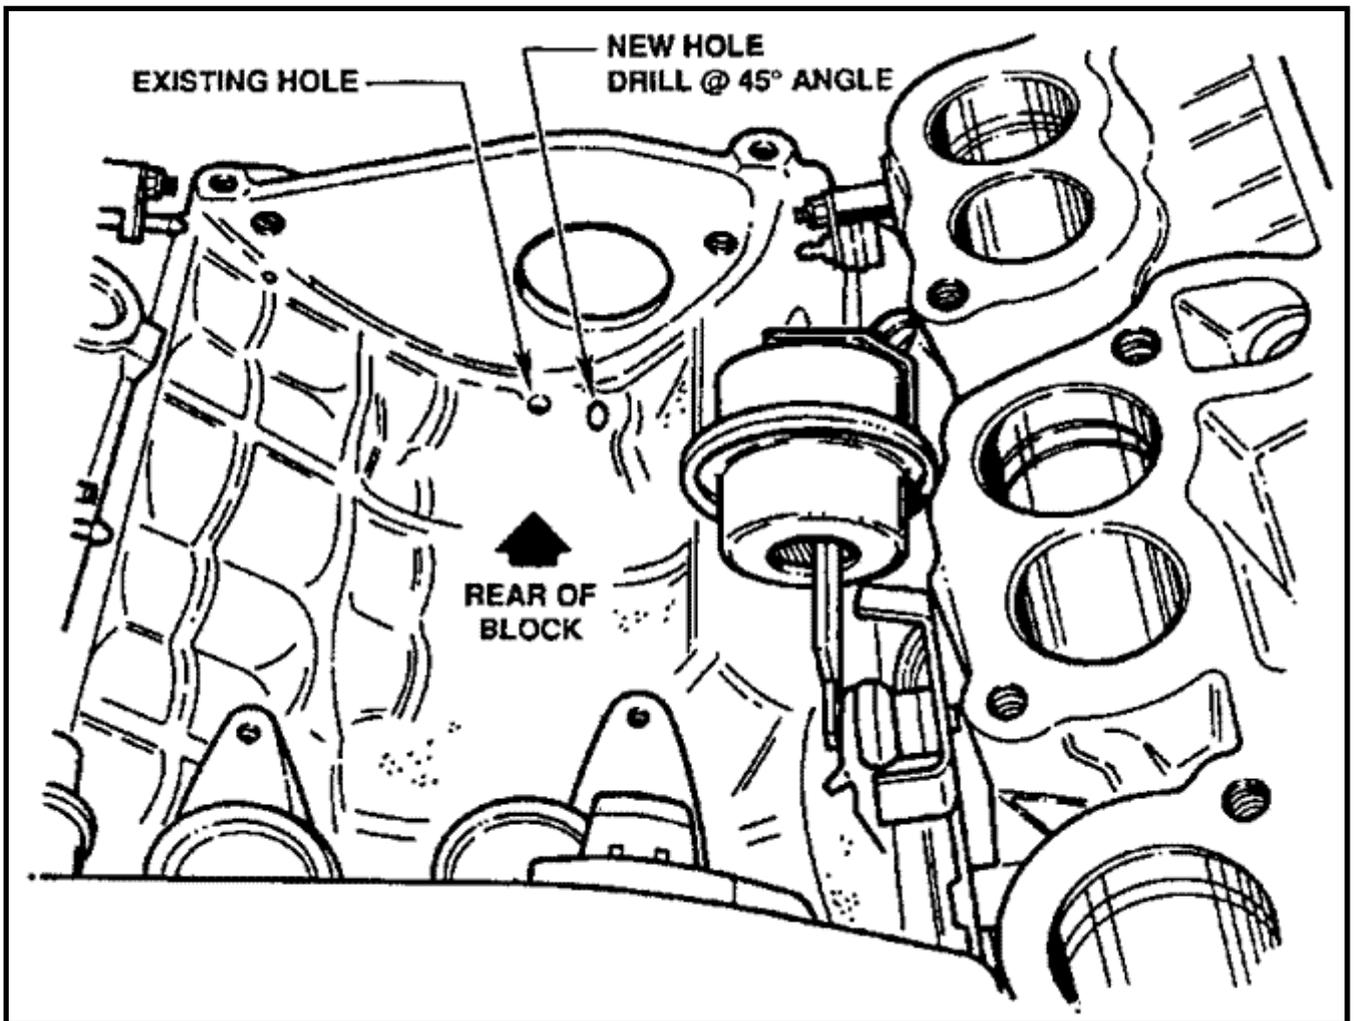
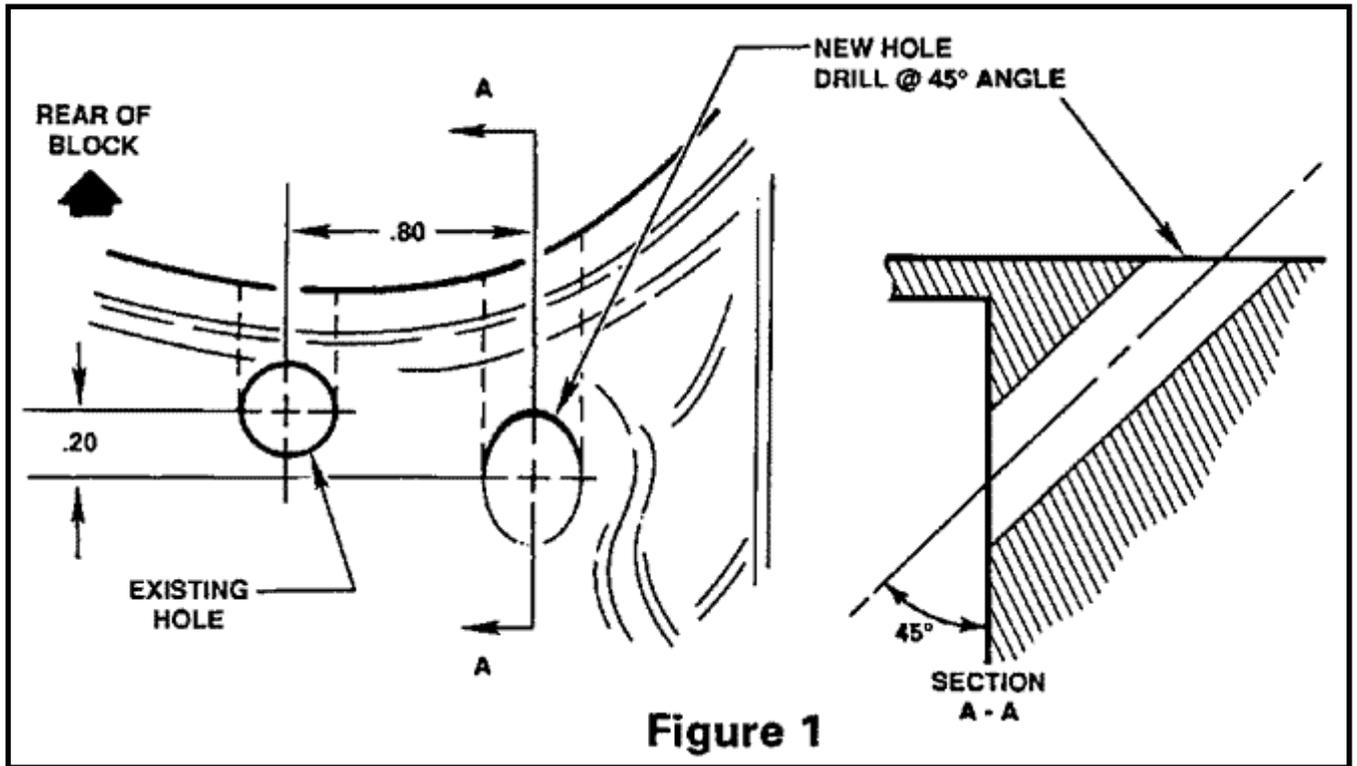
Figure 1

- 1 . Remove the old starter.
2. Clean any blockage in existing drain system.
3. Drill a 3/8" diameter hole through the engine "vee" to the back of the engine, allowing drainage (see Figure 1).

The starter on an LT5 engine is mounted in the engine "vee." A drain hole and drain tube are located at the rear of the engine valley. While washing the engine, debris may settle in the engine "vee" and block the drain system.
