1992 - 1996 Corvette: Technical Article: Rebuilding the LT1 Engine

Rebuilding the Chevrolet LT1 Engine, Doug Anderson,
Automotive Rebuilder, September 1999

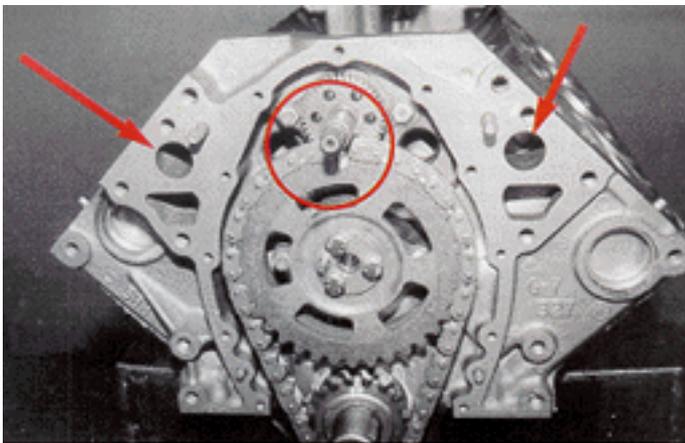
The front of the LT1 block is considerably different. Note the location of the coolant holes that direct the water to the heads and the shaft that drives the water pump.

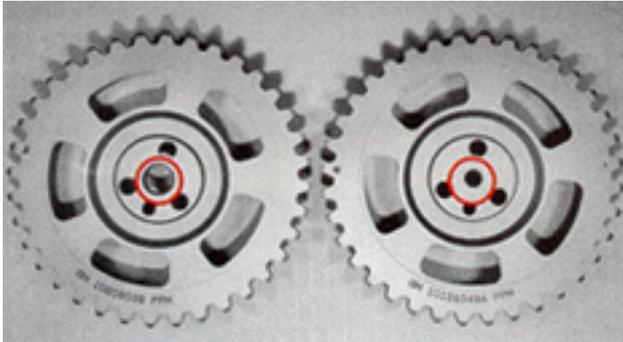
There were two cam gears used on these engines. The early ones (right) had a small hole with 16 splines for the distributor drive shaft while the later ones had a larger, unspined hole.

The original cam had a small, tapered hole in the center and a short dowel pin. It was used with the cam gear that had the small hole in the center with 16 splines in it. It was connected to the distributor with a short drive shaft that was splined on both ends. The cam gear is a GM p/n 10128349. This combination was used from 1992-'95 on the aluminum-headed motors.

The cam gear had a bigger hole and it didn't have the splines that were found in the early gear. The pilot shaft for the distributor extends through the hole in the cam gear and seats in the hole in the cam; the distributor is driven by the long dowel pin that sticks up through the cam gear. The cam gear is a GM p/n 10206039.

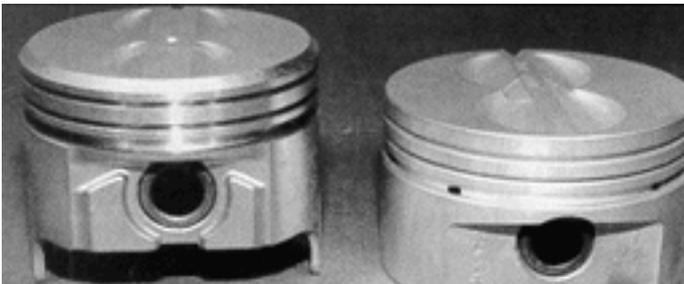
The piston for the 350 LT1 is a special, lightweight flat top with four valve reliefs. The piston for the 265 (left) looks like a smaller version of a 305.

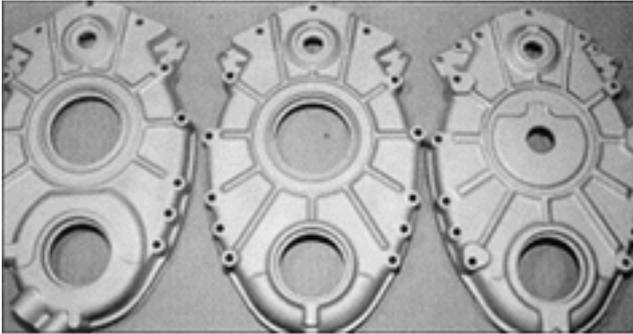
The original front cover (1992-'94) (right) had two small holes, one for the water pump drive and one for the distributor drive. The later one (1994-'95) had a large hole for the distributor. The latest one (1996-'97) (left) had another hole in the bottom corner for the crank position sensor.

The original cover had three holes, one for the crank, a small hole (@ 0.70") for the water pump drive and a second one for the small drive shaft for the distributor. It's a 10128289 casting.

The second front cover still had the small hole for the water pump shaft, but it had a much larger hole (@ 2.63") that sealed on the outside of the distributor housing itself. It's a 10214196 casting.

The second cover was modified again in 1996 to accommodate the crank position sensor that was located in the lower corner of the cover on the passenger side. This same cover was used for the few engines that were installed in 1997, too. It's a 12550032 casting.

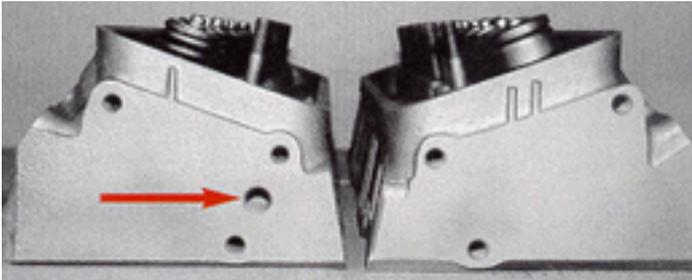
The LT1 heads have an extra hole on both ends. It must be plugged when it's on the front of either head.

There is an extra hole that goes into the water jacket on both ends of the heads. These should be plugged when they're in the front, but left open when they're on the back. There's an external coolant transfer line that connects the holes on the back side to a reservoir that vents the air and steam vapors that would be trapped in the head and cause hot spots.

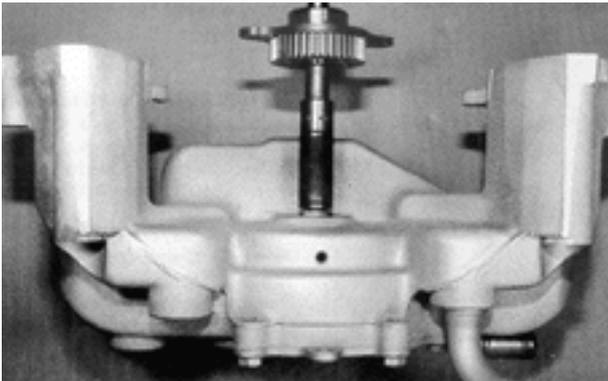
The water pump for the LT1 is gear driven off the cam.
