# 1992 - 1996 Corvette: Technical Article: Rebuilding the LT1 Engine

Rebuilding the Chevrolet LT1 Engine, Doug Anderson,  
Automotive Rebuilder, September 1999

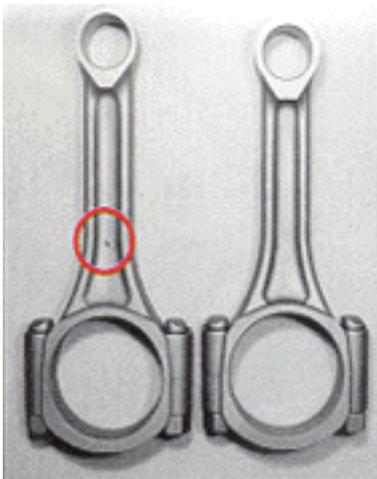
The rods for the 265 (left) are longer than the ones for the 350. They can be identified by the single, raised dot on the shank of the rod.

**265** - The 265 rods are 0.240" longer than the ones in the 350. Both blocks are the same height, but the stroke for the 265 is 0.480" shorter, so the rods have to be longer to make up for half the difference. These rods can be identified by the single, raised dot on both sides of the shank.

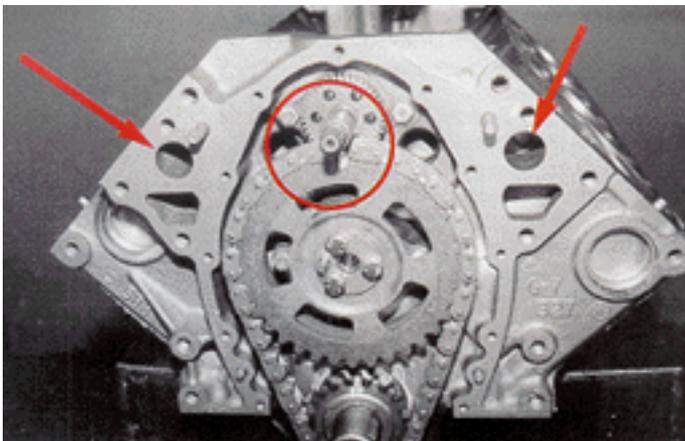
The front of the LT1 block is considerably different. Note the location of the coolant holes that direct the water to the heads and the shaft that drives the water pump.

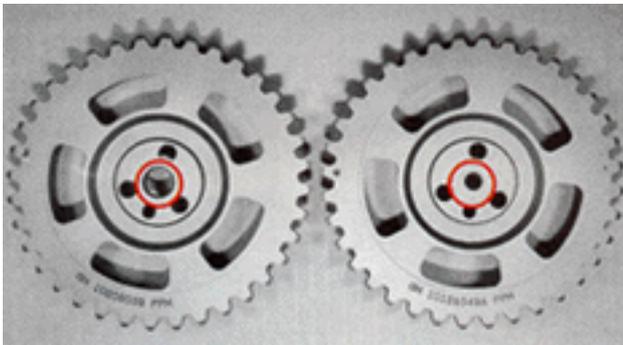
There were two cam gears used on these engines. The early ones (right) had a small hole with 16 splines for the distributor drive shaft while the later ones had a larger, unspined hole.

The original cam had a small, tapered hole in the center and a short dowel pin. It was used with the cam gear that had the small hole in the center with 16 splines in it. It was connected to the distributor with a short drive shaft that was splined on both ends. The cam gear is a GM p/n 10128349. This combination was used from 1992-'95 on the aluminum-headed motors.

The cam gear had a bigger hole and it didn't have the splines that were found in the early gear. The pilot shaft for the distributor extends through the hole in the cam gear and seats in the hole in the cam; the distributor is driven by the long dowel pin that sticks up through the cam gear. The cam gear is a GM p/n 10206039.

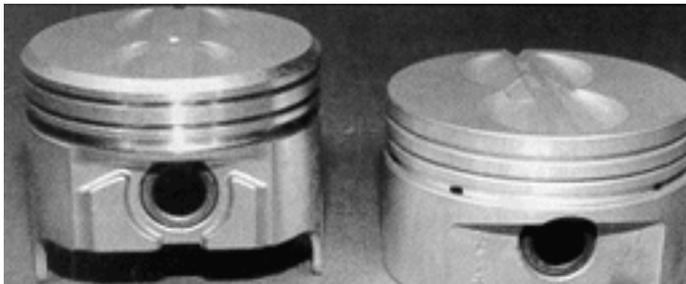
The piston for the 350 LT1 is a special, lightweight flat top with four valve reliefs. The piston for the 265 (left) looks like a smaller version of a 305.

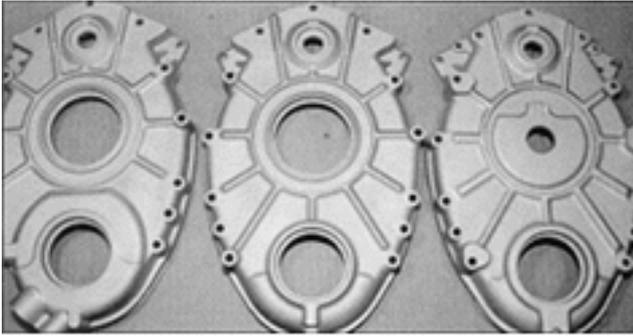
The original front cover (1992-'94) (right) had two small holes, one for the water pump drive and one for the distributor drive. The later one (1994-'95) had a large hole for the distributor. The latest one (1996-'97) (left) had another hole in the bottom corner for the crank position sensor.

The original cover had three holes, one for the crank, a small hole (@ 0.70") for the water pump drive and a second one for the small drive shaft for the distributor. It's a 10128289 casting.

The second front cover still had the small hole for the water pump shaft, but it had a much larger hole (@ 2.63") that sealed on the outside of the distributor housing itself. It's a 10214196 casting.

The second cover was modified again in 1996 to accommodate the crank position sensor that was located in the lower corner of the cover on the passenger side. This same cover was used for the few engines that were installed in 1997, too. It's a 12550032 casting.

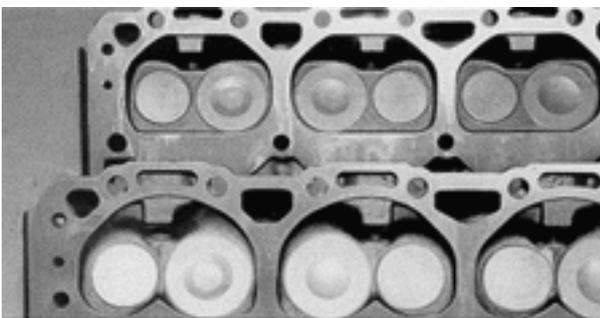
The chamber on the LT1 head (bottom) is much smaller and shaped different than the one for the regular Chevy 350.

All LT1 heads used small combustion chambers to get the higher compression ratios with flat top pistons; the 350s had a 10.5 to 1 ratio and the 265s had a 9.8 to 1 ratio.

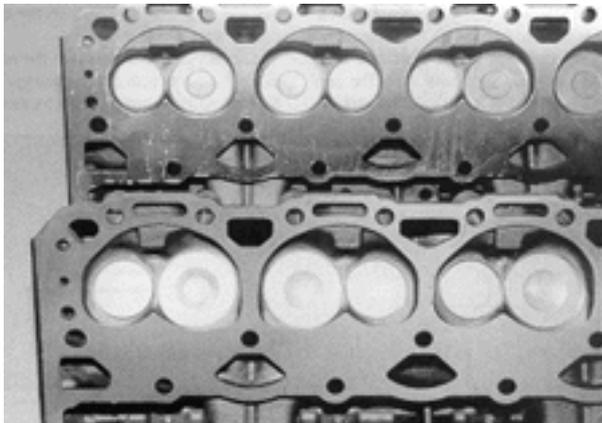
The chamber for the 265 (top) is shaped like the one for the 350 LT1, but it's even smaller.

**265 IRON HEADS** - The 265 had its own unique cast iron head with a 10208890 casting number. The chambers are smaller, so these heads cannot be interchanged with any of the 350 LT1 heads.

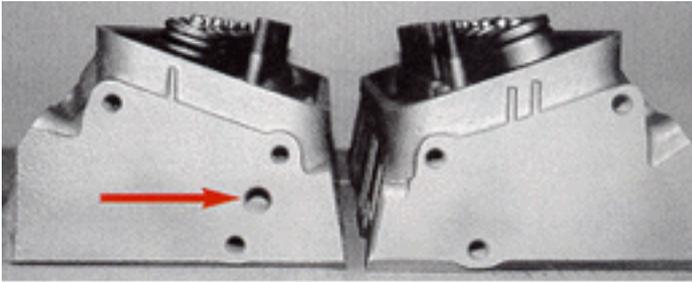
The LT1 heads have an extra hole on both ends. It must be plugged when it's on the front of either head.

There is an extra hole that goes into the water jacket on both ends of the heads. These should be plugged when they're in the front, but left open when they're on the back. There's an external coolant transfer line that connects the holes on the back side to a reservoir that vents the air and steam vapors that would be trapped in the head and cause hot spots.

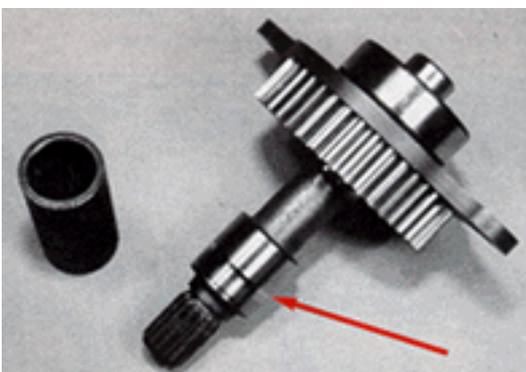
The water pump is driven by this gear and coupling. Make sure the bearing is good and that the seal surface isn't grooved before reusing it.

Be sure to check the seal surface on the geared shaft that drives the water pump. If it's grooved, it will leak and it will be your fault. New ones are available from GM (p/n 10219554) for around \$40. That's cheap insurance when you consider that the timing cover, chain and gears have to come off to replace it.

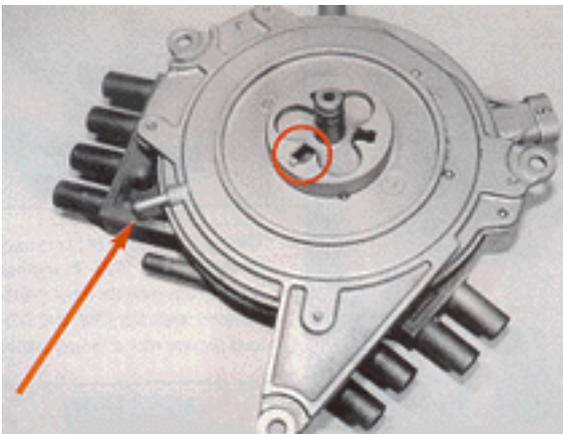
The late Optispark distributor is a sealed assembly that is vented to the intake. It is piloted by the stub shaft that centers in the cam and is driven by a long pin in the cam that engages a slot in the hub of the distributor.

GM had some problems with the early distributor due to both carbon tracking and moisture, so a new sealed distributor with a vacuum port was introduced on the iron-headed 265s and 350s in 1994 and used on all LT1s in 1995. The new distributor was located with a pilot shaft and driven by a pin, so both the cam and the gear were changed. The cam had a large, deep hole in the center for the pilot shaft and a longer dowel pin to drive the distributor.

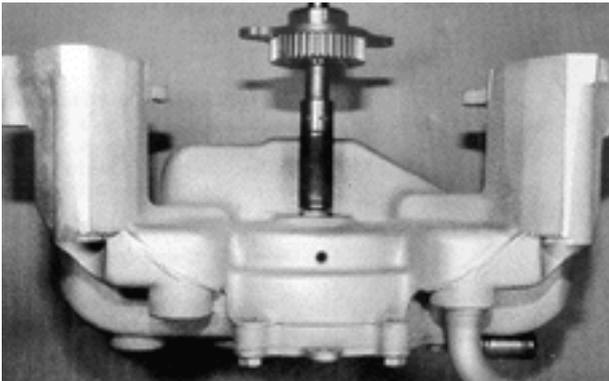
The water pump for the LT1 is gear driven off the cam.

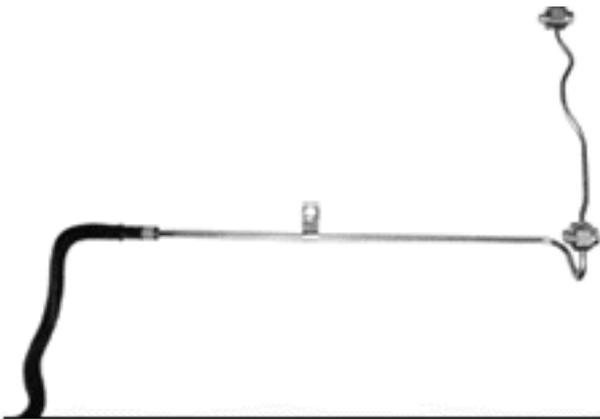
The holes in the back of the heads are connected to the reservoir with this manifold. It is needed to purge the air and steam vapors that would otherwise be trapped in the head.

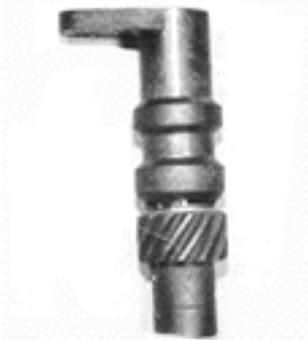
The oil pump is driven by a stub shaft that fits into the original distributor hole.
