# 1988 - 1989 Corvette: Recall: Evaporative Emission Hoses

**Subject:** CAMPAIGN: EVAPORATIVE EMISSION HOSES

**Model and Year:** 1988-89 CHEVROLET CORVETTE

**Bulletin Number:** 89C25 - (08/23/1993)

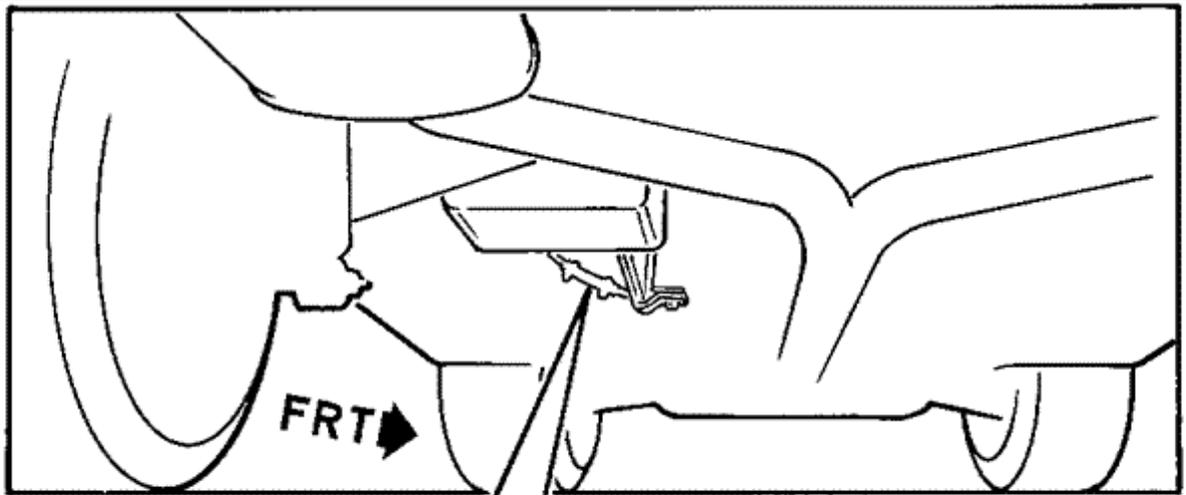
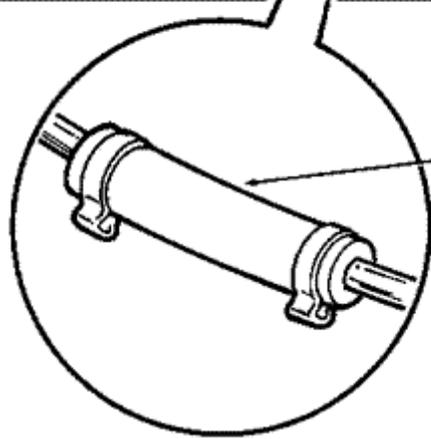
FIGURE 1

1. Raise vehicle.
2. Referring to Figure 1, locate rubber hose (approximately 2-9/16" long - 65mm) connecting fuel tank evaporative emission pipe to chassis fore-aft evaporative emission pipe.

HOSE MUST BE POSITIONED EQUALLY OVER BOTH PIPES

3. Remove both hose clamps and hose. Hose clamps and hose will not be reused.
4. Inspect pipes and bend if required to insure ends of pipes are in line with one another.

5. Install two (2) new clamps (P/N 01622744) and new hose (P/N 09442928) onto pipe ends. Insuring hose is positioned an equal distance over both ends. Position clamps onto hose and secure.

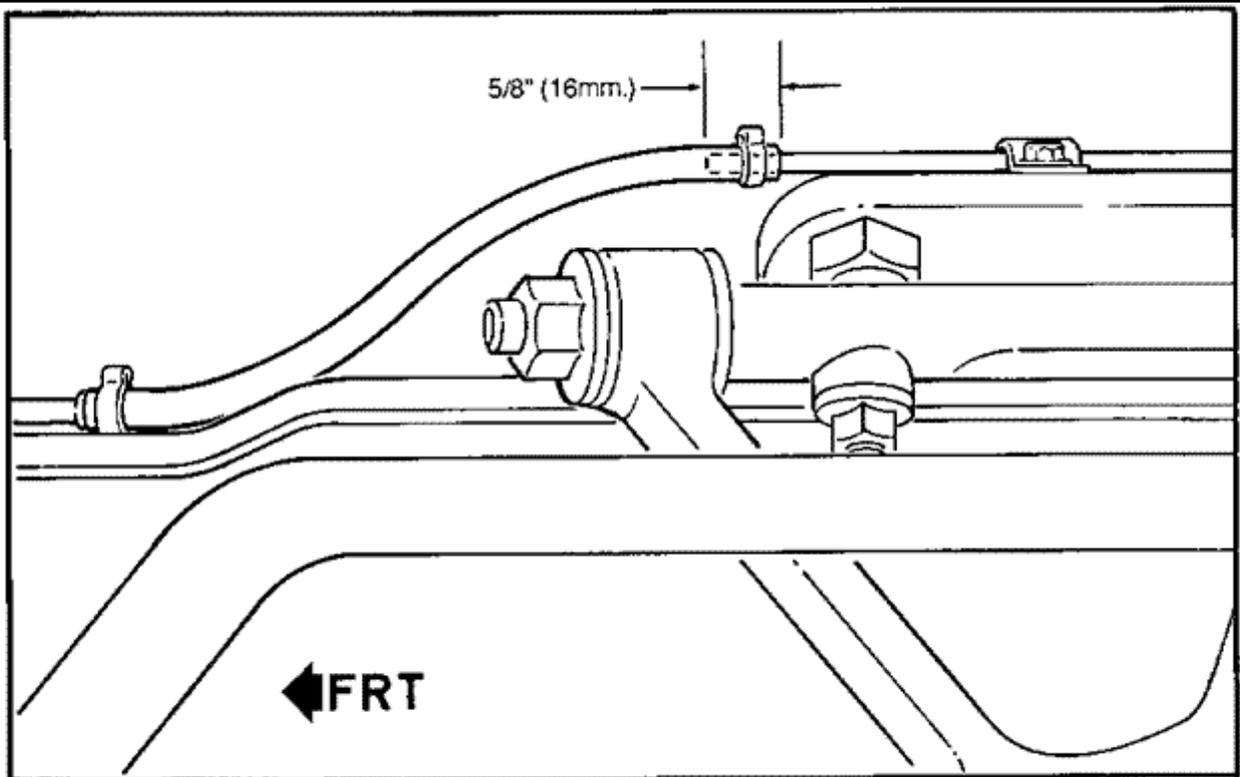
FIGURE 2

6. Lower vehicle.
7. Underhood, locate the evaporative emission hose connecting chassis fore/aft evaporative emission pipe to evaporative emission line shown in Figure 2.

10. Install larger end of new hose (P/N 10248651) over nylon evaporative emission line and install the opposite end approximately 1/2" over the fore/aft chassis pipe as illustrated in Figure 2.

8. Remove both hose clamps and hose. Hose clamps and hose will not be reused.
9. Install new large clamp (P/N 10028454) over nylon evaporative emission line, and install new small clamp (P/N 01622744) over chassis pipe.

**Notice: If hose appears taut when assembled as indicated above, repositioning of chassis fore/aft pipe may be required to alleviate condition.**

11. Position clamps onto hose and secure.
12. Install Campaign Identification Label.
