# 1984 - 1985 Corvette: Service Bulletin: Door Ajar Switch Corrosion

**Source:** Chevrolet Dealer Service Bulletin

**Bulletin Number:** 85-43, Number 8B (XII) & 10(I)

**Date:** Feb., 1985

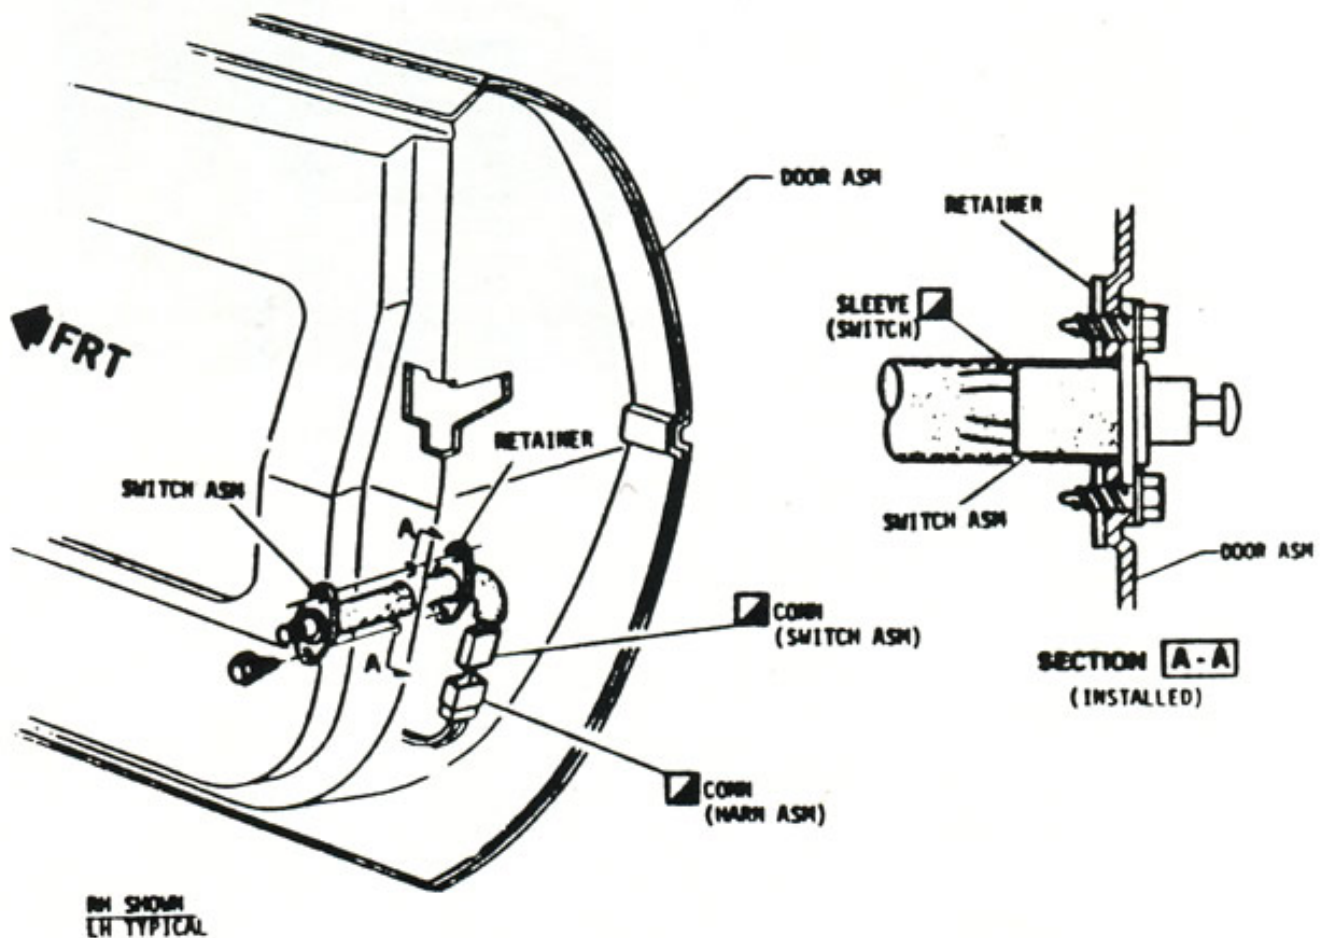
A NEW CORROSION RESISTANT SWITCH (P/N 14087681) AND AN ASSOCIATED RETAINER (P/N 14087682) ARE TO BE USED AS SERVICE REPLACEMENTS. THE NEW SWITCH INCLUDES A SLEEVE (SEE ILLUSTRATION) THAT FITS TIGHTLY AROUND THE SWITCH'S HOUSING AND HAS SUFFICIENT LENGTH TO COVER THE WIRE CONNECTOR ONCE CONNECTION TO THE DOOR HARNESS IS MADE.

- REPLACEMENT 14087681 DOOR AJAR SWITCH  
(WITH SLEEVE)

WHEN REPLACING THE EXISTING SWITCH WITH A NEW 14087681 SWITCH, THE DOOR INSERT HOLE WILL NEED TO BE ENLARGED FROM 16MM TO 18MM TO ACCOMMODATE THE SLEEVE PROVISION. CARE MUST BE EXERCISED WHEN ENLARGING THE INSERT HOLE SO THAT ADJOINING MOUNTING HOLES ARE NOT ALTERED. SCRATCHES, CHIPS, ETC., TO DOOR PANEL SURFACE RESULTING FROM THE HOLE ENLARGING PROCESS ARE TO BE COSMETICALLY REPAIRED AS OUTLINED IN SECTION 10 (BODY) OF THE CORVETTE SHOP MANUAL.
