1987 - 1991 Corvette: Service Bulletin: 4L60 Low & Reverse Clutch New Plate Available

Subject: 4L60 LOW & REVERSE CLUTCH NEW WAVE PLATE IS AVAILABLE

Model and Year: 1987-91 CAPRICE, CAMARO, CORVETTE AND 1987-91 C/K, RN, S/T TRUCKS, G, M VANS AND 1990-91 L VAN WITH 4L60 AUTOMATIC TRANSMISSION

Bulletin Number: 91-186-7A - (01/29/1991)

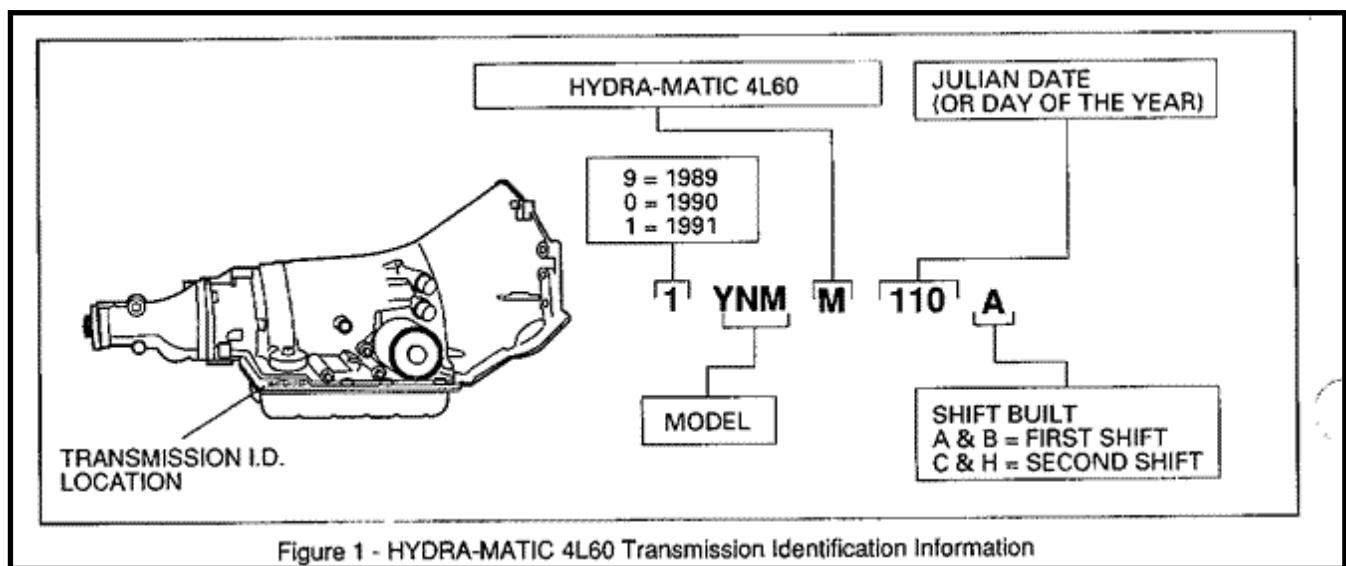
----- Beginning March 28, 1990 (Julian Date 087), all HYDRA-MATIC 4L60 transmissions were built using the new low and reverse clutch wave plate.

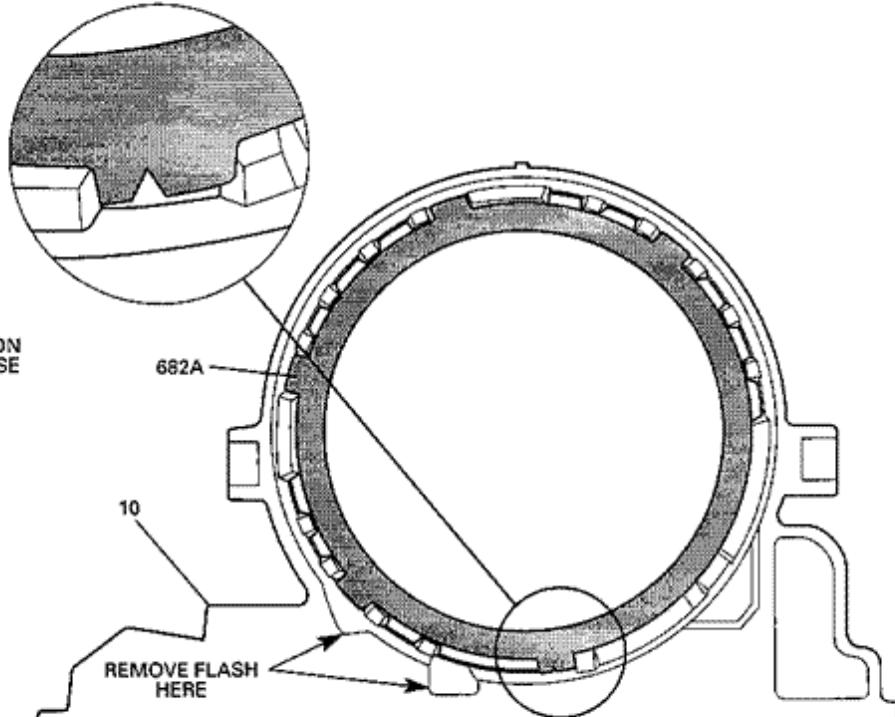
Figure 2 - Lo And Reverse Clutch Waved Plate

SERVICE INFORMATION: (Figure 2) ----- Low and Reverse Clutch failure can be caused by case casting flash interfering with clutch plate travel. A new wave plate is now available which will alleviate this condition. This new plate can be used to service any Hydra-matic 4L60 transmission produced after February 9, 1987 (Julian Date 040).

10 CASE, TRANSMISSION
682A PLATE, LO & REVERSE
CLUTCH (WAVED)

REMOVE FLASH
HERE

When installing the new wave plate, check for any case flash that may be present in the low and reverse grooves, and use a metal file to remove. See Figure 2 for case location information.
