# 1987 - 1991 Corvette: Service Bulletin: 4L60 Low & Reverse Clutch New Plate Available

**Subject:** 4L60 LOW & REVERSE CLUTCH NEW WAVE PLATE IS AVAILABLE

**Model and Year:** 1987-91 CAPRICE, CAMARO, CORVETTE AND 1987-91 C/K, RN, S/T TRUCKS, G, M VANS AND 1990-91 L VAN WITH 4L60 AUTOMATIC TRANSMISSION

**Bulletin Number:** 91-186-7A - (01/29/1991)

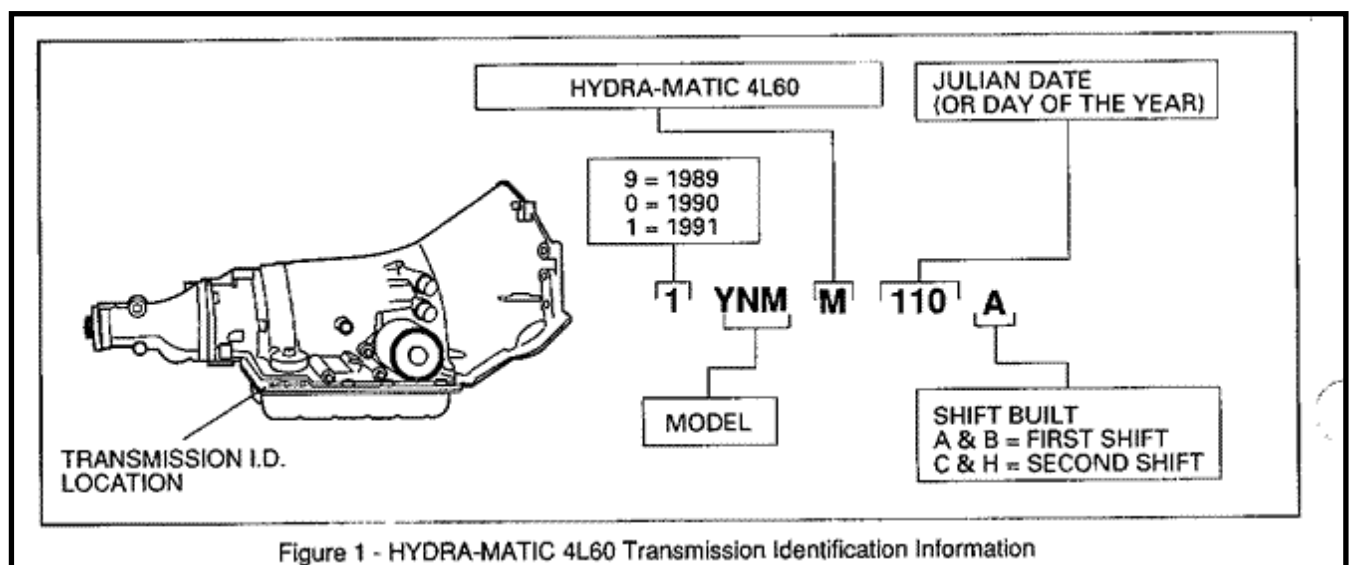
----- Beginning March 28,1990 (Julian Date 087),  
all HYDRA-MATIC 4L60 transmissions were built using the new low and  
reverse clutch wave plate.

10 CASE, TRANSMISSION  
682A PLATE, LO & REVERSE  
CLUTCH (WAVED)

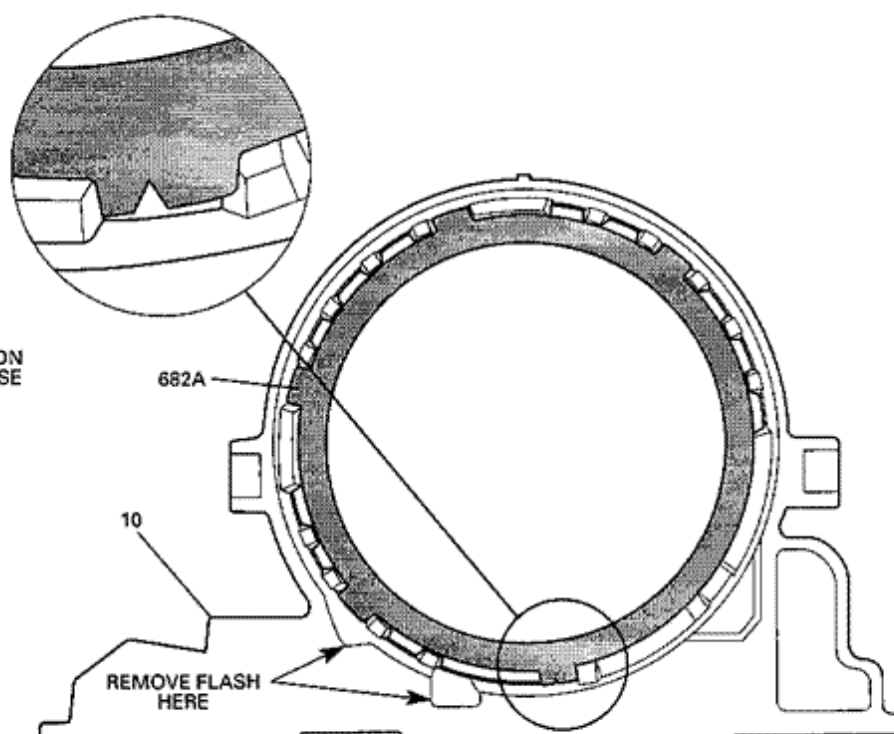
Figure 2 - Lo And Reverse Clutch Waved Plate

SERVICE INFORMATION: (Figure 2) ----- Low and Reverse Clutch failure can be caused by case casting flash interfering with clutch plate travel. A new wave plate is now available which will alleviate this condition. This new plate can be used to service any Hydra-matic 4L60 transmission produced after February 9, 1987 (Julian Date 040).

When installing the new wave plate, check for any case flash that may be present in the low and reverse grooves, and use a metal file to remove. See Figure 2 for case location information.
