1993 Corvette: Service Bulletin: Hood Will Not Open - Cable Disconnection

Subject: HOOD WILL NOT OPEN, CABLE DISCONNECTED

Bulletin Number: 93-151-10

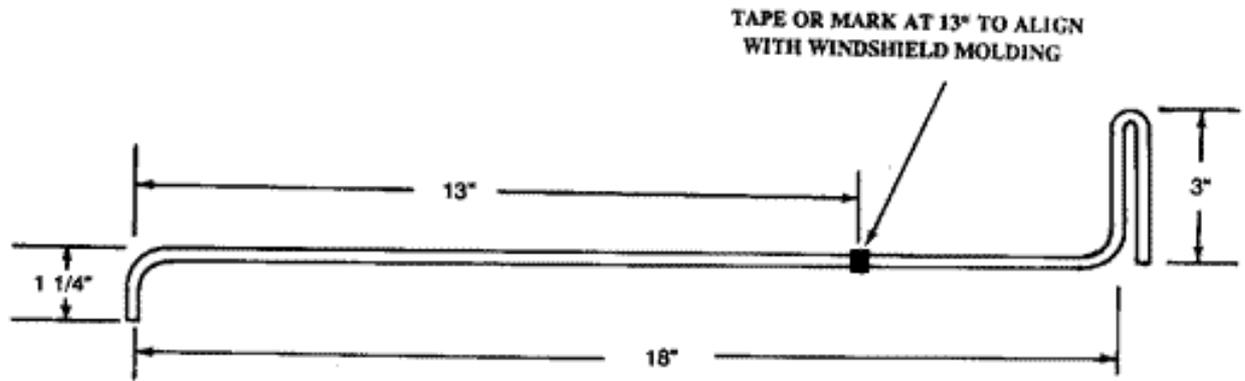
TOOL

- Obtain material locally and fabricate the tool shown on the illustration from 3/16" or 1/4" steel rod.
- With the door open, locate the short bent end of the tool inboard of the vertical flange of the hood latch support.
- insert the tool forward until the tape is aligned with the lower end of the windshield pillar molding.
- Twist the tool to contact and move the latch lever until the latch disengages. A slight downward pressure on the hood in the latch area may be helpful to disengage the latch lever.

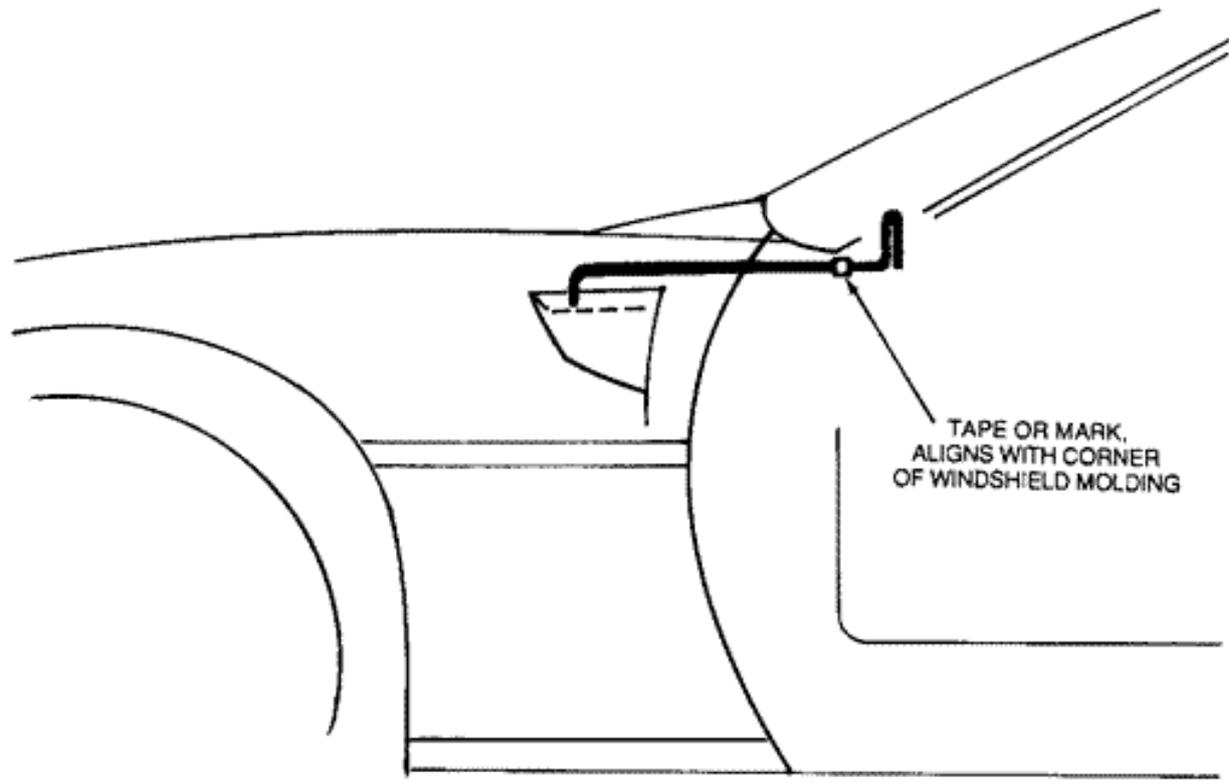
TOOL IN POSITION
(DOOR REMOVED FOR ILLUSTRATIVE PURPOSES)
