1993 Corvette: Service Bulletin: Hood Will Not Open - Cable Disconnection

Subject: HOOD WILL NOT OPEN, CABLE DISCONNECTED

Model and Year: 1993 Corvette prior to V.I.N.'s: Non-ZR1 - P5110787 ZR1 - P5800217

Bulletin Number: 93-151-10

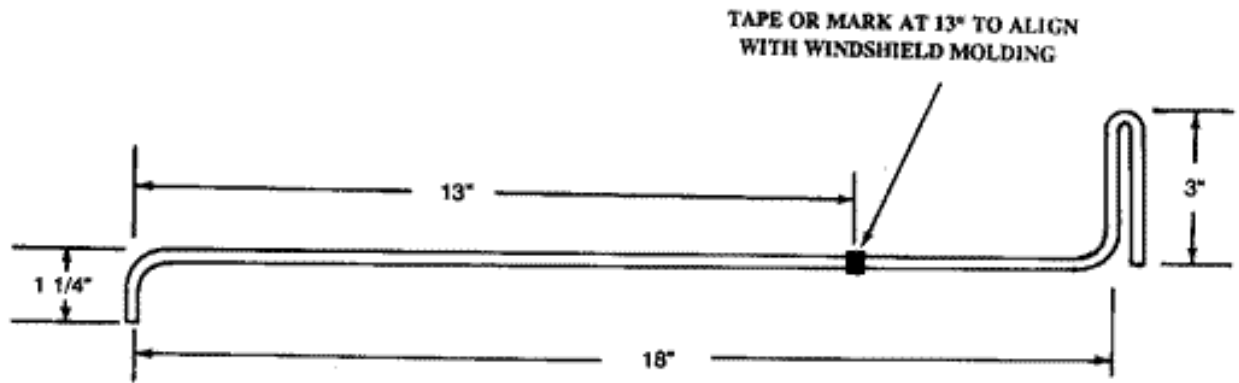
TOOL

- Obtain material locally and fabricate the tool shown on the illustration from 3/16" or 1/4" steel rod.
- With the door open, locate the short bent end of the tool inboard of the vertical flange of the hood latch support.
- insert the tool forward until the tape is aligned with the lower end of the windshield pillar molding.
- Twist the tool to contact and move the latch lever until the latch disengages. A slight downward pressure on the hood in the latch area may be helpful to disengage the latch lever.

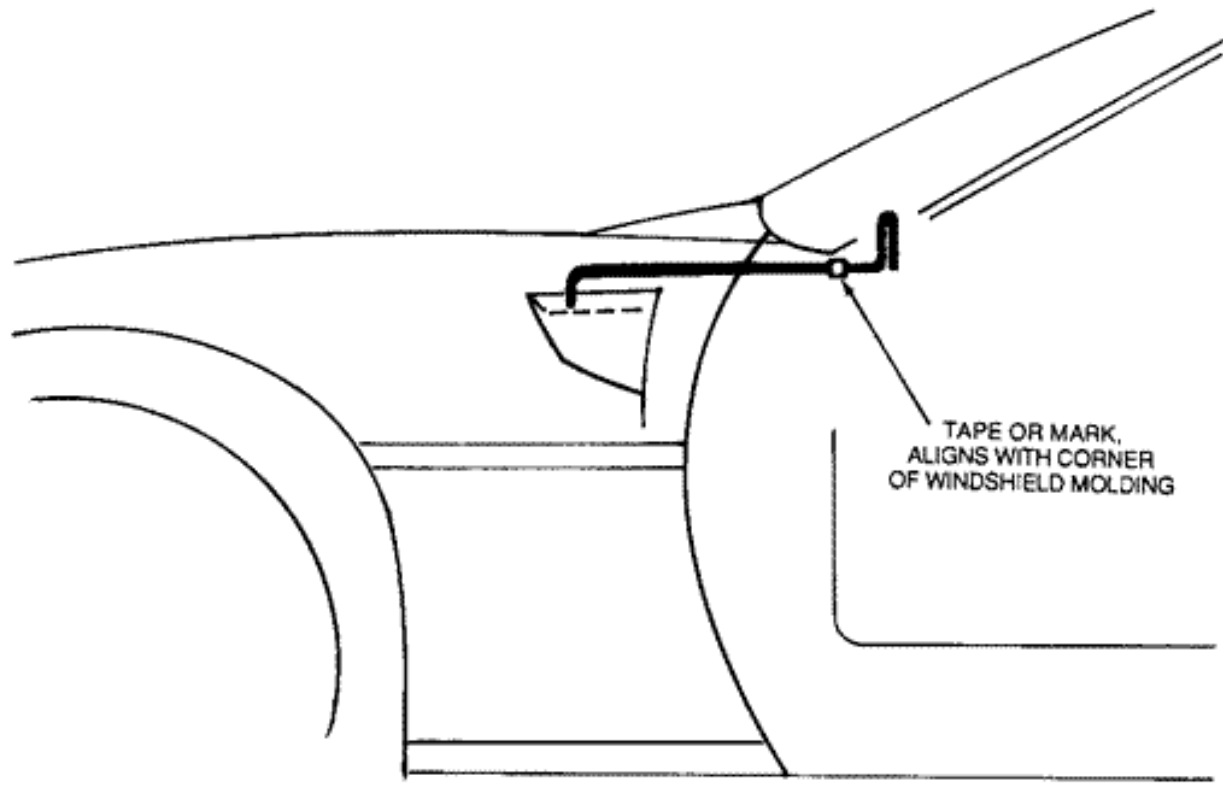
TOOL IN POSITION
(DOOR REMOVED FOR ILLUSTRATIVE PURPOSES)
