# 1982 - 1991 Corvette: Service Bulletin: Checking Connector Terminal Contact - Metri-Pack

**Subject:** CHECKING CONNECTOR TERMINAL CONTACT - METRI - PACK

**Model and Year:** 1982-91 PASSENGER CARS AND TRUCKS

**Bulletin Number:** 91-85-8A - (09/21/1990)

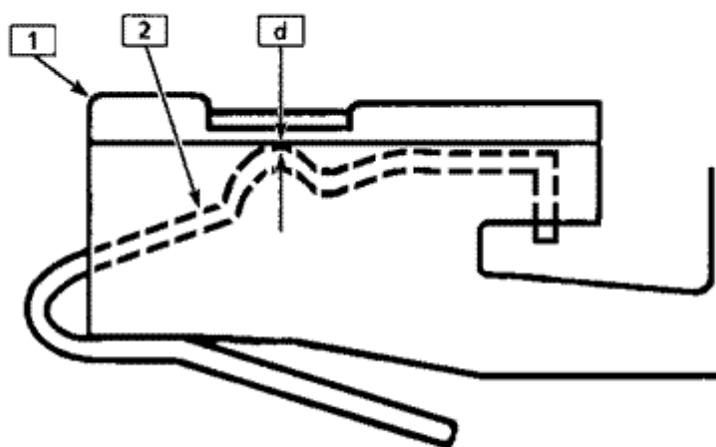
$d = 0$ , GOOD TERMINAL CONTACT

- 
- 1** TYPICAL METRI-PACK 150/280/480/630 SERIES FEMALE TERMINAL  
(150 SERIES PUSH-TO-SEAT SHOWN)
  - 2** CONTACT TANG
  - d** AMOUNT OF DEFORMATION

to the female terminal contact tang, can result in poor terminal contact, see Figure 1, causing an open or intermittently open circuit.

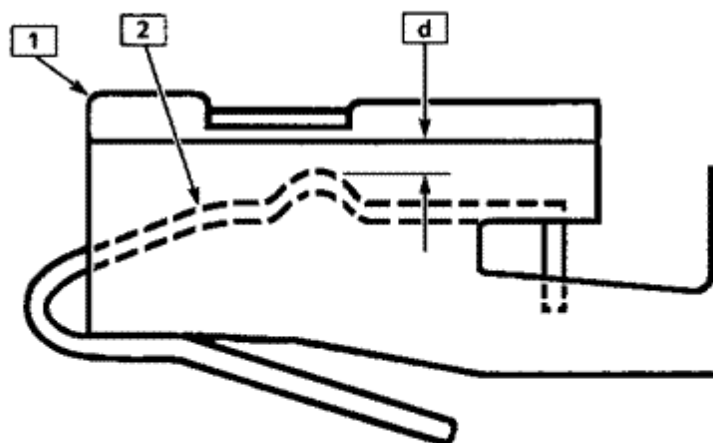
Figure 1 - Deformation of a typical Metri-Pack 150/280/480/630 series female terminal.

$d > 0$ , POOR TERMINAL CONTACT

Deformation is caused by probing the mating side of a connector terminal without the proper adapter, improperly joining the connector halves or repeatedly separating and joining the connector halves. Deformation, usually

4. Using an equivalent female terminal from the Terminal Repair Kit J 38125-2, compare the retention force of this terminal to the female terminal in question by joining and separating the male terminal to the good female terminal, and then joining and separating the male terminal to the female terminal in question. If the retention force is significantly different between the two female terminals, replace the female terminal in question, refer to Terminal Repair Kit J 38125-2.
