1982 - 1991 Corvette: Service Bulletin: Checking Connector Terminal Contact - Metri-Pack

Subject: CHECKING CONNECTOR TERMINAL CONTACT - METRI-PACK

Source: Chevrolet Service Bulletin

Bulletin Number: 91-85-8A - (09/21/1990)

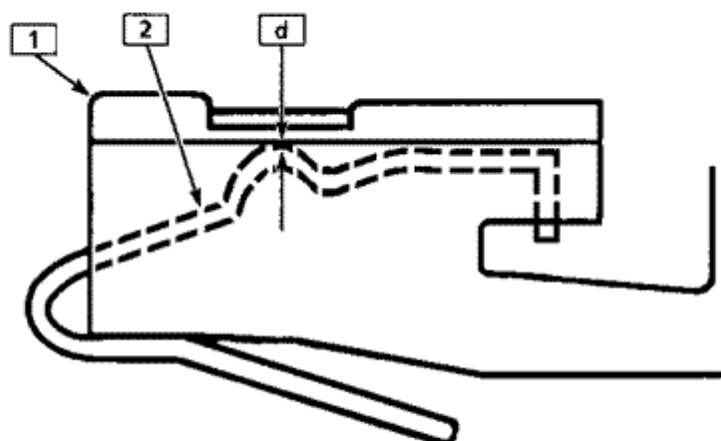
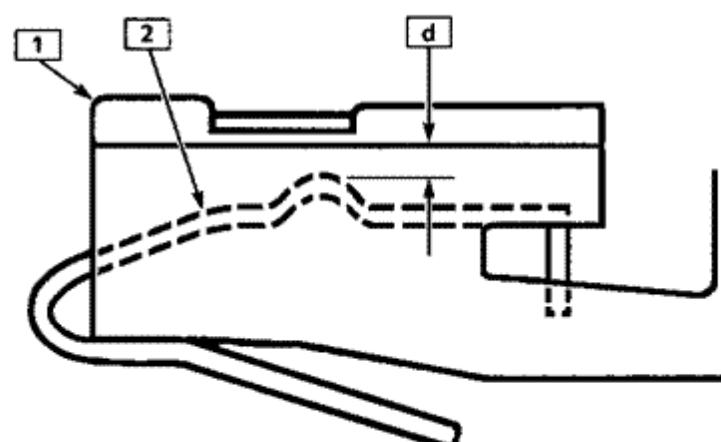
Figure 1 - Deformation of a typical Metri-Pack 150/280/480/630 series female terminal.

$d = 0$, GOOD TERMINAL CONTACT

$d > 0$, POOR TERMINAL CONTACT

1 TYPICAL METRI-PACK 150/280/480/630 SERIES FEMALE TERMINAL
(150 SERIES PUSH-TO-SEAT SHOWN)

2 CONTACT TANG

d AMOUNT OF DEFORMATION

Deformation is caused by probing the mating side of a connector terminal without the proper adapter, improperly joining the connector halves or repeatedly separating and joining the connector halves. Deformation, usually

to the female terminal contact tang, can result in poor terminal contact, see Figure 1, causing an open or intermittently open circuit.

3. Using an equivalent male terminal from the Terminal Repair Kit J 38125-2, check the retention force of the female terminal in question by inserting and removing the male terminal to the female terminal in the connector body. Good terminal contact will require a certain amount of force to separate the terminals.

4. Using an equivalent female terminal from the Terminal Repair Kit J 38125-2, compare the retention force of this terminal to the female terminal in question by joining and separating the male terminal to the good female terminal, and then joining and separating the male terminal to the female terminal in question. If the retention force is significantly different between the two female terminals, replace the female terminal in question, refer to Terminal Repair Kit J 38125-2.
