1982 - 1991 Corvette: Service Bulletin: Checking Connector Terminal Contact - Metri-Pack

Subject: CHECKING CONNECTOR TERMINAL CONTACT - METRI - PACK

Model and Year: 1982-91 PASSENGER CARS AND TRUCKS

Bulletin Number: 91-85-8A - (09/21/1990)

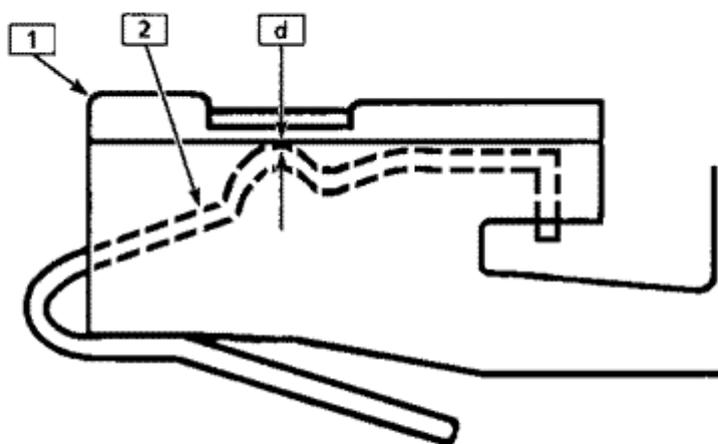
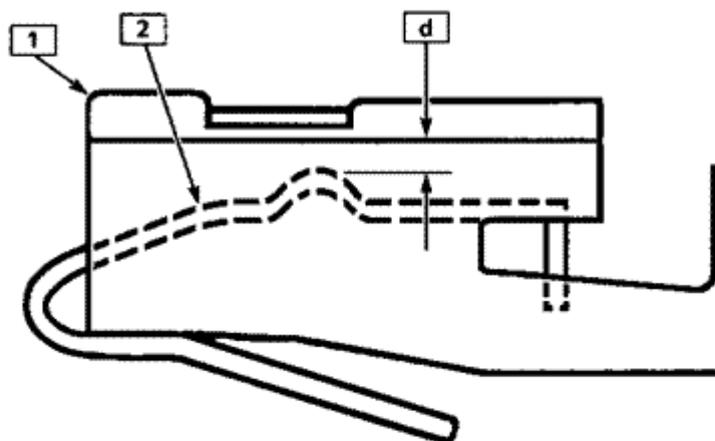
Figure 1 - Deformation of a typical Metri-Pack 150/280/480/630 series female terminal.

to the female terminal contact tang, can result in poor terminal contact, see Figure 1, causing an open or intermittently open circuit.

$d=0$, GOOD TERMINAL CONTACT

$d > 0$, POOR TERMINAL CONTACT

-
- 1** TYPICAL METRI-PACK 150/280/480/630 SERIES FEMALE TERMINAL
(150 SERIES PUSH-TO-SEAT SHOWN)
 - 2** CONTACT TANG
 - d** AMOUNT OF DEFORMATION

3. Using an equivalent male terminal from the Terminal Repair Kit J 38125-2, check the retention force of the female terminal in question by inserting and removing the male terminal to the female terminal in the connector body. Good terminal contact will require a certain amount of force to separate the terminals.

4. Using an equivalent female terminal from the Terminal Repair Kit J 38125-2, compare the retention force of this terminal to the female terminal in question by joining and separating the male terminal to the good female terminal, and then joining and separating the male terminal to the female terminal in question. If the retention force is significantly different between the two female terminals, replace the female terminal in question, refer to Terminal Repair Kit J 38125-2.
