1976 - 1990 Corvette: Service Bulletin: New On-Vehicle Service Procedure to Remove Rear Case or Extension Bushing

Subject: NEW ON-VEHICLE SERV. PROCEDURE REMOVE REAR CASE OR EXT. BUSH

Bulletin Number: 90-162-7A - (01/30/1990)

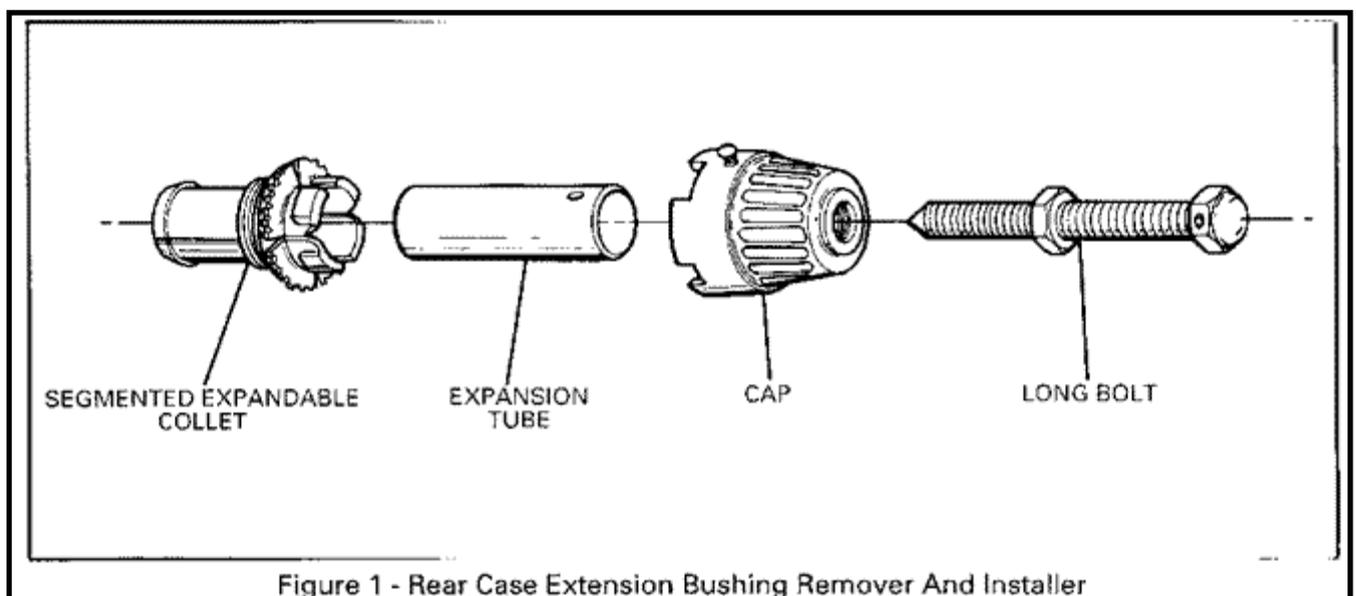
1. DISCONNECT PROPSHAFT FROM REAR OF TRANSMISSION
2. PRY OUT REAR CASE SEAL

3. ASSEMBLE TOOL

1. Disconnect propshaft from rear of transmission.
2. Remove rear case seal.
3. Assemble tool as shown in Figure 2.
4. Insert collet into rear opening of transmission case.
5. Slide expansion tube into segmented collet.
6. Turn cap to lock collet into position.
7. Use a 15/16" end wrench and turn bolt clockwise to remove bushing.
8. Remove J 38119 with collet attached.

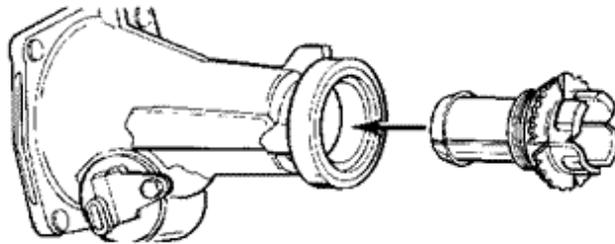
4. INSERT COLLET INTO TRANSMISSION

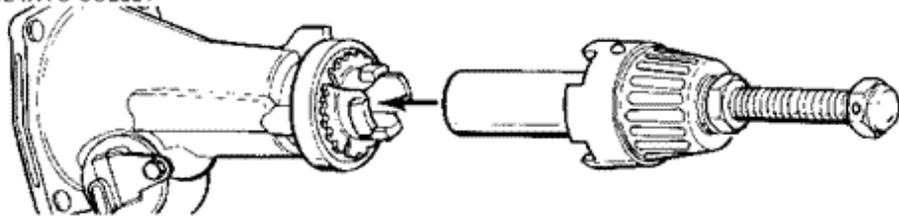
5. SLIDE EXPANSION TUBE INTO COLLET

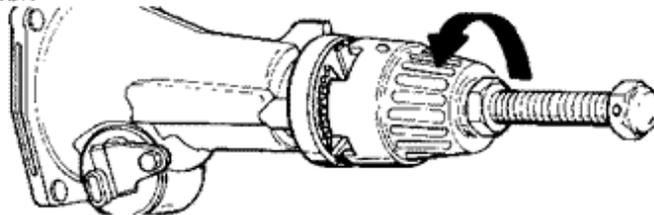
6. TURN CAP TO LOCK INTO POSITION

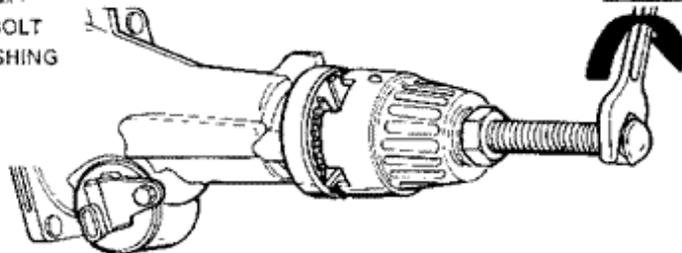
7. USE 15/16" WRENCH TO TURN BOLT CLOCKWISE AND REMOVE BUSHING

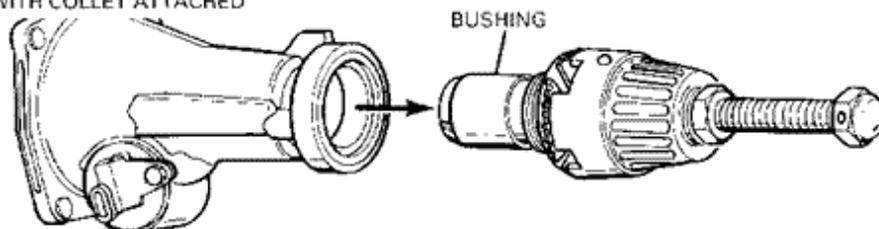
Figure 2 - Bushing Removal Procedure

8. PULL OUT J 38119 WITH COLLET ATTACHED

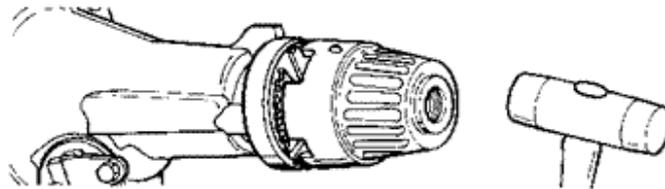
5. INSTALL J 38119 INTO TRANSMISSION WITH A PLASTIC HAMMER

1. Remove long bolt from cap of J 38119.
2. Place new bushing over segmented collet.
3. Slide black expansion tube into segments.
4. Turn cap to lock collet into place.
5. Install new bushing into transmission by driving J 38119 in firmly with a plastic hammer.
6. Turn cap to unlock collet.
7. Remove J 38119.
8. Remove collet.
9. Install rear case seal.
10. Connect propshaft to rear of transmission.

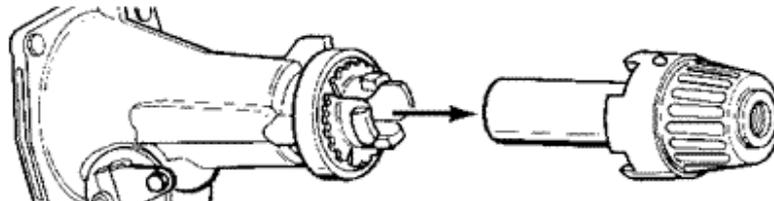
7. PULL OUT J 38119

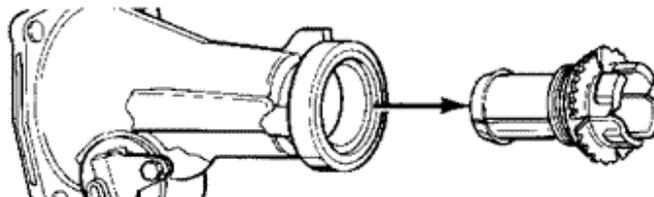
Figure 3 - Bushing Installation Procedure

8. REMOVE COLLET
