1976 - 1990 Corvette: Service Bulletin: New On-Vehicle Service Procedure to Remove Rear Case or Extension Bushing

Subject: NEW ON-VEHICLE SERV. PROCEDURE REMOVE REAR CASE OR EXT. BUSH

Model and Year: 1976-90 B, F, G, Y CARS & 1976-90 C, G, K, L, M, R, S, T, V TRUCKS WITH THM 200-4R, THM 200-C, THM 200 & 4L60/THM 700R4 AUTOMATIC TRANSMISSION

Bulletin Number: 90-162-7A - (01/30/1990)

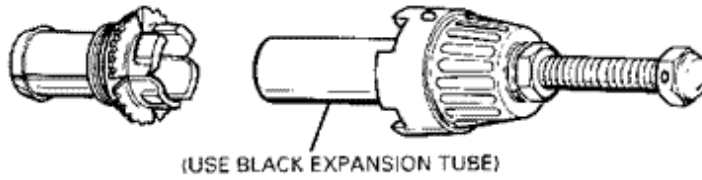
3. ASSEMBLE TOOL

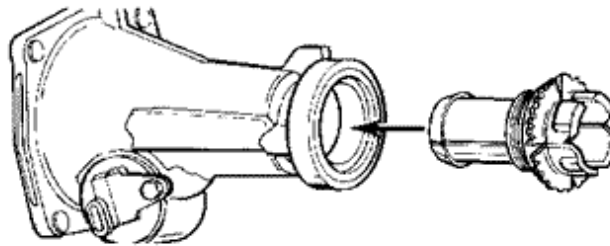
4. INSERT COLLET INTO TRANSMISSION

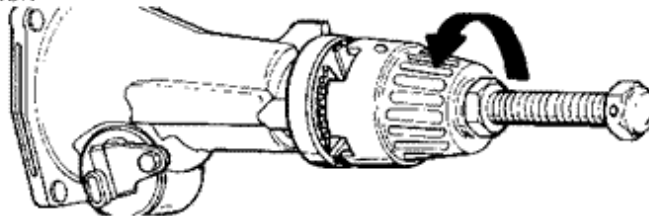
6. TURN CAP TO LOCK INTO POSITION

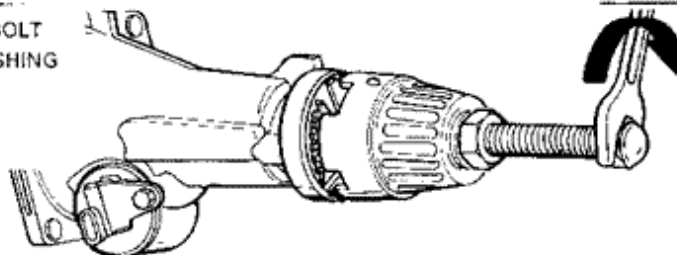
7. USE 15/16" WRENCH TO TURN BOLT CLOCKWISE AND REMOVE BUSHING

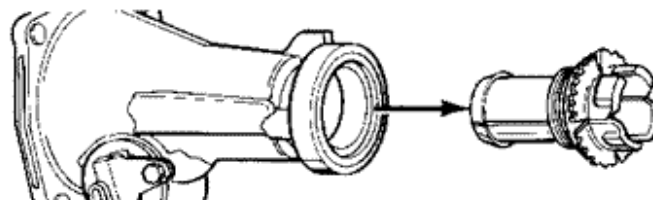
Figure 3 - Bushing Installation Procedure

8. REMOVE COLLET

Bushing Installation Procedure: (Figure 3)

1. Remove long bolt from cap of J 38119.
2. Place new bushing over segmented collet.
3. Slide black expansion tube into segments.
4. Turn cap to lock collet into place.
5. Install new bushing into transmission by driving J 38119 in firmly with a plastic hammer.
6. Turn cap to unlock collet.
7. Remove J 38119.
8. Remove collet.
9. Install rear case seal.
10. Connect propshaft to rear of transmission.
