# 1984 Corvette: Service Bulletin: No Heat - A/C Control Unit

**Subject:** No Heat - A/C Control Unit

**Bulletin Number:** 83-T-70, Number Ia

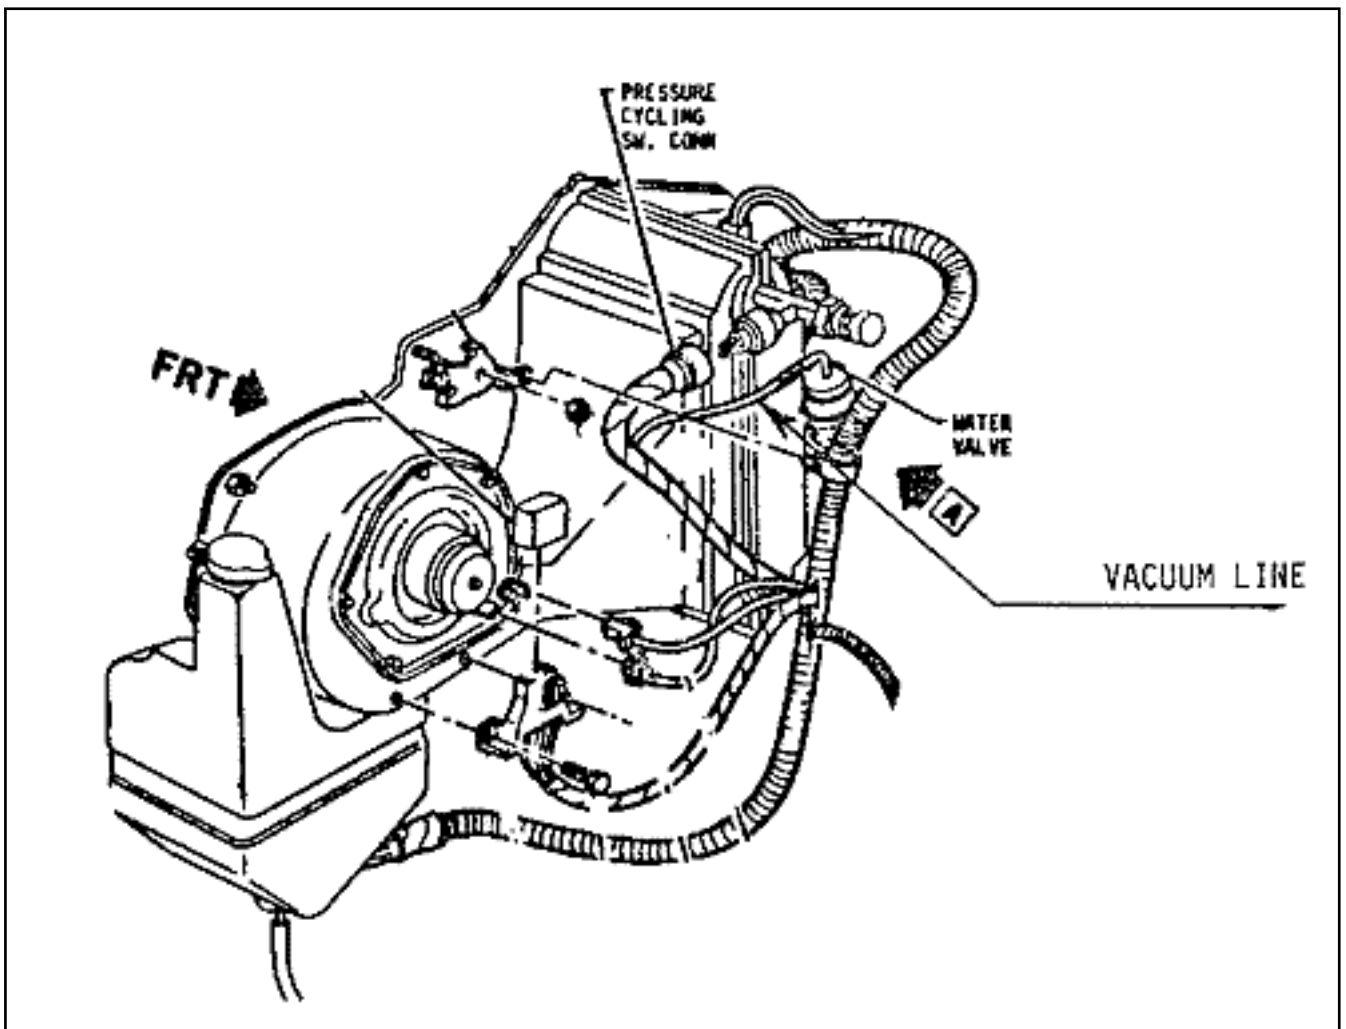
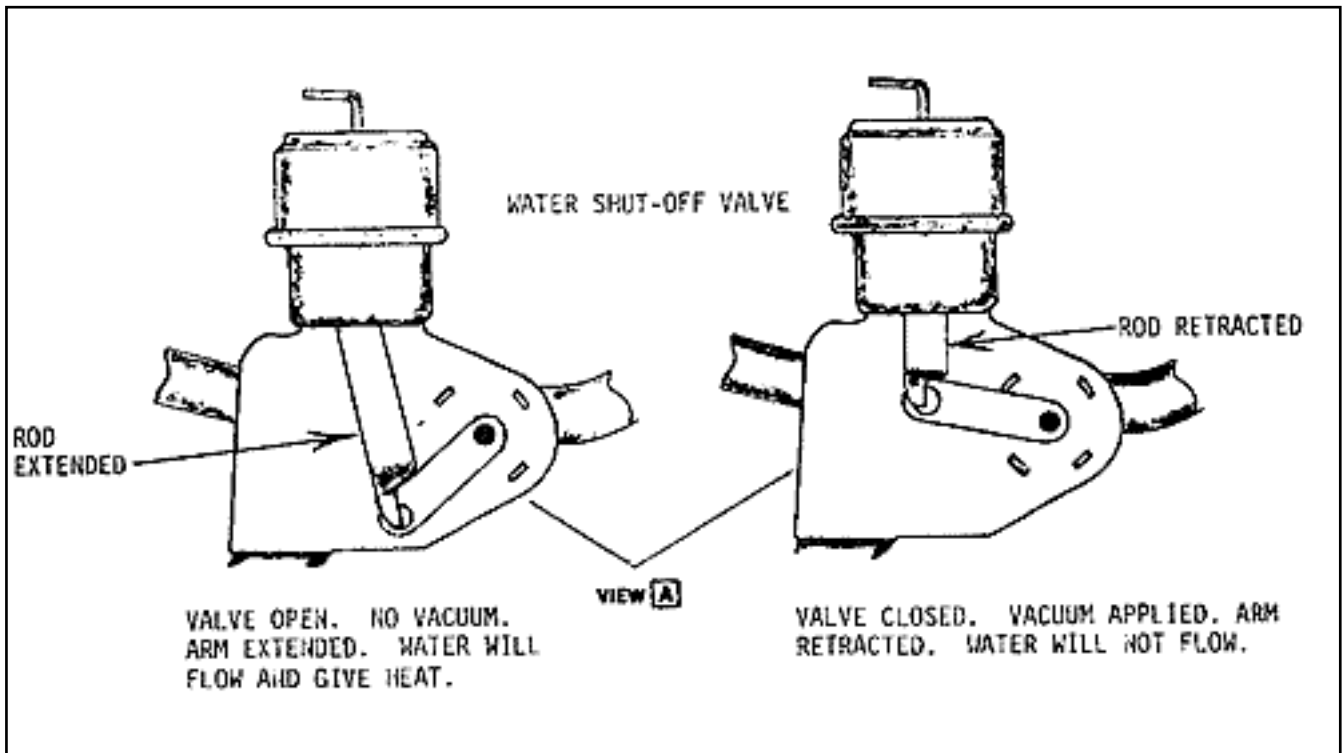
The vacuum switch in the A/C control unit controls a water shut off valve on the evaporator blower assembly. This valve should be closed with the temperature selector lever in the full cold position and open with the lever in any other position. Water will not flow through the heater core when the valve is closed (vacuum applied). Note that the valve actuating rod will be extended when the valve is open and retracted when closed (refer to sketch).

1. Observe the operation of the valve on the blower assembly while the temperature selector lever is moved from "cold" to "hot" position. The engine must be running to supply vacuum and should be at operating temperature.
2. If the valve opens (rod extended) when the temperature selector lever is moved to the "hot" position and heat output does not occur, the condition is not directly related to this particular control unit problem and should be further diagnosed, as described in Chevrolet Service Manual, Section 1.

3. If the valve does not open (rod retracted) remove the vacuum line from the valve. If this causes the valve to open and results in heat output, refer to Step 4.
4. Leave the vacuum line off the valve and seal off the end of the line to prevent a vacuum leak. (This can be done by fabricating a rubber plug or equivalent.) Secure the loose line to the harness with a band strap.
5. The vehicle can be operated with this line disconnected from the valve with no adverse effect to the A/C system.
