1984 Corvette: Service Bulletin: No Heat - A/C Control Unit

Source: Chevrolet Dealer Service Technical Bulletin

Bulletin Number: 83-T-70, Number Ia

Date: August, 1983

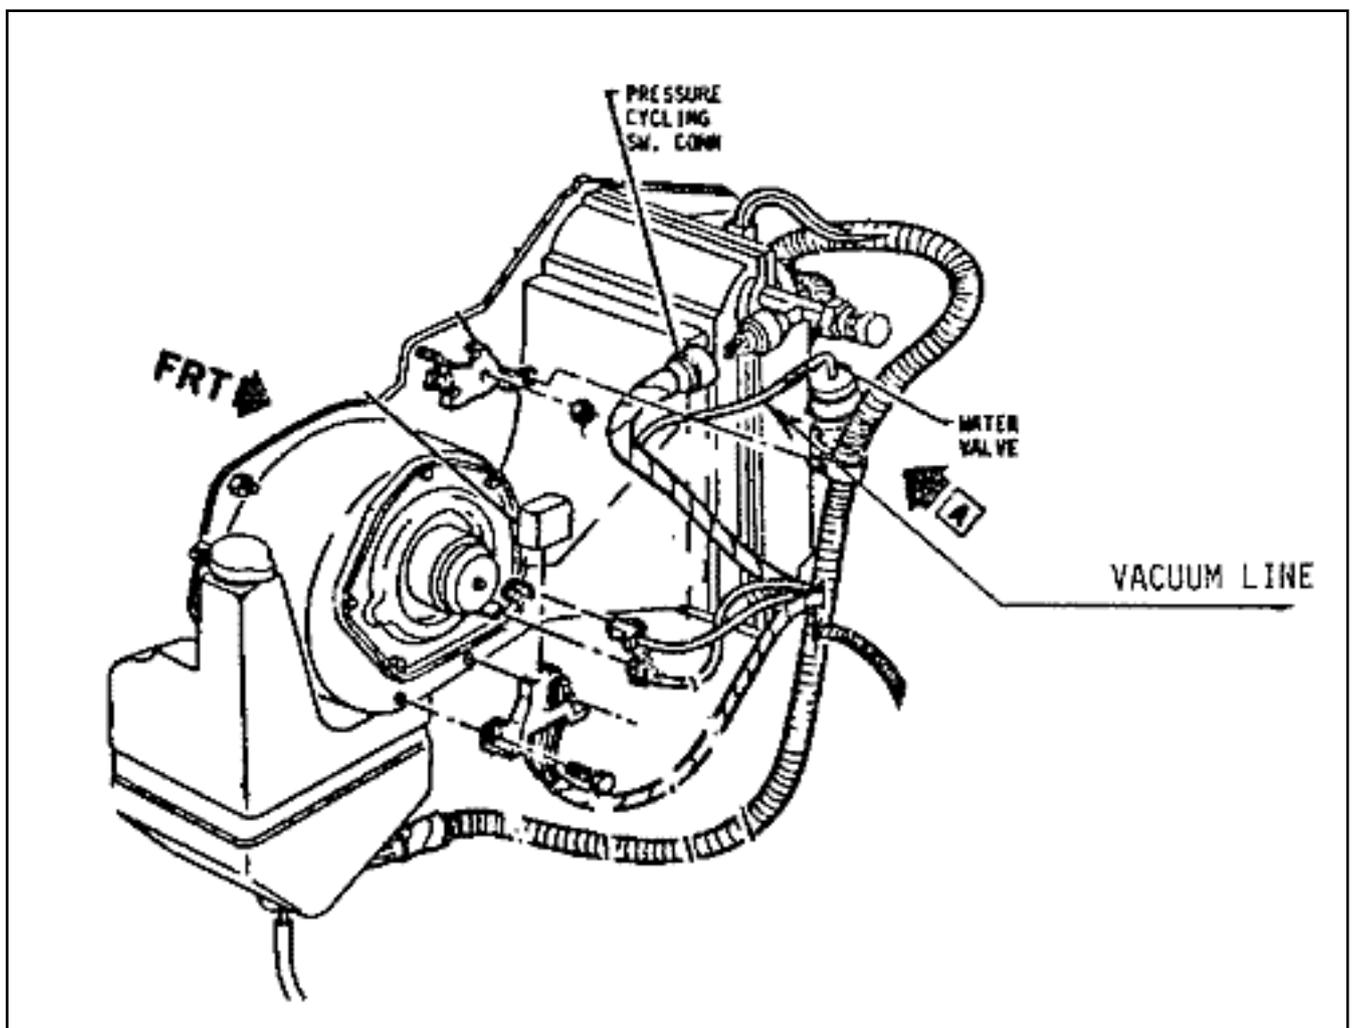
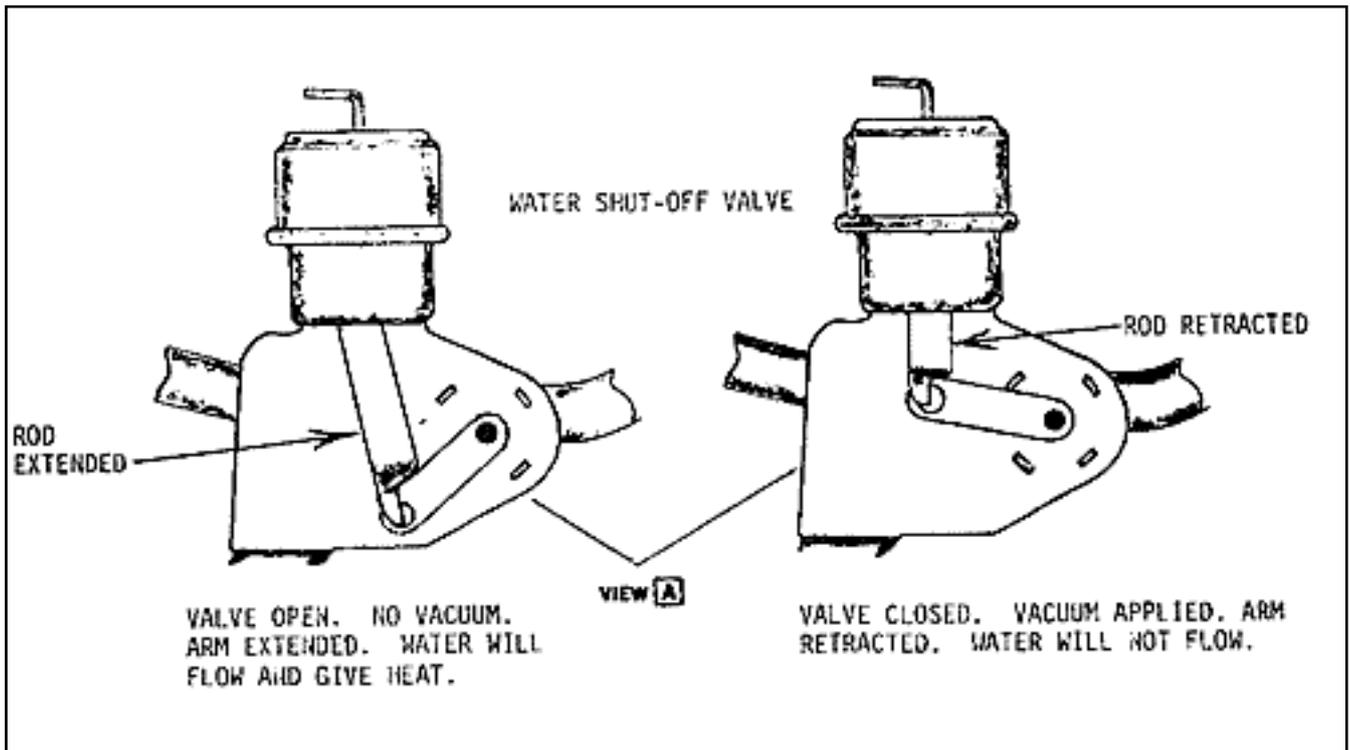
The vacuum switch in the A/C control unit controls a water shut off valve on the evaporator blower assembly. This valve should be closed with the temperature selector lever in the full cold position and open with the lever in any other position. Water will not flow through the heater core when the valve is closed (vacuum applied). Note that the valve actuating rod will be extended when the valve is open and retracted when closed (refer to sketch).

1. Observe the operation of the valve on the blower assembly while the temperature selector lever is moved from "cold" to "hot" position. The engine must be running to supply vacuum and should be at operating temperature.
2. If the valve opens (rod extended) when the temperature selector lever is moved to the "hot" position and heat output does not occur, the condition is not directly related to this particular control unit problem and should be further diagnosed, as described in Chevrolet Service Manual, Section 1.

3. If the valve does not open (rod retracted) remove the vacuum line from the valve. If this causes the valve to open and results in heat output, refer to Step 4.

4. Leave the vacuum line off the valve and seal off the end of the line to prevent a vacuum leak. (This can be done by fabricating a rubber plug or equivalent.) Secure the loose line to the harness with a band strap.

5. The vehicle can be operated with this line disconnected from the valve with no adverse effect to the A/C system.
